Manhole Inspection Report

Date:	05/04/2018	Weather:		Coding:	RZMACP
MH#:	M-705-009	Owner:	NA	Len. Surveyed:	12.7
P.O.#:		Surveyor:	Jen Costello	Rim to Invert:	15.0
Customer:		Cert. #:	U-907-5518	Wall Material:	Brick

Street:	Cleveland Ave. 463' East of Center S	Project:	Hobart, IN
City:	Hobart, IN	GPS Northing:	2905990.811
Location:		GPS Easting:	2905990.811
Drain Area:	South	GPS Accuracy:	Sub-Meter
Cover Shape:	Circular	Evidence of Surcharge:	No
Cover Size:	22.5	Potential for Runoff:	None
Comments:

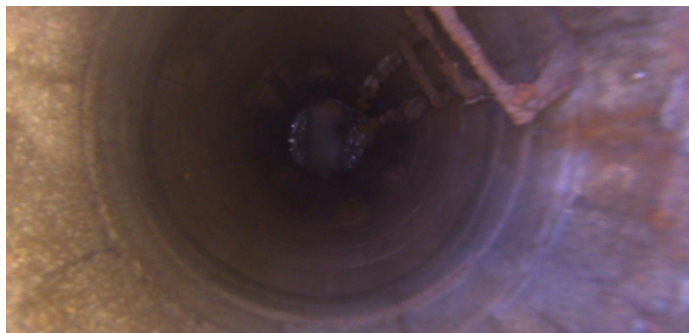
Code: **MGO**
Description: **General Observation**

Distance (ft): **.0**
Structural Grade: **0**
O&M Grade: **0**
Clock Start/From:
Clock To:
1st Value:
2nd Value:
Value Percent:
Step: **NO**
Remarks: **ACCESS MH**

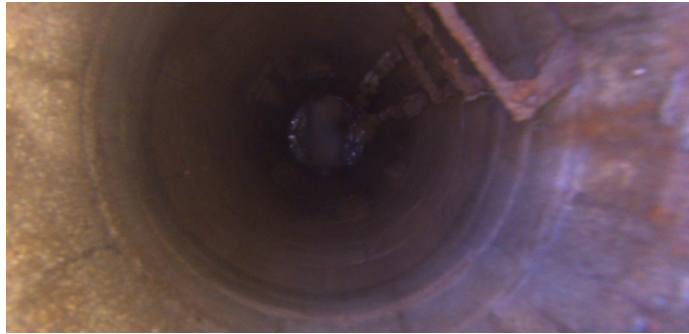
Code: **SAV**
Description: **Surface Aggregate Visible**

Distance (ft): **.0**
Structural Grade: **3**
O&M Grade: **0**
Clock Start/From: **12**
Clock To: **12**
1st Value:
2nd Value:
Value Percent:
Step: **NO**
Remarks:

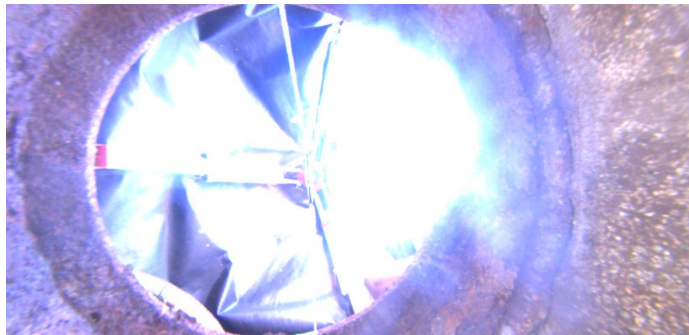
Code: **MGO**
Description: **General Observation**

Distance (ft): **1.6**
Structural Grade: **0**
O&M Grade: **0**
Clock Start/From:
Clock To:
1st Value:
2nd Value:
Value Percent:
Step: **NO**
Remarks: **UNDERSIDE OF FRAME**

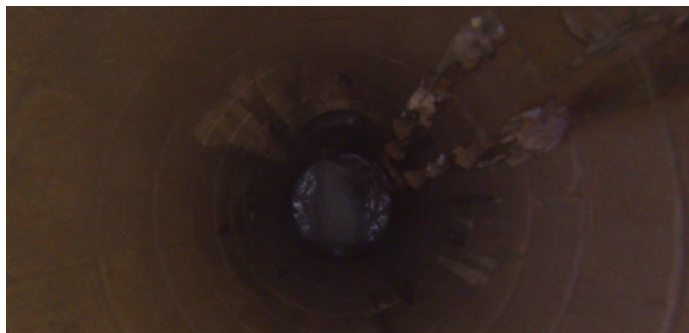
Code: **MGO**
Description: **General Observation**

Distance (ft): **3.2**
Structural Grade: **0**
O&M Grade: **0**
Clock Start/From:
Clock To:
1st Value:
2nd Value:
Value Percent:
Step: **NO**
Remarks: **MISSING AND BROKEN STEPS**

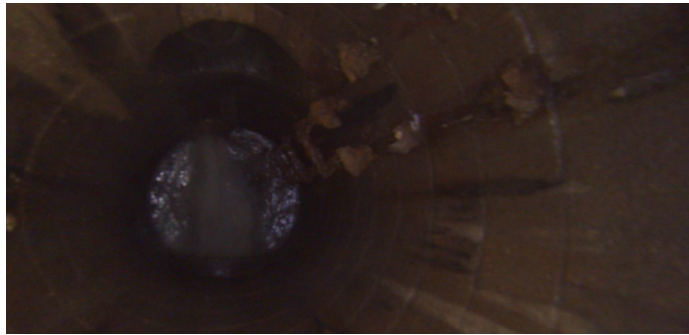
Code: **IW**
Description: **Infil Weeper**

Distance (ft): **5.7**
Structural Grade: **0**
O&M Grade: **2**
Clock Start/From: **3**
Clock To:
1st Value:
2nd Value:
Value Percent:
Step: **NO**
Remarks:

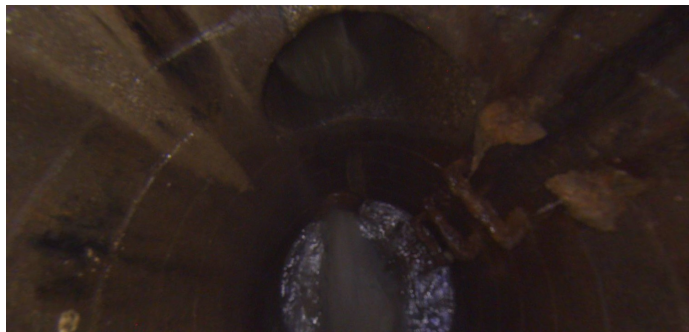
Code: **IW**
Description: **Infil Weeper**

Distance (ft): **7.7**
Structural Grade: **0**
O&M Grade: **2**
Clock Start/From: **12**
Clock To: **12**
1st Value:
2nd Value:
Value Percent:
Step: **NO**
Remarks:

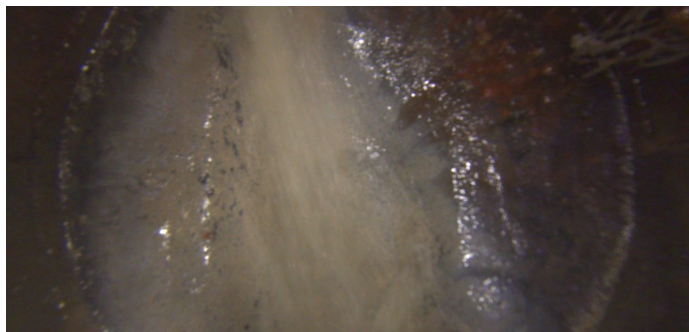
Code: **MGO**
Description: **General Observation**

Distance (ft): **12.7**
Structural Grade: **0**
O&M Grade: **0**
Clock Start/From:
Clock To:
1st Value:
2nd Value:
Value Percent:
Step: **NO**
Remarks: **END SURVEY**
