# Manhole Inspection Report

Date:	05/06/2018	Weather:		Coding:	RZMACP
MH#:	M-705-014	Owner:	NA	Len. Surveyed:	9.5
P.O.#:		Surveyor:	Jen Costello	Rim to Invert:	11.1
Customer:		Cert. #:	U-907-5518	Wall Material:	Concrete (reinforced)

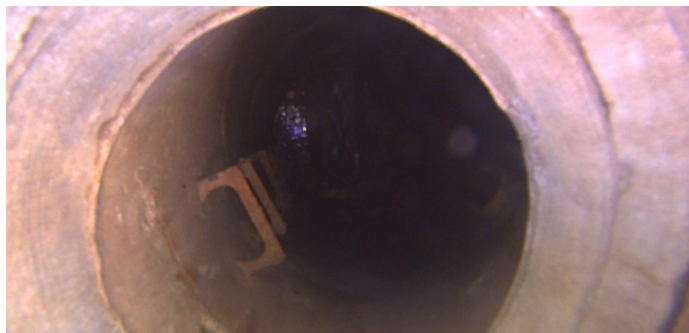
Code: **MGP**  
Description: **General Photo**

Distance (ft): **.0**  
Structural Grade: **0**  
O&M Grade: **0**  
Clock Start/From:  
Clock To:  
1st Value:  
2nd Value:  
Value Percent:  
Step: **NO**  
Remarks: **ACCESS MH**

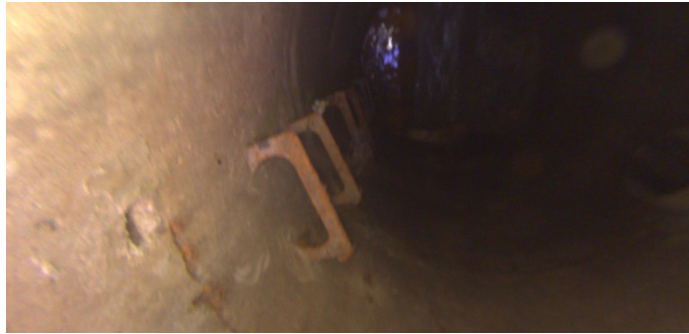
Code: **MGO**  
Description: **General Observation**

Distance (ft): **1.2**  
Structural Grade: **0**  
O&M Grade: **0**  
Clock Start/From:  
Clock To:  
1st Value:  
2nd Value:  
Value Percent:  
Step: **NO**  
Remarks: **MISSING STEP**

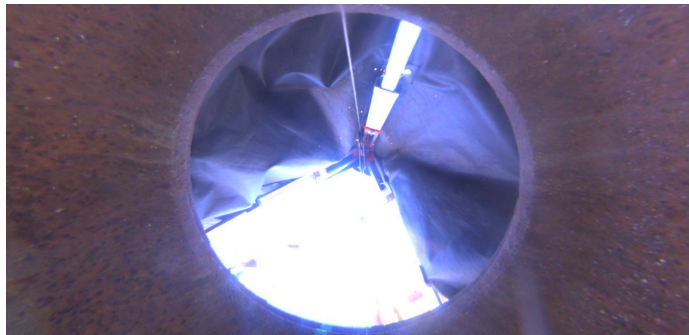
Code: **MGO**  
Description: **General Observation**

Distance (ft): **1.2**  
Structural Grade: **0**  
O&M Grade: **0**  
Clock Start/From:  
Clock To:  
1st Value:  
2nd Value:  
Value Percent:  
Step: **NO**  
Remarks: **END SURVEY**

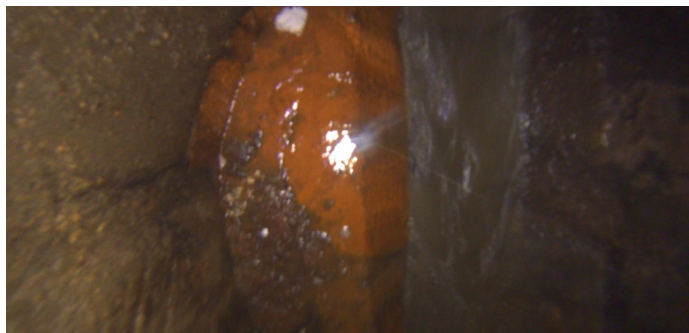
Code: **FL**  
Description: **Fracture Longitudinal**

Distance (ft): **8.0**  
Structural Grade: **3**  
O&M Grade: **0**  
Clock Start/From: **9**  
Clock To:  
1st Value:  
2nd Value:  
Value Percent:  
Step: **NO**  
Remarks:

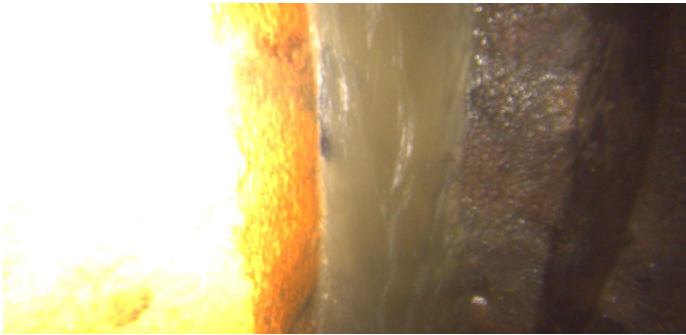
Code:	<b>MGO</b>
Description:	<b>General Observation</b>
Distance (ft):	<b>9.5</b>
Structural Grade:	<b>0</b>
O&M Grade:	<b>0</b>
Clock Start/From:	
Clock To:	
1st Value:	
2nd Value:	
Value Percent:	
Step:	<b>NO</b>
Remarks:	<b>END SURVEY</b>
