Manhole Inspection Report

Date:	05/04/2018	Weather:		Coding:	RZMACP
MH#:	M-705-016	Owner:	NA	Len. Surveyed:	11.6
P.O.#:		Surveyor:	Jen Costello	Rim to Invert:	11.8
Customer:		Cert. #:	U-907-5518	Wall Material:	Concrete (reinforced)

Street:	Intersection of Main St. and 5th St.	Project:	Hobart, IN
City:	Hobart, IN	GPS Northing:	2906176.776
Location:		GPS Easting:	2906176.776
Drain Area:	South	GPS Accuracy:	Sub-Meter
Cover Shape:	Circular	Evidence of Surcharge:	No
Cover Size:	22.5	Potential for Runoff:	None
Comments:

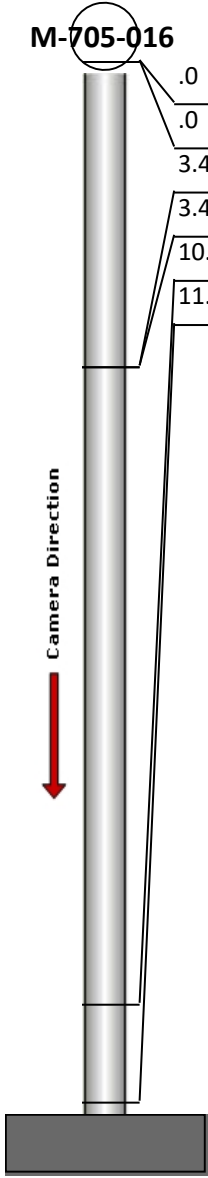
M-705-016				
	.0	MGP	General Photo	10	NA
	.0	B	Broken	21	S 5
	3.4	MGO	General Observation	42	NA
	3.4	MGO	General Observation	55	NA
	10.5	DSF	Deposits Settled Fine	81	M 2
	11.6	MGO	General Observation	94	NA

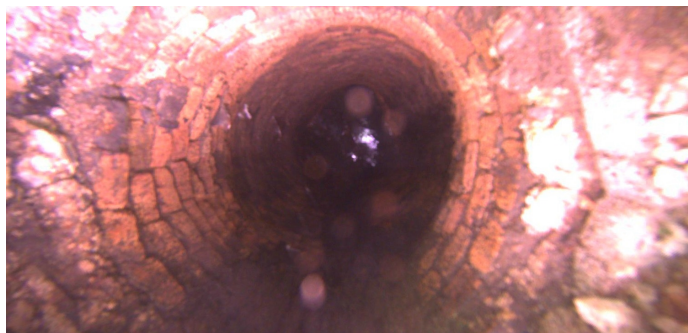
Code: **MGP**
Description: **General Photo**

Distance (ft): **.0**
Structural Grade: **0**
O&M Grade: **0**
Clock Start/From:
Clock To:
1st Value:
2nd Value:
Value Percent:
Step: **NO**
Remarks: **access mh**

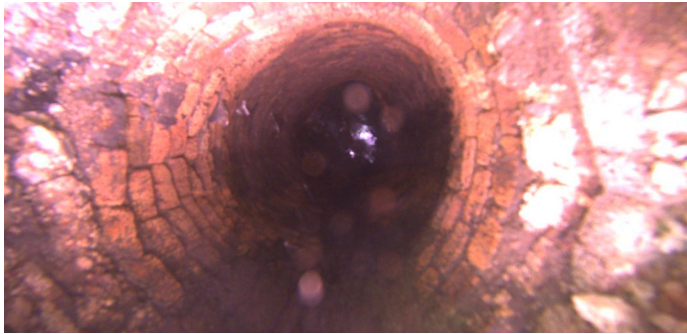
Code: **B**
Description: **Broken**

Distance (ft): **.0**
Structural Grade: **5**
O&M Grade: **0**
Clock Start/From: **12**
Clock To: **12**
1st Value:
2nd Value:
Value Percent:
Step: **NO**
Remarks:

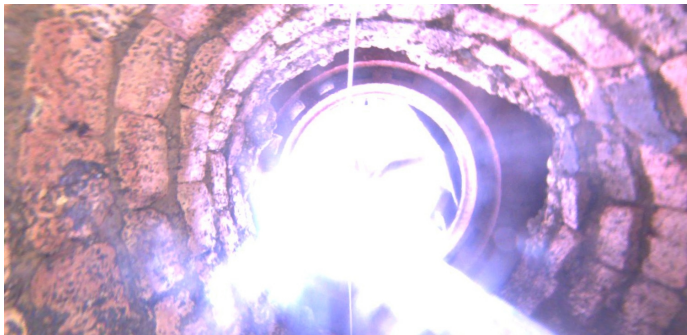
Code: **MGO**
Description: **General Observation**

Distance (ft): **3.4**
Structural Grade: **0**
O&M Grade: **0**
Clock Start/From:
Clock To:
1st Value:
2nd Value:
Value Percent:
Step: **NO**
Remarks: **underside of frame**

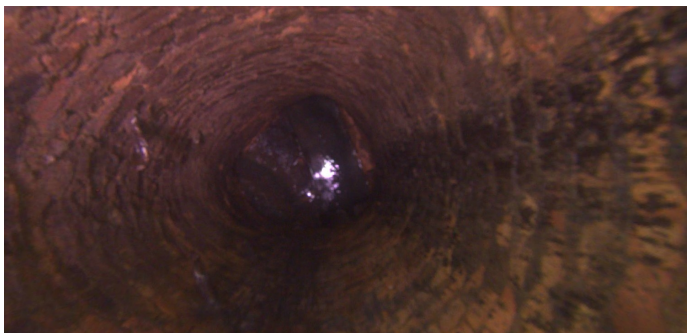
Code: **MGO**
Description: **General Observation**

Distance (ft): **3.4**
Structural Grade: **0**
O&M Grade: **0**
Clock Start/From:
Clock To:
1st Value:
2nd Value:
Value Percent:
Step: **NO**
Remarks: **missing step**

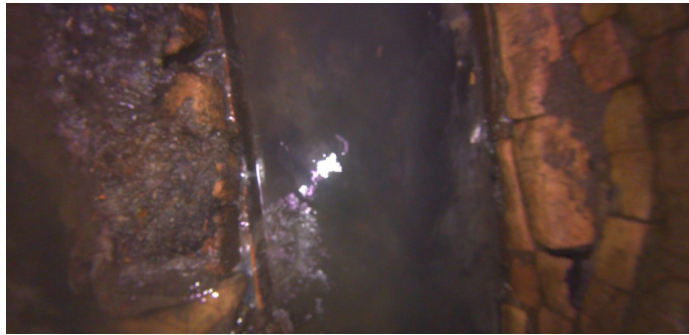
Code:	DSF
Description:	Deposits Settled Fine
Distance (ft):	10.5
Structural Grade:	0
O&M Grade:	2
Clock Start/From:	12
Clock To:	12
1st Value:	
2nd Value:	
Value Percent:	5.000
Step:	NO
Remarks:

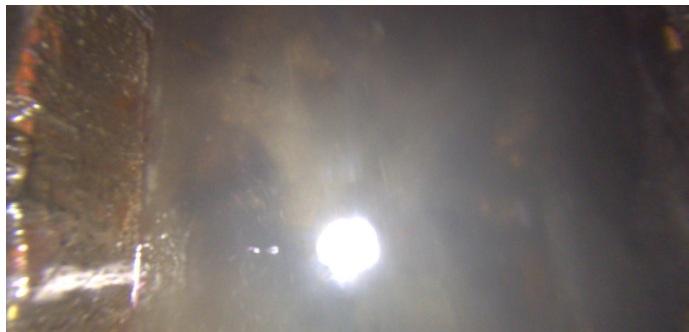
Code:	MGO
Description:	General Observation
Distance (ft):	11.6
Structural Grade:	0
O&M Grade:	0
Clock Start/From:	
Clock To:	
1st Value:	
2nd Value:	
Value Percent:	
Step:	NO
Remarks:	end survey
