Manhole Inspection Report

Date:	04/29/2018	Weather:		Coding:	RZMACP
MH#:	M-705-017	Owner:	NA	Len. Surveyed:	9.6
P.O.#:		Surveyor:	Jen Costello	Rim to Invert:	9.9
Customer:		Cert. #:	U-907-5518	Wall Material:	Concrete (reinforced)

Street:	Intersection of 6th St. and Main St.	Project:	Hobart, IN
City:	Hobart, IN	GPS Northing:	41.52897644
Location:		GPS Easting:	-87.25286865
Drain Area:	South	GPS Accuracy:	Nearest Meter
Cover Shape:	Circular	Evidence of Surcharge:	No
Cover Size:	22.5	Potential for Runoff:	None
Comments:

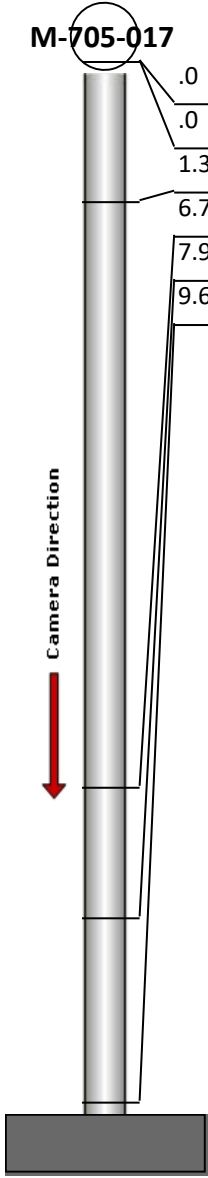
.0	MGO	General Observation	10	NA
	.0	DB	Displaced Brick	21	S 3
	1.3	MGO	General Observation	37	NA
	6.7	MGO	General Observation	61	NA
	7.9	DSF	Deposits Settled Fine	74	M 2
	9.6	MGO	General Observation	90	NA

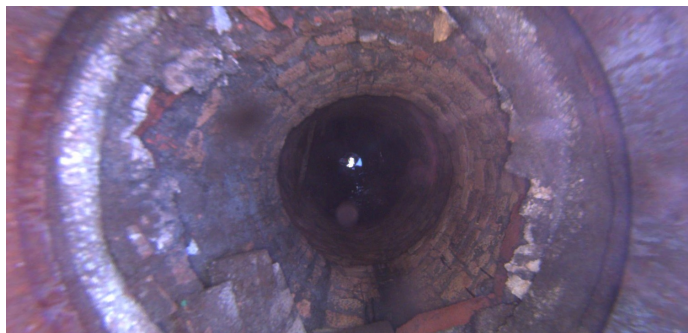
Code: **MGO**
Description: **General Observation**

Distance (ft): **.0**
Structural Grade: **0**
O&M Grade: **0**
Clock Start/From:
Clock To:
1st Value:
2nd Value:
Value Percent:
Step: **NO**
Remarks: **ACCESS MH**

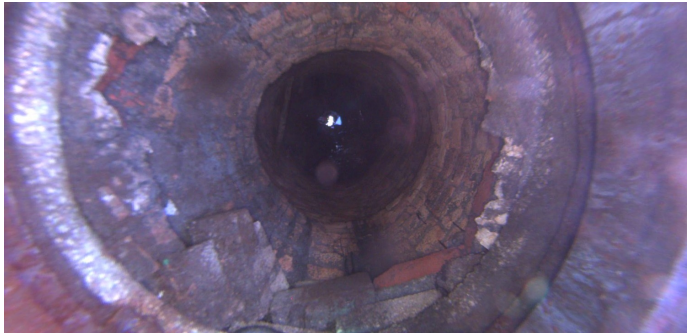
Code: **DB**
Description: **Displaced Brick**

Distance (ft): **.0**
Structural Grade: **3**
O&M Grade: **0**
Clock Start/From: **6**
Clock To: **7**
1st Value:
2nd Value:
Value Percent:
Step: **NO**
Remarks:

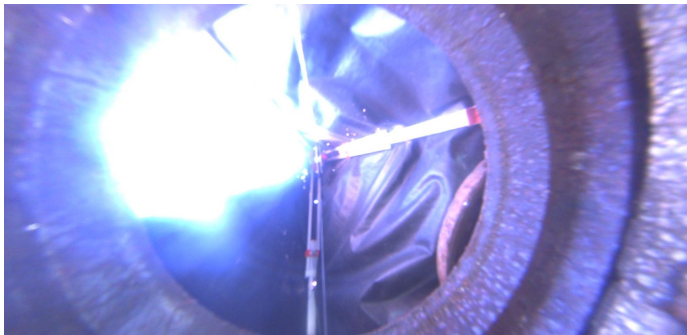
Code: **MGO**
Description: **General Observation**

Distance (ft): **1.3**
Structural Grade: **0**
O&M Grade: **0**
Clock Start/From:
Clock To:
1st Value:
2nd Value:
Value Percent:
Step: **NO**
Remarks: **UNDERSIDE OF FRAME**

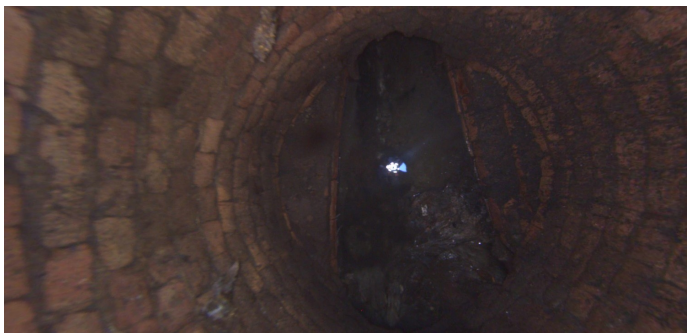
Code: **MGO**
Description: **General Observation**

Distance (ft): **6.7**
Structural Grade: **0**
O&M Grade: **0**
Clock Start/From:
Clock To:
1st Value:
2nd Value:
Value Percent:
Step: **NO**
Remarks: **BROKEN AND MISSING STEPS**

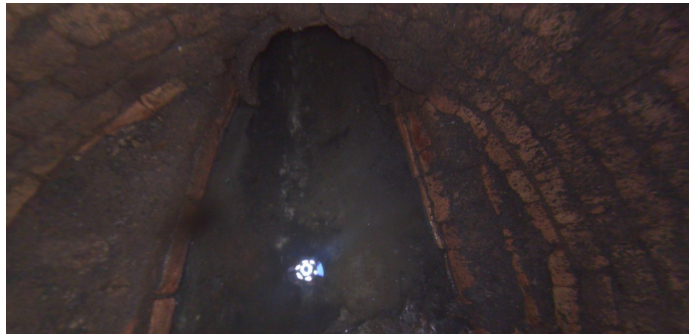
Code: **DSF**
Description: **Deposits Settled Fine**

Distance (ft): **7.9**
Structural Grade: **0**
O&M Grade: **2**
Clock Start/From: **12**
Clock To: **12**
1st Value:
2nd Value:
Value Percent: **5.000**
Step: **NO**
Remarks:

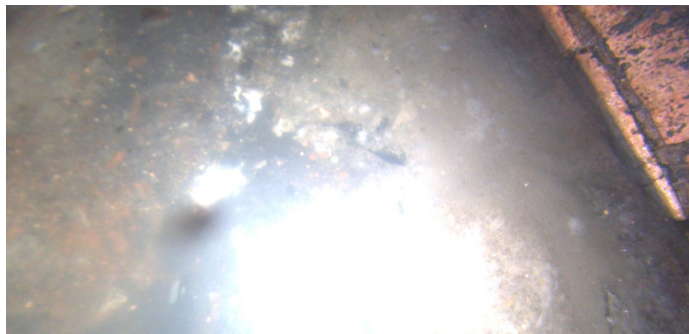
Code: **MGO**
Description: **General Observation**

Distance (ft): **9.6**
Structural Grade: **0**
O&M Grade: **0**
Clock Start/From:
Clock To:
1st Value:
2nd Value:
Value Percent:
Step: **NO**
Remarks: **END SURVEY**
