# Manhole Inspection Report

Date:	05/03/2018	Weather:		Coding:	RZMACP
MH#:	M-705-033	Owner:	NA	Len. Surveyed:	9.3
P.O.#:		Surveyor:	Jen Costello	Rim to Invert:	10.0
Customer:		Cert. #:	U-907-5518	Wall Material:	Brick

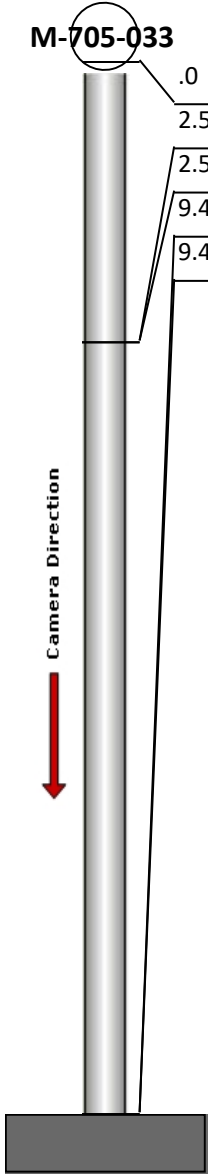
M-705-033				
	.0	MGP	General Photo	10	NA
	2.5	IS	Infil Stain	27	NA
	2.5	DAE	Deposits Attached Encrustation	38	M 2
	9.4	DSZ	Deposits Settled Other	64	M 3
	9.4	MGO	General Observation	75	NA

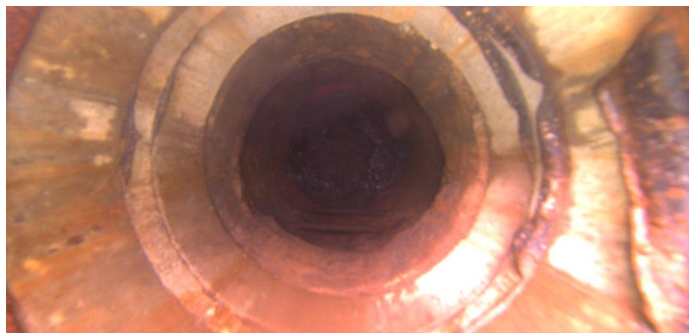
Code: **MGP**  
Description: **General Photo**

Distance (ft): **.0**  
Structural Grade: **0**  
O&M Grade: **0**  
Clock Start/From:  
Clock To:  
1st Value:  
2nd Value:  
Value Percent:  
Step: **NO**  
Remarks: **ACCESS MH**

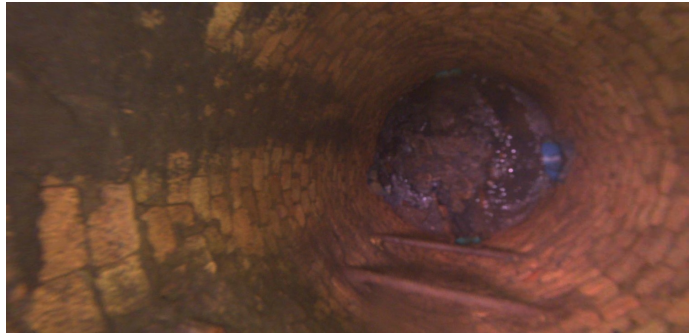
Code: **IS**  
Description: **Infil Stain**

Distance (ft): **2.5**  
Structural Grade: **0**  
O&M Grade: **0**  
Clock Start/From: **10**  
Clock To:  
1st Value:  
2nd Value:  
Value Percent:  
Step: **NO**  
Remarks:

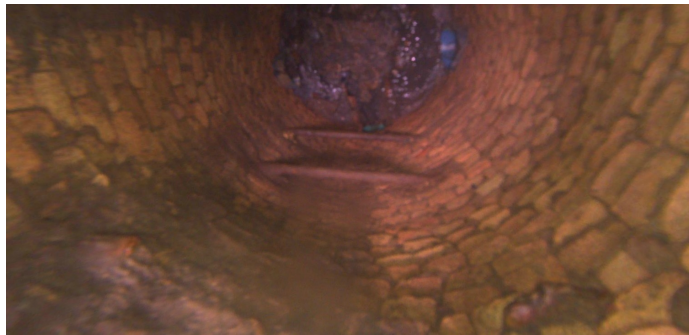
Code: **DAE**  
Description: **Deposits Attached Encrustation**

Distance (ft): **2.5**  
Structural Grade: **0**  
O&M Grade: **2**  
Clock Start/From: **6**  
Clock To: **8**  
1st Value:  
2nd Value:  
Value Percent: **5.000**  
Step: **NO**  
Remarks:

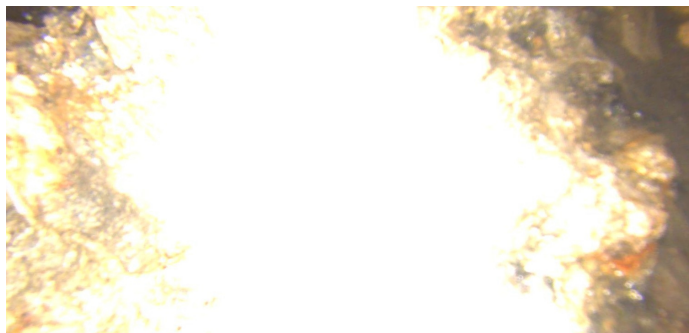
Code: **DSZ**  
Description: **Deposits Settled Other**

Distance (ft): **9.4**  
Structural Grade: **0**  
O&M Grade: **3**  
Clock Start/From: **12**  
Clock To: **12**  
1st Value:  
2nd Value:  
Value Percent: **20.000**  
Step: **NO**  
Remarks: **MISC**

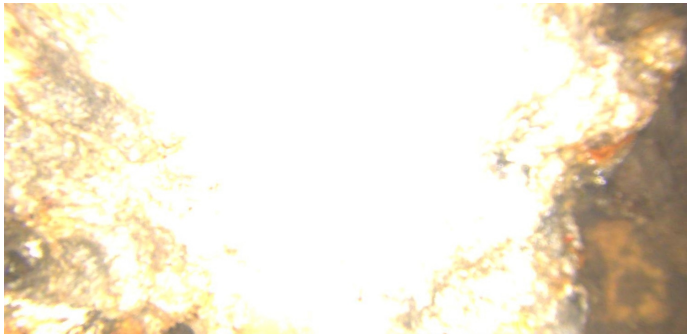
Code: **MGO**  
Description: **General Observation**

Distance (ft): **9.4**

O&M Grade: **0**

Remarks: **END SURVEY**
