Manhole Inspection Report

Date:	05/03/2018	Weather:		Coding:	RZMACP
MH#:	M-705-035	Owner:	NA	Len. Surveyed:	11.3
P.O.#:		Surveyor:	Jen Costello	Rim to Invert:	11.7
Customer:		Cert. #:	U-907-5518	Wall Material:	Concrete (reinforced)

Street:	Intersection of Center St. and Secon	Project:	Hobart, IN
City:	Hobart, IN	GPS Northing:	41.53341675
Location:		GPS Easting:	-87.25430298
Drain Area:	South	GPS Accuracy:	Nearest Meter
Cover Shape:	Circular	Evidence of Surcharge:	No
Cover Size:	22.5	Potential for Runoff:	None
Comments:

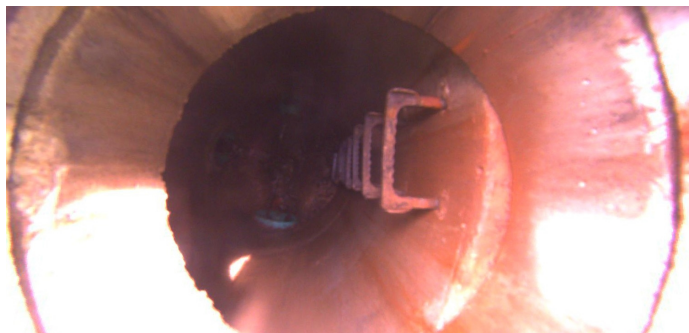
Code: **MGP**
Description: **General Photo**

Distance (ft): **.0**
Structural Grade: **0**
O&M Grade: **0**
Clock Start/From:
Clock To:
1st Value:
2nd Value:
Value Percent:
Step: **NO**
Remarks: **ACCESS MH**

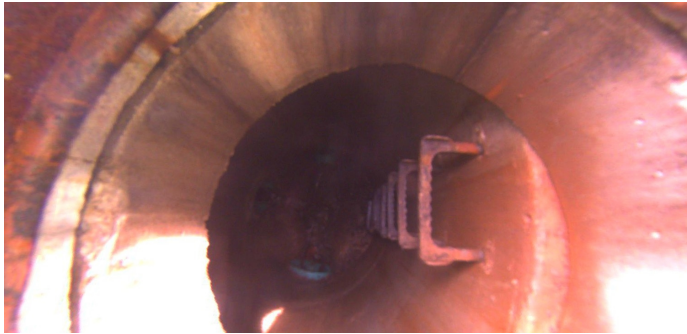
Code: **SSS**
Description: **Surface Spalling**

Distance (ft): **.0**
Structural Grade: **2**
O&M Grade: **0**
Clock Start/From: **9**
Clock To:
1st Value:
2nd Value:
Value Percent:
Step: **NO**
Remarks:

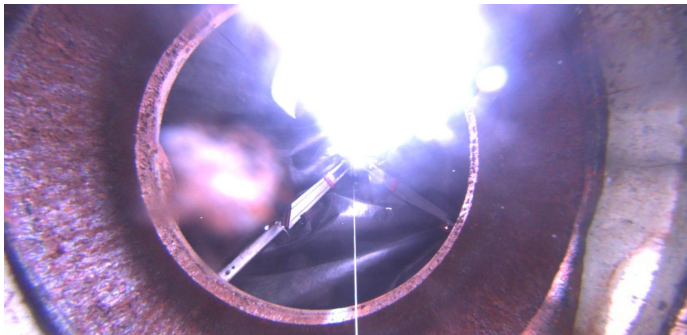
Code: **MGO**
Description: **General Observation**

Distance (ft): **1.4**
Structural Grade: **0**
O&M Grade: **0**
Clock Start/From:
Clock To:
1st Value:
2nd Value:
Value Percent:
Step: **NO**
Remarks: **UNDERSIDE OF FRAME**

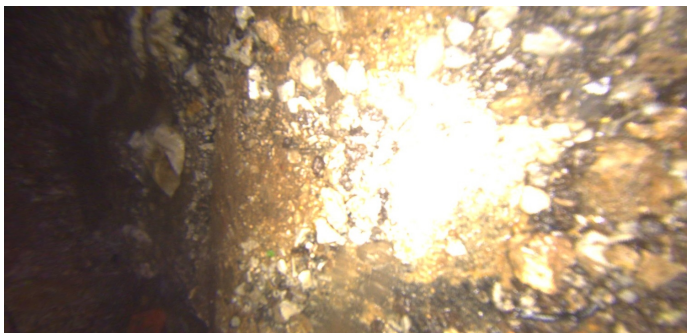
Code: **MGO**
Description: **General Observation**

Distance (ft): **11.3**
Structural Grade: **0**
O&M Grade: **0**
Clock Start/From:
Clock To:
1st Value:
2nd Value:
Value Percent:
Step: **NO**
Remarks: **END SURVEY**

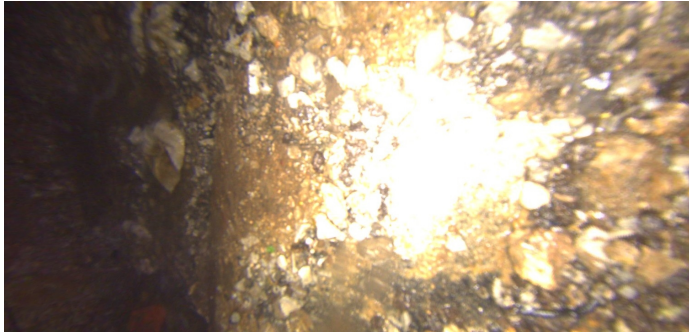
Code:	DSF
Description:	Deposits Settled Fine
Distance (ft):	11.3
Structural Grade:	0
O&M Grade:	2
Clock Start/From:	12
Clock To:	12
1st Value:	
2nd Value:	
Value Percent:	5.000
Step:	NO
Remarks:
