# Manhole Inspection Report

Date:	<b>09/29/2022</b>	Weather:		Coding:	<b>RZMACP</b>
MH#:	<b>M-705-045</b>	Owner:	<b>NA</b>	Len. Surveyed:	<b>7.2</b>
P.O.#:		Surveyor:	<b>Jen Costello</b>	Rim to Invert:	<b>8.7</b>
Customer:		Cert. #:	<b>U-907-5518</b>	Wall Material:	<b>Brick</b>

Street:	<b>Intersection of 4th St. and East St.</b>	Project:	<b>Hobart, IN</b>
City:	<b>Hobart, IN</b>	GPS Northing:	<b>2288834.314</b>
Location:	<b>Local Rural Streets</b>	GPS Easting:	<b>2906568.699</b>
Drain Area:	<b>South</b>	GPS Accuracy:	<b>Sub-Meter</b>
Cover Shape:	<b>Circular</b>	Evidence of Surcharge:	<b>No</b>
Cover Size:	<b>24.0</b>	Potential for Runoff:	<b>None</b>
Comments:

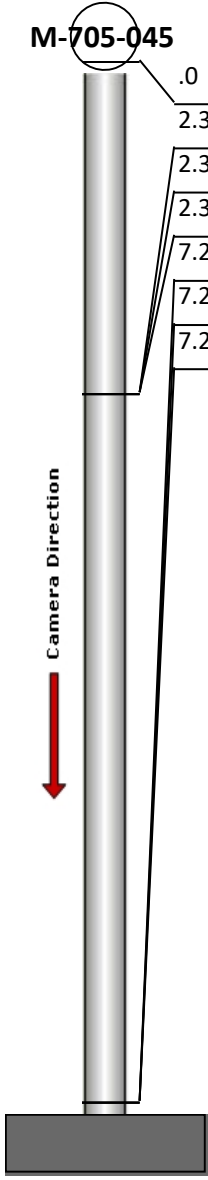
.0	MGO	General Observation	10	NA
	2.3	DB	Displaced Brick	28	S 3
	2.3	MGO	General Observation	39	NA
	2.3	VC	Vermin Cockroach	52	M 1
	7.2	OBR	Obstacle Rocks	74	M 2
	7.2	DSF	Deposits Settled Fine	86	M 2
	7.2	MGO	General Observation	97	NA

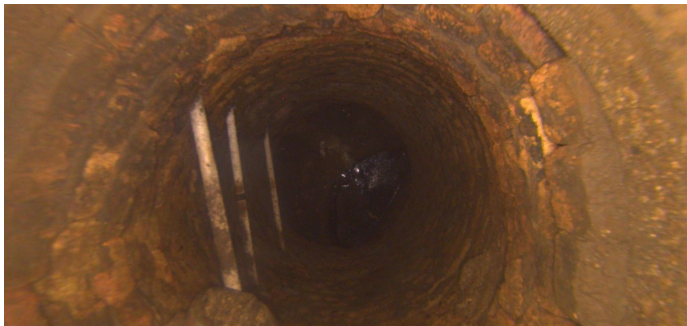
Code: **MGO**  
Description: **General Observation**

Distance (ft): **.0**  
Structural Grade: **0**  
O&M Grade: **0**  
Clock Start/From:  
Clock To:  
1st Value:  
2nd Value:  
Value Percent:  
Step: **NO**  
Remarks: **access mh**

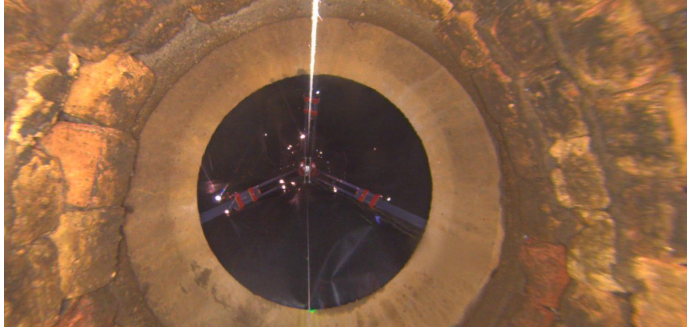
Code: **DB**  
Description: **Displaced Brick**

Distance (ft): **2.3**  
Structural Grade: **3**  
O&M Grade: **0**  
Clock Start/From: **2**  
Clock To: **4**  
1st Value:  
2nd Value:  
Value Percent:  
Step: **NO**  
Remarks:

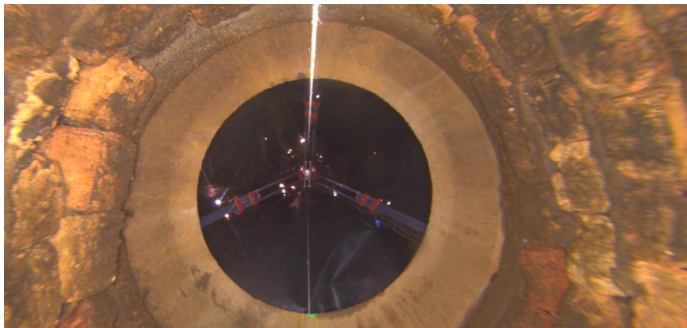
Code: **MGO**  
Description: **General Observation**

Distance (ft): **2.3**  
Structural Grade: **0**  
O&M Grade: **0**  
Clock Start/From:  
Clock To:  
1st Value:  
2nd Value:  
Value Percent:  
Step: **NO**  
Remarks: **underside of frame**

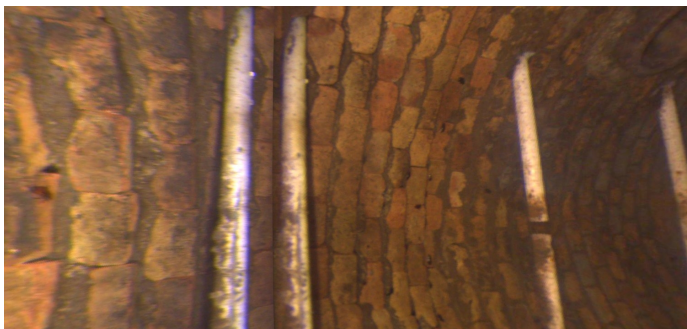
Code: **VC**  
Description: **Vermin Cockroach**

Distance (ft): **2.3**  
Structural Grade: **0**  
O&M Grade: **1**  
Clock Start/From:  
Clock To:  
1st Value:  
2nd Value:  
Value Percent:  
Step: **NO**  
Remarks:

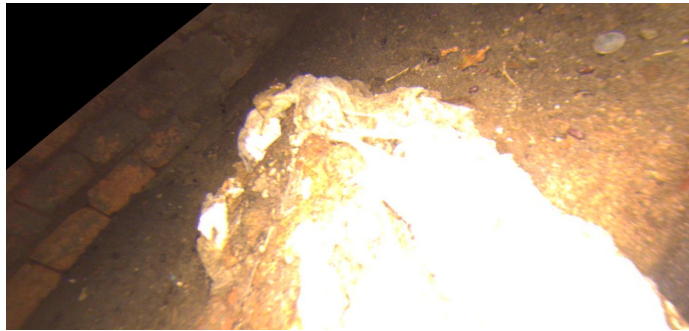
Code: **OBR**  
Description: **Obstacle Rocks**

Distance (ft): **7.2**  
Structural Grade: **0**  
O&M Grade: **2**  
Clock Start/From: **9**  
Clock To: **12**  
1st Value:  
2nd Value:  
Value Percent: **10.000**  
Step: **NO**  
Remarks:

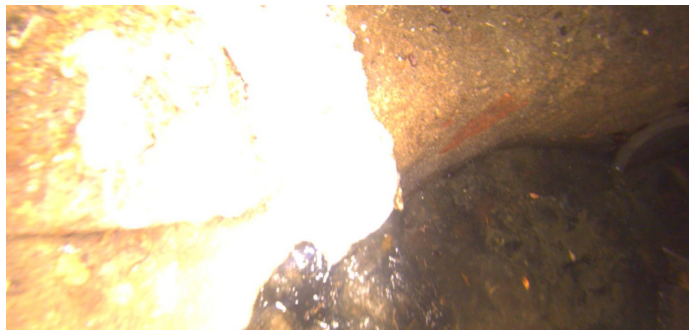
Code: **DSF**  
Description: **Deposits Settled Fine**

Distance (ft): **7.2**  
Structural Grade: **0**  
O&M Grade: **2**  
Clock Start/From: **12**  
Clock To: **12**  
1st Value:  
2nd Value:  
Value Percent: **5.000**  
Step: **NO**  
Remarks:

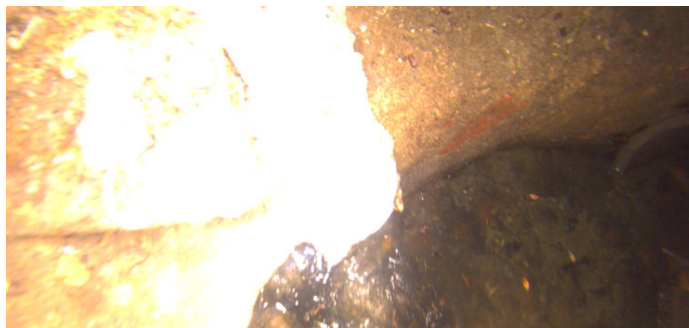
Code: **MGO**  
Description: **General Observation**

Distance (ft): **7.2**  
Structural Grade: **0**  
O&M Grade: **0**  
Clock Start/From:  
Clock To:  
1st Value:  
2nd Value:  
Value Percent:  
Step: **NO**  
Remarks: **end of survey**
