Manhole Inspection Report

Date:	05/04/2018	Weather:		Coding:	RZMACP
MH#:	M-705-050	Owner:	NA	Len. Surveyed:	9.6
P.O.#:		Surveyor:	Jen Costello	Rim to Invert:	10.6
Customer:		Cert. #:	U-907-5518	Wall Material:	Brick

Street:	Intersection of 3rd St. and New St.	Project:	Hobart, IN
City:	Hobart, IN	GPS Northing:	2906586.243
Location:		GPS Easting:	2906586.243
Drain Area:	South	GPS Accuracy:	Sub-Meter
Cover Shape:	Circular	Evidence of Surcharge:	No
Cover Size:	22.5	Potential for Runoff:	None
Comments:

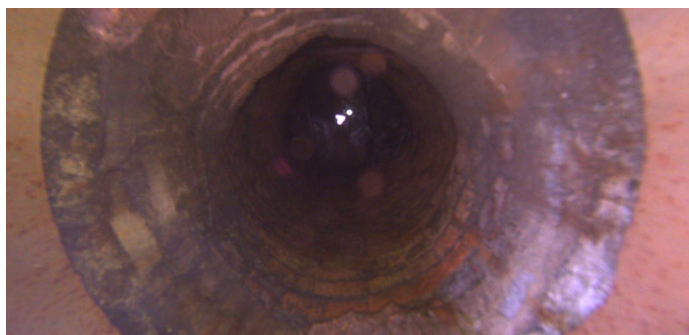
Code: **MGP**
Description: **General Photo**

Distance (ft): **.0**
Structural Grade: **0**
O&M Grade: **0**
Clock Start/From:
Clock To:
1st Value:
2nd Value:
Value Percent:
Step: **NO**
Remarks: **access mh**

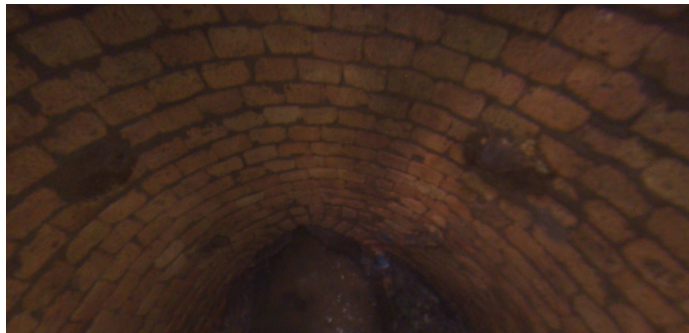
Code: **MGO**
Description: **General Observation**

Distance (ft): **5.6**
Structural Grade: **0**
O&M Grade: **0**
Clock Start/From:
Clock To:
1st Value:
2nd Value:
Value Percent:
Step: **NO**
Remarks: **missing steps**

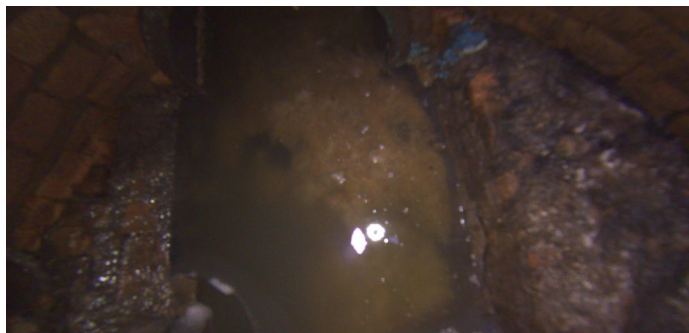
Code: **DSF**
Description: **Deposits Settled Fine**

Distance (ft): **8.9**
Structural Grade: **0**
O&M Grade: **2**
Clock Start/From: **12**
Clock To: **12**
1st Value:
2nd Value:
Value Percent: **5.000**
Step: **NO**
Remarks:
