Manhole Inspection Report

Date:	05/04/2018	Weather:		Coding:	RZMACP
MH#:	M-705-051	Owner:	NA	Len. Surveyed:	6.5
P.O.#:		Surveyor:	Jen Costello	Rim to Invert:	7.1
Customer:		Cert. #:	U-907-5518	Wall Material:	Concrete (reinforced)

Street:	New St. 310' North of 3rd St.	Project:	Hobart, IN
City:	Hobart, IN	GPS Northing:	2906453.988
Location:		GPS Easting:	2906453.988
Drain Area:	South	GPS Accuracy:	Sub-Meter
Cover Shape:	Circular	Evidence of Surcharge:	No
Cover Size:	22.5	Potential for Runoff:	None
Comments:

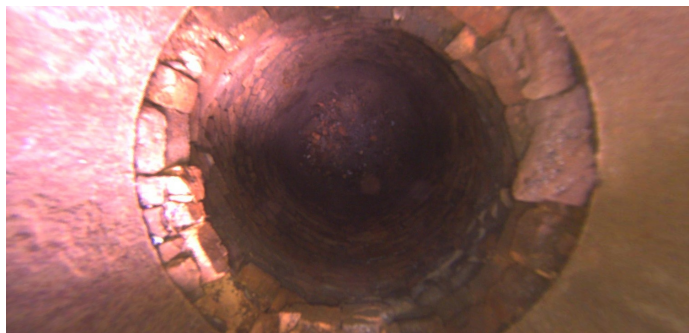
Code: **MGO**
Description: **General Observation**

Distance (ft): **.0**
Structural Grade: **0**
O&M Grade: **0**
Clock Start/From:
Clock To:
1st Value:
2nd Value:
Value Percent:
Step: **NO**
Remarks: **access MH**

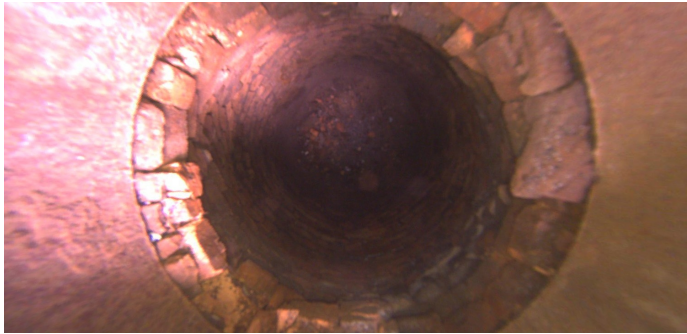
Code: **DB**
Description: **Displaced Brick**

Distance (ft): **.0**
Structural Grade: **3**
O&M Grade: **0**
Clock Start/From: **12**
Clock To: **12**
1st Value:
2nd Value:
Value Percent:
Step: **NO**
Remarks:

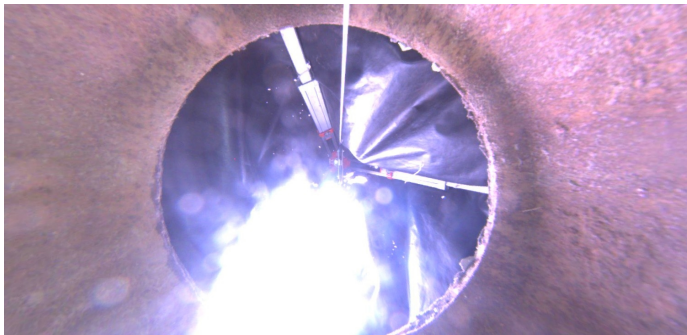
Code: **MGO**
Description: **General Observation**

Distance (ft): **1.5**
Structural Grade: **0**
O&M Grade: **0**
Clock Start/From:
Clock To:
1st Value:
2nd Value:
Value Percent:
Step: **NO**
Remarks: **UNDERSIDE OF FRAME**

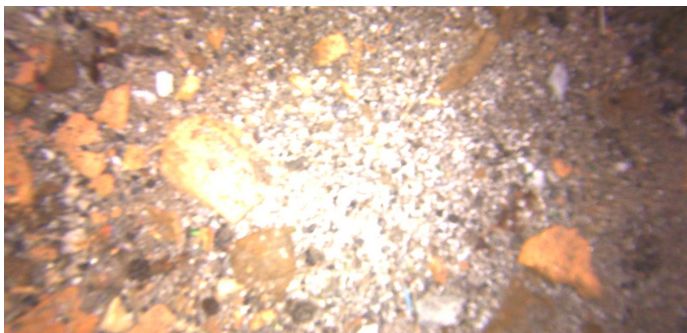
Code: **DSGV**
Description: **Deposits Settled Gravel**

Distance (ft): **6.5**
Structural Grade: **0**
O&M Grade: **2**
Clock Start/From: **12**
Clock To: **12**
1st Value:
2nd Value:
Value Percent: **10.000**
Step: **NO**
Remarks:

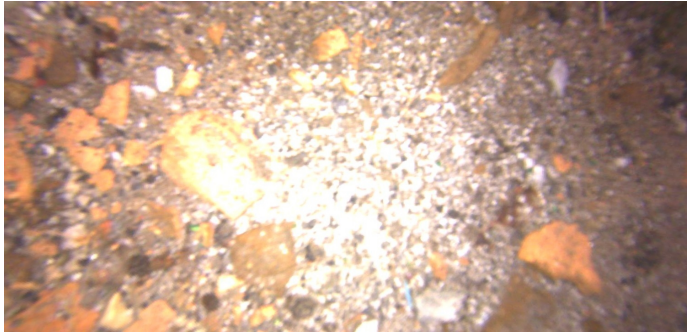
Code: **MGO**
Description: **General Observation**

Distance (ft): **6.5**
Structural Grade: **0**
O&M Grade: **0**
Clock Start/From:
Clock To:
1st Value:
2nd Value:
Value Percent:
Step: **NO**
Remarks: **END SURVEY**
