# Manhole Inspection Report

Date:	05/04/2018	Weather:		Coding:	RZMACP
MH#:	M-705-056	Owner:	NA	Len. Surveyed:	17.1
P.O.#:		Surveyor:	Jen Costello	Rim to Invert:	21.2
Customer:		Cert. #:	U-907-5518	Wall Material:	Concrete (reinforced)

Street:	East of New St. 86' North of Clevela	Project:	Hobart, IN
City:	Hobart, IN	GPS Northing:	41.53540039
Location:		GPS Easting:	-87.25411224
Drain Area:	South	GPS Accuracy:	Nearest Meter
Cover Shape:	Circular	Evidence of Surcharge:	No
Cover Size:	22.5	Potential for Runoff:	None
Comments:

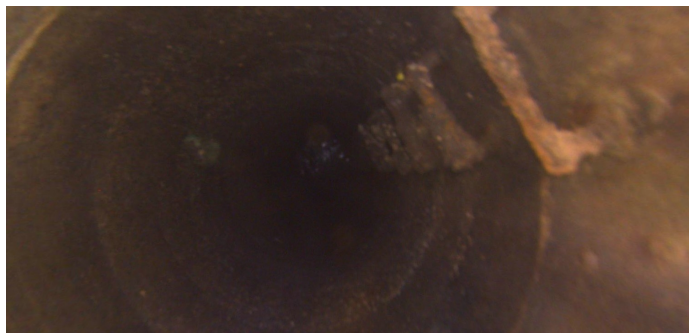
Code: **MGP**  
Description: **General Photo**

Distance (ft): **.0**  
Structural Grade: **0**  
O&M Grade: **0**  
Clock Start/From:  
Clock To:  
1st Value:  
2nd Value:  
Value Percent:  
Step: **NO**  
Remarks: **access mh**

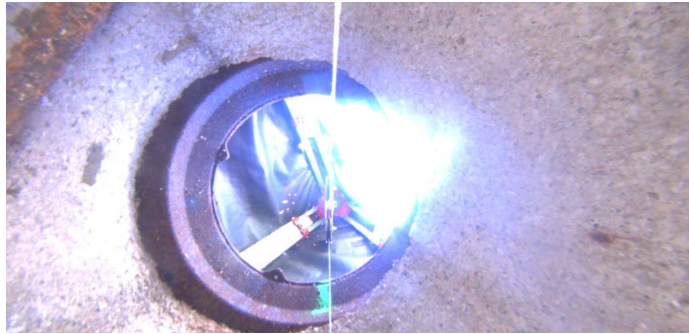
Code: **MGO**  
Description: **General Observation**

Distance (ft): **1.5**  
Structural Grade: **0**  
O&M Grade: **0**  
Clock Start/From:  
Clock To:  
1st Value:  
2nd Value:  
Value Percent:  
Step: **NO**  
Remarks: **underside of frame**

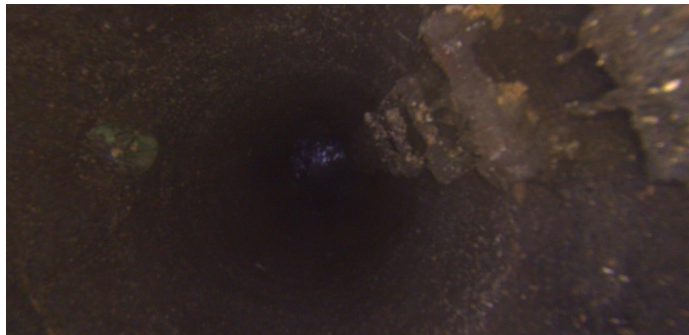
Code: **SAP**  
Description: **Surface Aggregate Projecting**

Distance (ft): **1.9**  
Structural Grade: **3**  
O&M Grade: **0**  
Clock Start/From: **12**  
Clock To: **12**  
1st Value:  
2nd Value:  
Value Percent:  
Step: **NO**  
Remarks:

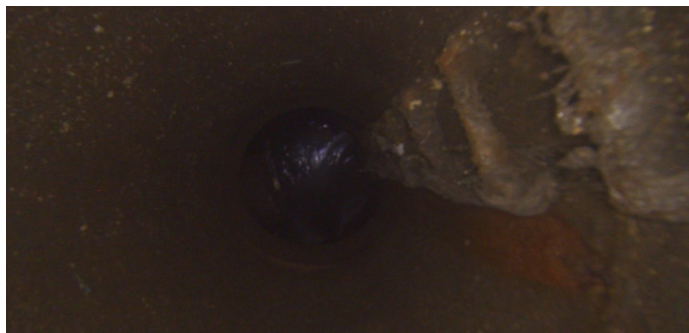
Code: **IW**  
Description: **Infil Weeper**

Distance (ft): **8.7**  
Structural Grade: **0**  
O&M Grade: **2**  
Clock Start/From: **4**  
Clock To:  
1st Value:  
2nd Value:  
Value Percent:  
Step: **NO**  
Remarks:

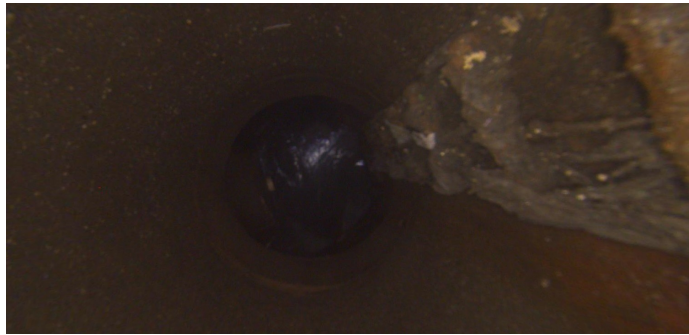
Code:	<b>DAR</b>
Description:	<b>Deposits Attached Ragging</b>
Distance (ft):	<b>9.9</b>
Structural Grade:	<b>0</b>
O&M Grade:	<b>2</b>
Clock Start/From:	<b>4</b>
Clock To:	
1st Value:	
2nd Value:	
Value Percent:	<b>5.000</b>
Step:	<b>YES</b>
Remarks:

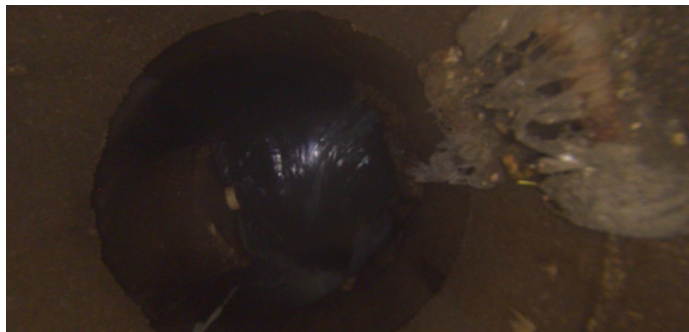
Code:	<b>SAP</b>
Description:	<b>Surface Aggregate Projecting</b>
Distance (ft):	<b>13.6</b>
Structural Grade:	<b>3</b>
O&M Grade:	<b>0</b>
Clock Start/From:	<b>12</b>
Clock To:	<b>12</b>
1st Value:	
2nd Value:	
Value Percent:	
Step:	<b>NO</b>
Remarks:
