# Manhole Inspection Report

Date:	<b>05/04/2018</b>	Weather:		Coding:	<b>RZMACP</b>
MH#:	<b>M-705-057</b>	Owner:	<b>NA</b>	Len. Surveyed:	<b>15.1</b>
P.O.#:		Surveyor:	<b>Jen Costello</b>	Rim to Invert:	<b>20.3</b>
Customer:		Cert. #:	<b>U-907-5518</b>	Wall Material:	<b>Concrete (reinforced)</b>

Street:	<b>105' North of Cleveland Ave. East of</b>	Project:	<b>Hobart, IN</b>
City:	<b>Hobart, IN</b>	GPS Northing:	<b>2905872.334</b>
Location:		GPS Easting:	<b>2905872.334</b>
Drain Area:	<b>South</b>	GPS Accuracy:	<b>Sub-Meter</b>
Cover Shape:	<b>Circular</b>	Evidence of Surcharge:	<b>No</b>
Cover Size:	<b>22.5</b>	Potential for Runoff:	<b>None</b>
Comments:

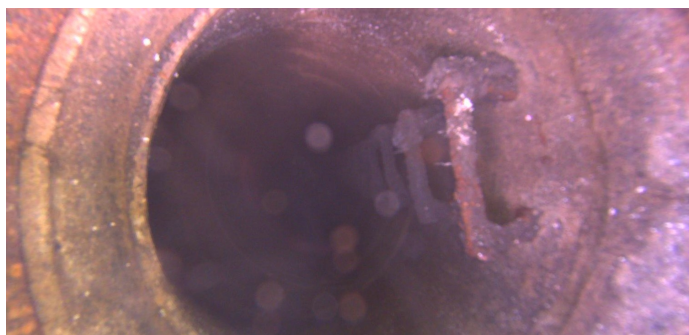
Code: **MGP**  
Description: **General Photo**

Distance (ft): **.0**  
Structural Grade: **0**  
O&M Grade: **0**  
Clock Start/From:  
Clock To:  
1st Value:  
2nd Value:  
Value Percent:  
Step: **NO**  
Remarks: **ACCESS MH**

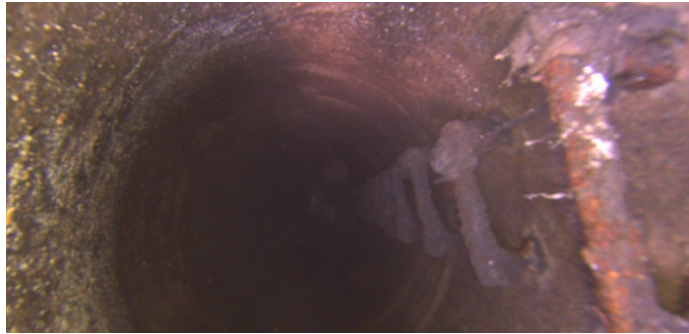
Code: **SRI**  
Description: **Surface Roughness Increased**

Distance (ft): **.8**  
Structural Grade: **1**  
O&M Grade: **0**  
Clock Start/From: **12**  
Clock To: **12**  
1st Value:  
2nd Value:  
Value Percent:  
Step: **NO**  
Remarks:

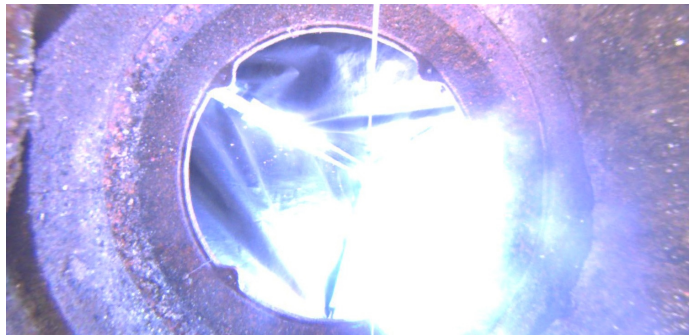
Code: **MGO**  
Description: **General Observation**

Distance (ft): **2.3**  
Structural Grade: **0**  
O&M Grade: **0**  
Clock Start/From:  
Clock To:  
1st Value:  
2nd Value:  
Value Percent:  
Step: **NO**  
Remarks: **UNDERSIDE OF FRAME**

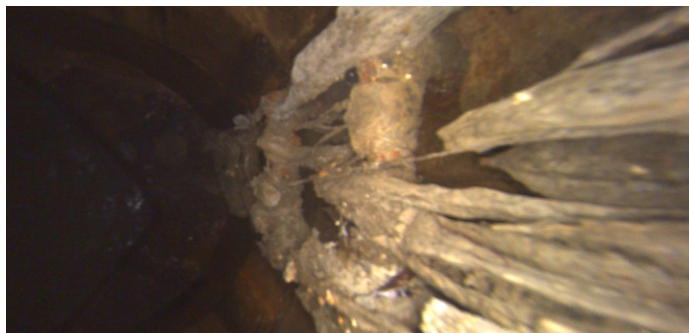
Code: **DAR**  
Description: **Deposits Attached Ragging**

Distance (ft): **12.0**  
Structural Grade: **0**  
O&M Grade: **2**  
Clock Start/From: **2**  
Clock To: **4**  
1st Value:  
2nd Value:  
Value Percent: **10.000**  
Step: **YES**  
Remarks:

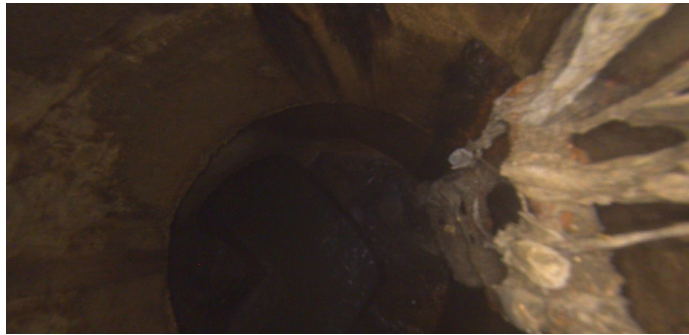
Code: **IW**  
Description: **Infil Weeper**

Distance (ft): **12.6**  
Structural Grade: **0**  
O&M Grade: **2**  
Clock Start/From: **12**  
Clock To: **1**  
1st Value:  
2nd Value:  
Value Percent:  
Step: **NO**  
Remarks:

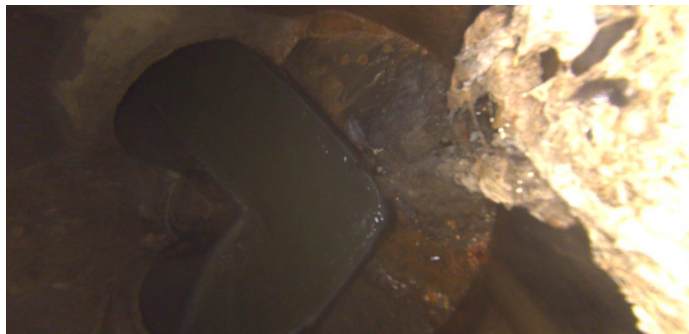
Code: **MGO**  
Description: **General Observation**

Distance (ft): **15.1**  
Structural Grade: **0**  
O&M Grade: **0**  
Clock Start/From:  
Clock To:  
1st Value:  
2nd Value:  
Value Percent:  
Step: **NO**  
Remarks: **END SURVEY**

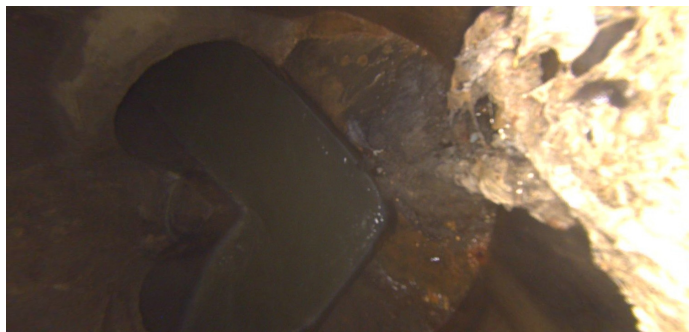
Code: **SRI**  
Description: **Surface Roughness Increased**

Distance (ft): **15.1**  
Structural Grade: **1**  
O&M Grade: **0**  
Clock Start/From: **12**  
Clock To: **12**  
1st Value:  
2nd Value:  
Value Percent:  
Step: **NO**  
Remarks:
