Manhole Inspection Report

Date:	05/04/2018	Weather:		Coding:	RZMACP
MH#:	M-705-058	Owner:	NA	Len. Surveyed:	14.3
P.O.#:		Surveyor:	Jen Costello	Rim to Invert:	20.5
Customer:		Cert. #:	U-907-5518	Wall Material:	Concrete (reinforced)

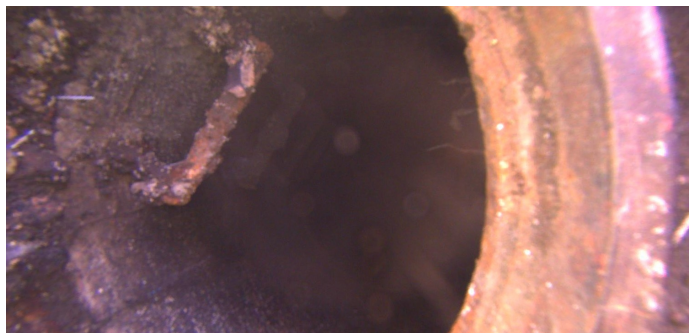
Code: **MGP**
Description: **General Photo**

Distance (ft): **.0**
Structural Grade: **0**
O&M Grade: **0**
Clock Start/From:
Clock To:
1st Value:
2nd Value:
Value Percent:
Step: **NO**
Remarks: **ACCESS MH**

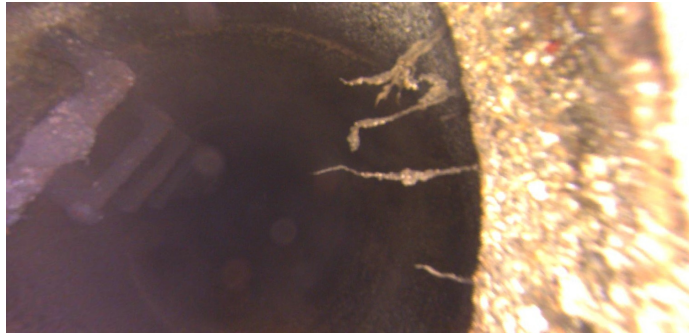
Code: **RFJ**
Description: **Roots Fine Joint**

Distance (ft): **.6**
Structural Grade: **0**
O&M Grade: **1**
Clock Start/From: **2**
Clock To: **4**
1st Value:
2nd Value:
Value Percent:
Step: **NO**
Remarks:

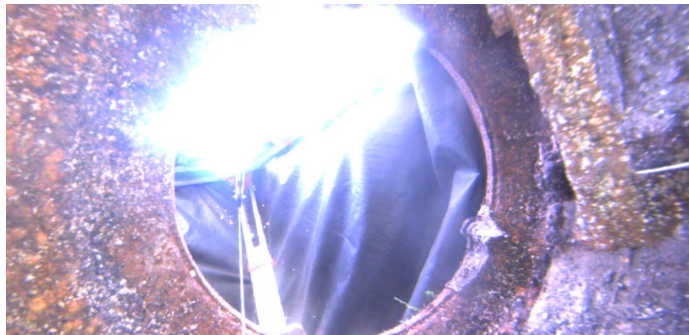
Code: **MGO**
Description: **General Observation**

Distance (ft): **2.1**
Structural Grade: **0**
O&M Grade: **0**
Clock Start/From:
Clock To:
1st Value:
2nd Value:
Value Percent:
Step: **NO**
Remarks: **UNDERSIDE OF FRAME**

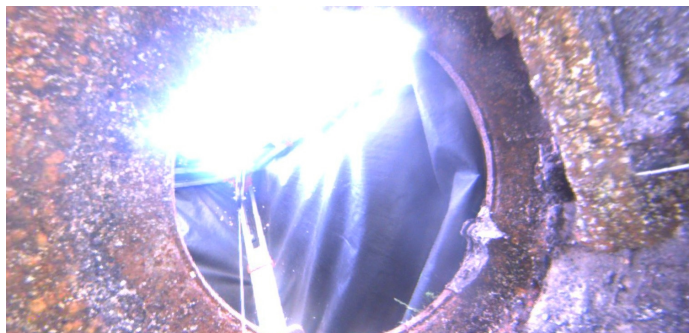
Code: **SAV**
Description: **Surface Aggregate Visible**

Distance (ft): **2.1**
Structural Grade: **3**
O&M Grade: **0**
Clock Start/From: **12**
Clock To: **12**
1st Value:
2nd Value:
Value Percent:
Step: **NO**
Remarks:

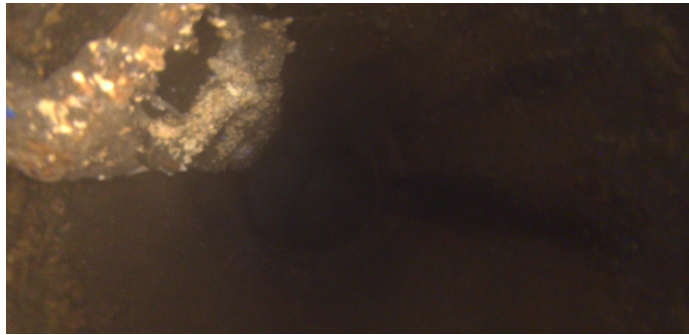
Code: **IS**
Description: **Infil Stain**

Distance (ft): **8.6**
Structural Grade: **0**
O&M Grade: **0**
Clock Start/From: **1**
Clock To: **3**
1st Value:
2nd Value:
Value Percent:
Step: **NO**
Remarks:

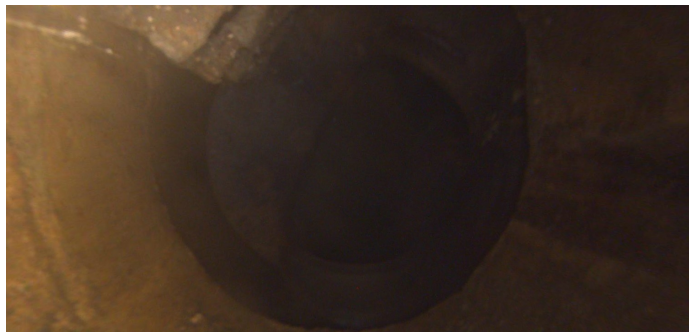
Code: **SAV**
Description: **Surface Aggregate Visible**

Distance (ft): **14.3**
Structural Grade: **3**
O&M Grade: **0**
Clock Start/From: **12**
Clock To: **12**
1st Value:
2nd Value:
Value Percent:
Step: **NO**
Remarks:

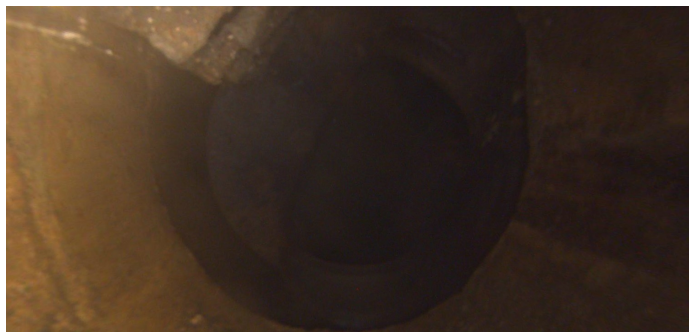
Code: **MSA**
Description: **Abandoned Survey**

Distance (ft): **14.3**
Structural Grade: **0**
O&M Grade: **0**
Clock Start/From:
Clock To:
1st Value:
2nd Value:
Value Percent:
Step: **NO**
Remarks: **UNKNOWN**
