# Manhole Inspection Report

Date:	05/04/2018	Weather:		Coding:	RZMACP
MH#:	M-705-060	Owner:	NA	Len. Surveyed:	24.1
P.O.#:		Surveyor:	Jen Costello	Rim to Invert:	20.1
Customer:		Cert. #:	U-907-5518	Wall Material:	Concrete (reinforced)

Street:	135' East of Ridge Rd. North of Cleve	Project:	Hobart, IN
City:	Hobart, IN	GPS Northing:	2905592.205
Location:		GPS Easting:	2905592.205
Drain Area:	South	GPS Accuracy:	Sub-Meter
Cover Shape:	Circular	Evidence of Surcharge:	No
Cover Size:	22.5	Potential for Runoff:	None
Comments:

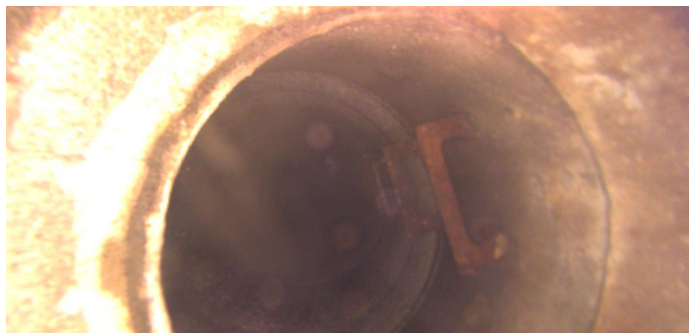
Code: **MGP**  
Description: **General Photo**

Distance (ft): **.0**  
Structural Grade: **0**  
O&M Grade: **0**  
Clock Start/From:  
Clock To:  
1st Value:  
2nd Value:  
Value Percent:  
Step: **NO**  
Remarks: **ACCESS MH**

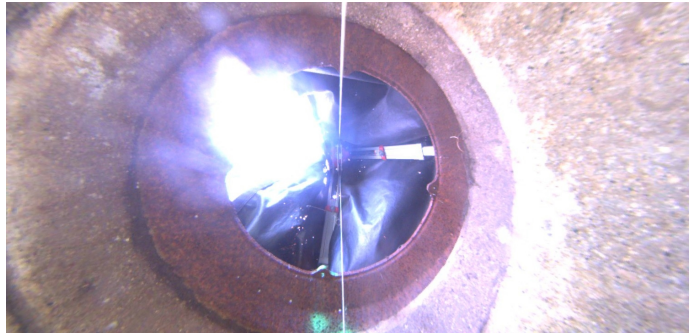
Code: **MGO**  
Description: **General Observation**

Distance (ft): **1.8**  
Structural Grade: **0**  
O&M Grade: **0**  
Clock Start/From:  
Clock To:  
1st Value:  
2nd Value:  
Value Percent:  
Step: **NO**  
Remarks: **UNDERSIDE OF FRAME**

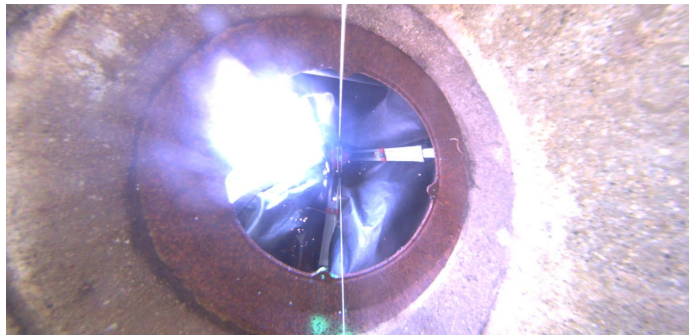
Code: **SAV**  
Description: **Surface Aggregate Visible**

Distance (ft): **1.8**  
Structural Grade: **3**  
O&M Grade: **0**  
Clock Start/From: **12**  
Clock To: **12**  
1st Value:  
2nd Value:  
Value Percent:  
Step: **NO**  
Remarks:

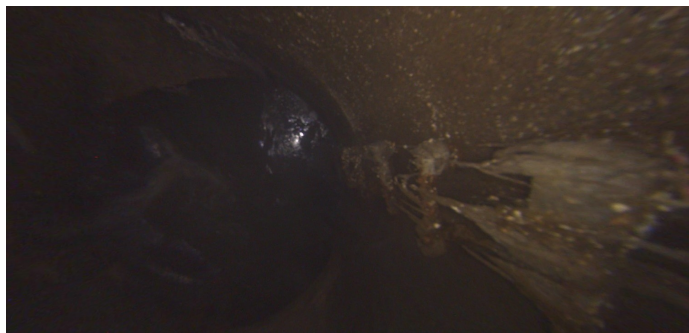
Code: **DAR**  
Description: **Deposits Attached Ragging**

Distance (ft): **21.1**  
Structural Grade: **0**  
O&M Grade: **2**  
Clock Start/From: **3**  
Clock To: **4**  
1st Value:  
2nd Value:  
Value Percent: **5.000**  
Step: **YES**  
Remarks:

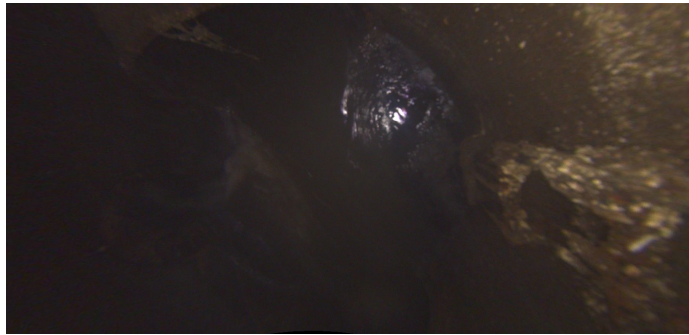
Code:	<b>SAV</b>
Description:	<b>Surface Aggregate Visible</b>
Distance (ft):	<b>24.1</b>
Structural Grade:	<b>3</b>
O&M Grade:	<b>0</b>
Clock Start/From:	<b>12</b>
Clock To:	<b>12</b>
1st Value:	
2nd Value:	
Value Percent:	
Step:	<b>NO</b>
Remarks:

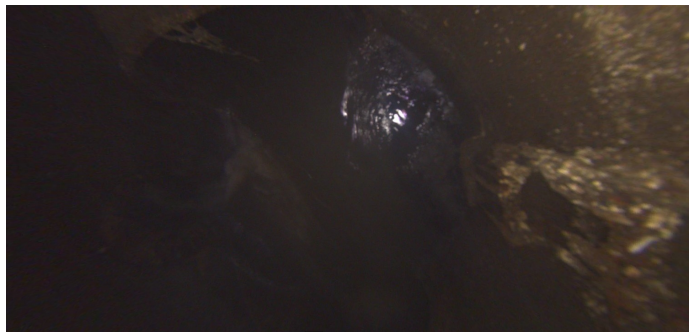
Code:	<b>MGO</b>
Description:	<b>General Observation</b>
Distance (ft):	<b>24.1</b>
Structural Grade:	<b>0</b>
O&M Grade:	<b>0</b>
Clock Start/From:	
Clock To:	
1st Value:	
2nd Value:	
Value Percent:	
Step:	<b>NO</b>
Remarks:	<b>END SURVEY</b>
