# Manhole Inspection Report

| MH#: | M-705-063.1 | Owner: | NA | Len. Surveyed: | 9.0 |

| Street: | Northeast of L/S. Across Lake. the N | Project: | Hobart, IN |

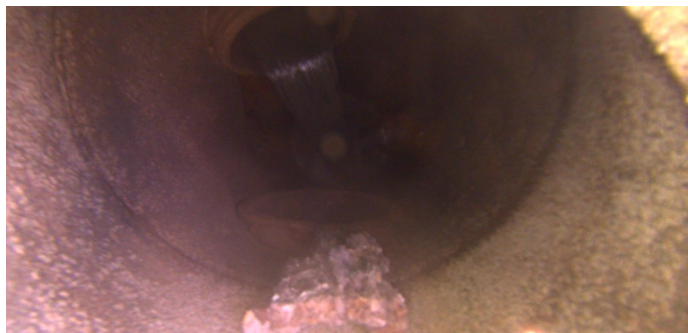
Code: **MGP**  
Description: **General Photo**

Distance (ft): **.0**  
Structural Grade: **0**  
O&M Grade: **0**  
Clock Start/From:  
Clock To:  
1st Value:  
2nd Value:  
Value Percent:  
Step: **NO**  
Remarks: **ACCESS MH**

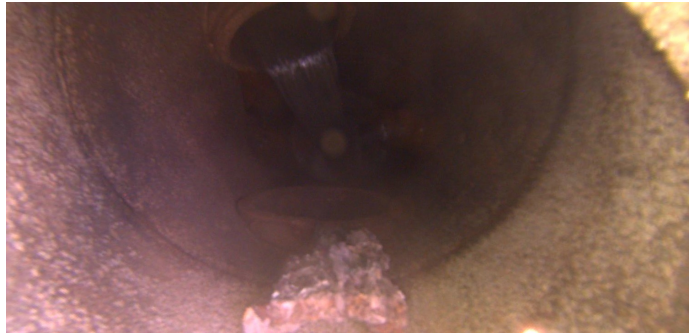
Code: **SAV**  
Description: **Surface Aggregate Visible**

Distance (ft): **.0**  
Structural Grade: **3**  
O&M Grade: **0**  
Clock Start/From: **12**  
Clock To: **12**  
1st Value:  
2nd Value:  
Value Percent:  
Step: **NO**  
Remarks:

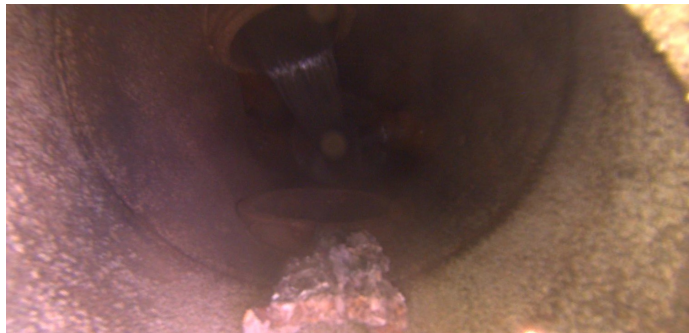
Code: **DAGS**  
Description: **Deposits Attached Grease**

Distance (ft): **.0**  
Structural Grade: **0**  
O&M Grade: **2**  
Clock Start/From: **6**  
Clock To:  
1st Value:  
2nd Value:  
Value Percent: **5.000**  
Step: **NO**  
Remarks:

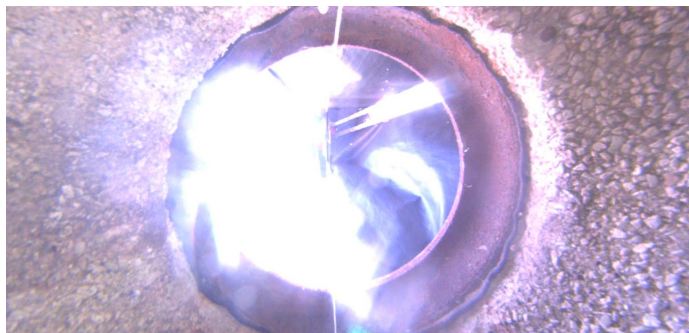
Code: **MGO**  
Description: **General Observation**

Distance (ft): **1.9**  
Structural Grade: **0**  
O&M Grade: **0**  
Clock Start/From:  
Clock To:  
1st Value:  
2nd Value:  
Value Percent:  
Step: **NO**  
Remarks: **END SURVEY**

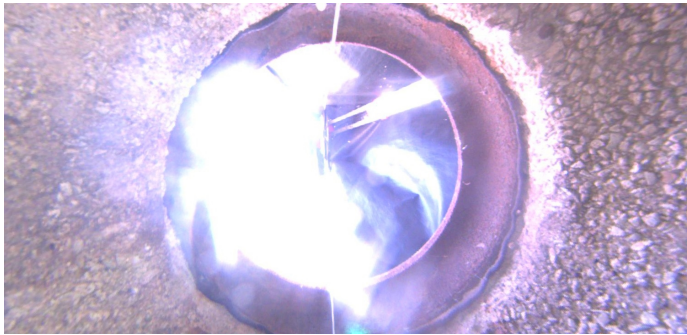
| Code: | <b>SAP</b> |
| Description: | <b>Surface Aggregate Projecting</b> |
| Distance (ft): | <b>1.9</b> |
| Structural Grade: | <b>3</b> |
| Clock Start/From: | <b>12</b> |

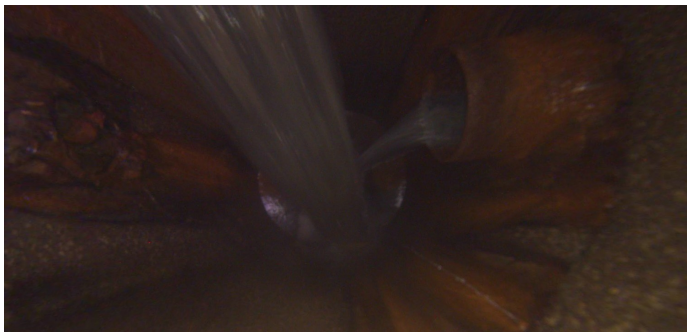
| Code: | <b>IW</b> |
| Description: | <b>Infil Weeper</b> |
| Distance (ft): | <b>7.5</b> |
| O&M Grade: | <b>2</b> |
| Clock Start/From: | <b>12</b> |

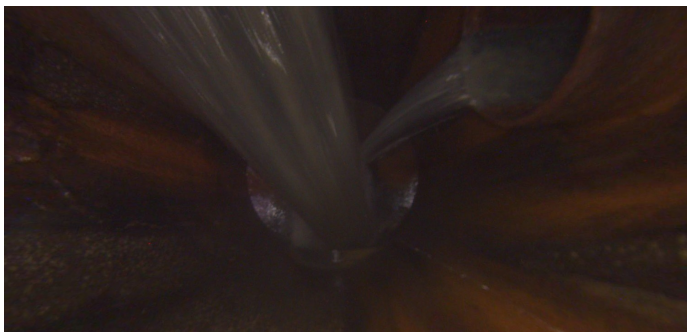
| Code: | <b>MSA</b> |
| Description: | <b>Abandoned Survey</b> |
| Distance (ft): | <b>9.0</b> |
| Remarks: | <b>INTRUDING LINES</b> |
