Manhole Inspection Report

Date:	05/06/2018	Weather:		Coding:	RZMACP
MH#:	M-705-063.2	Owner:	NA	Len. Surveyed:	14.1
P.O.#:		Surveyor:	Jen Costello	Rim to Invert:	14.5
Customer:		Cert. #:	U-907-5518	Wall Material:	Concrete (reinforced)

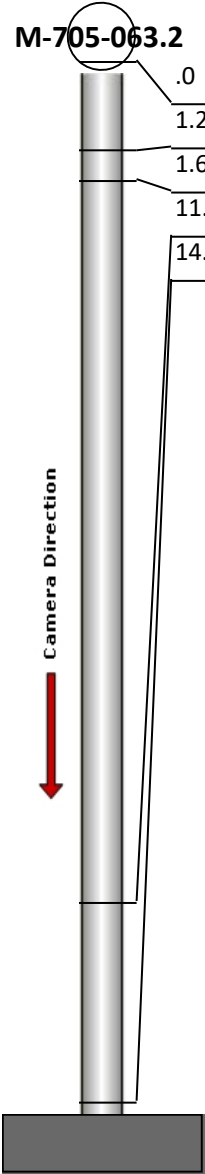
.0	MGP	General Photo	10	NA
	1.2	CL	Crack Longitudinal	24	S 2
	1.6	MGO	General Observation	38	NA
	11.4	SAV	Surface Aggregate Visible	71	S 3
	14.1	MGO	General Observation	88	NA

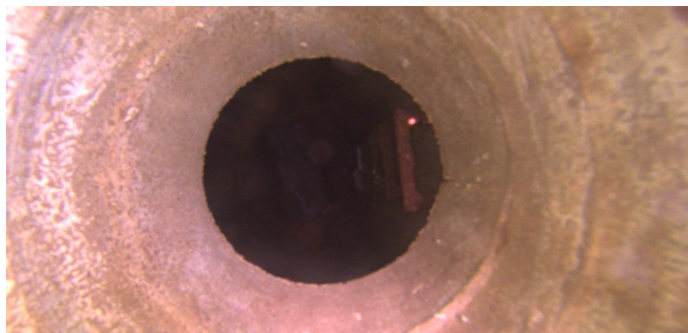
Code: **MGP**
Description: **General Photo**

Distance (ft): **.0**
Structural Grade: **0**
O&M Grade: **0**
Clock Start/From:
Clock To:
1st Value:
2nd Value:
Value Percent:
Step: **NO**
Remarks: **ACCESS MH**

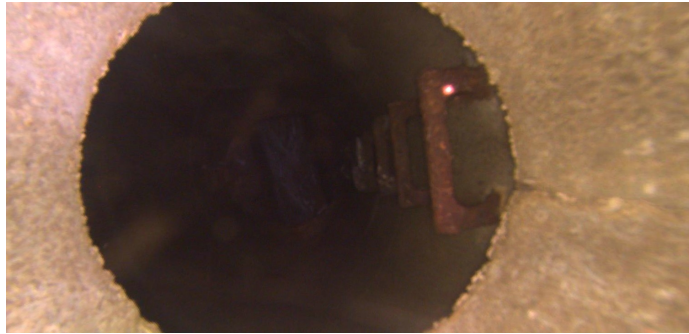
Code: **CL**
Description: **Crack Longitudinal**

Distance (ft): **1.2**
Structural Grade: **2**
O&M Grade: **0**
Clock Start/From: **3**
Clock To:
1st Value:
2nd Value:
Value Percent:
Step: **NO**
Remarks:

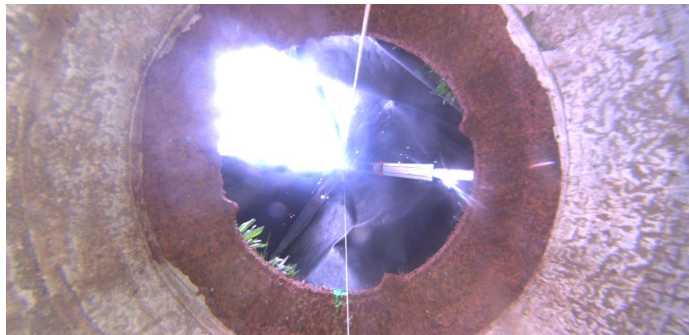
Code: **MGO**
Description: **General Observation**

Distance (ft): **1.6**
Structural Grade: **0**
O&M Grade: **0**
Clock Start/From:
Clock To:
1st Value:
2nd Value:
Value Percent:
Step: **NO**
Remarks: **UNDERSIDE OF FRAME**

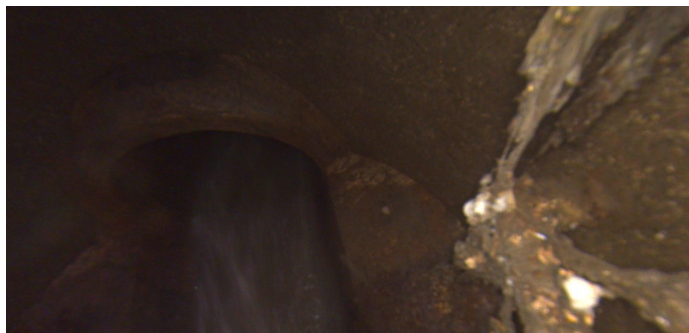
Code: **SAV**
Description: **Surface Aggregate Visible**

Distance (ft): **11.4**
Structural Grade: **3**
O&M Grade: **0**
Clock Start/From: **12**
Clock To: **12**
1st Value:
2nd Value:
Value Percent:
Step: **NO**
Remarks:

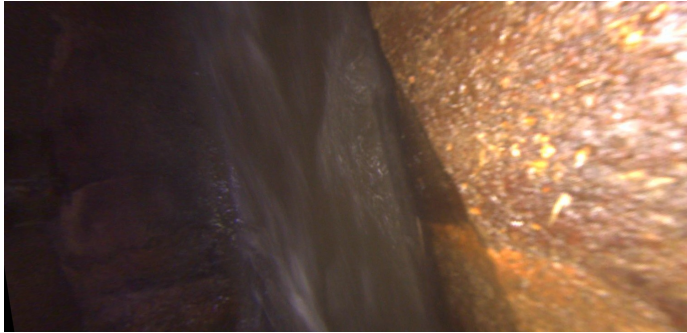
Code: **MGO**
Description: **General Observation**

Distance (ft): **14.1**

Remarks: **END SURVEY**
