# Manhole Inspection Report

Date:	05/06/2018	Weather:		Coding:	RZMACP
MH#:	M-705-063.3	Owner:	NA	Len. Surveyed:	12.9
P.O.#:		Surveyor:	Jen Costello	Rim to Invert:	16.3
Customer:		Cert. #:	U-907-5518	Wall Material:	Concrete (reinforced)

Street:	South of Cleveland Ave. in Park. by	Project:	Hobart, IN
City:	Hobart, IN	GPS Northing:	41.53594208
Location:		GPS Easting:	-87.25688934
Drain Area:	West	GPS Accuracy:	Nearest Meter
Cover Shape:	Circular	Evidence of Surcharge:	No
Cover Size:	22.5	Potential for Runoff:	None
Comments:

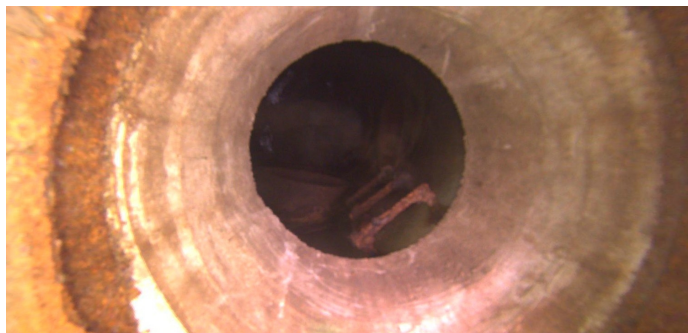
Code: **MGP**  
 Description: **General Photo**

Distance (ft): **.0**  
 Structural Grade: **0**  
 O&M Grade: **0**  
 Clock Start/From:  
 Clock To:  
 1st Value:  
 2nd Value:  
 Value Percent:  
 Step: **NO**  
 Remarks: **ACCESS MH**

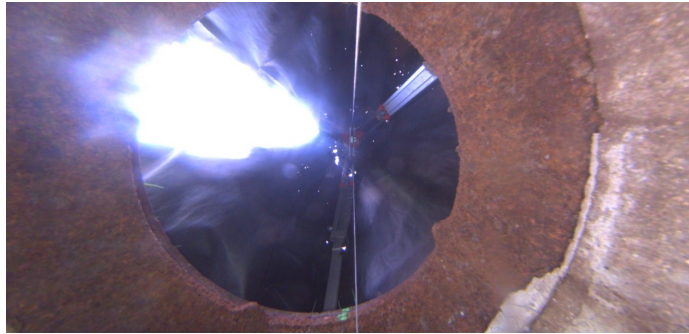
Code: **MGO**  
Description: **General Observation**

Distance (ft): **1.5**  
Structural Grade: **0**  
O&M Grade: **0**  
Clock Start/From:  
Clock To:  
1st Value:  
2nd Value:  
Value Percent:  
Step: **NO**  
Remarks: **UNDERSIDE OF FRAME**

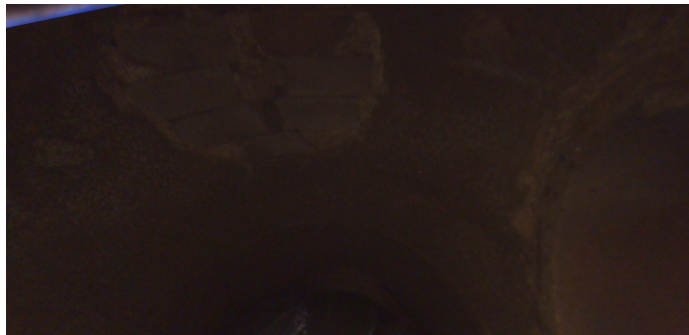
Code: **MGO**  
Description: **General Observation**

Distance (ft): **6.5**  
Structural Grade: **0**  
O&M Grade: **0**  
Clock Start/From:  
Clock To:  
1st Value:  
2nd Value:  
Value Percent:  
Step: **NO**  
Remarks: **ABANDONED CONNECTION**

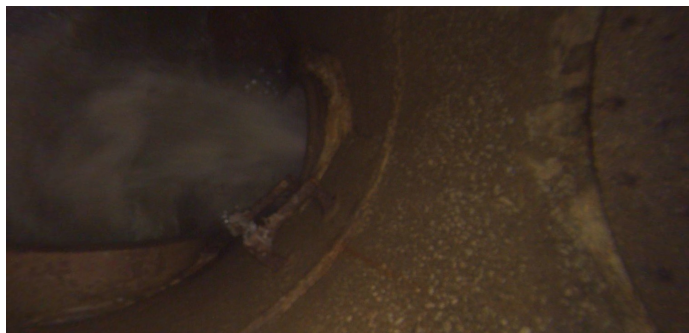
Code: **SAP**  
Description: **Surface Aggregate Projecting**

Distance (ft): **9.3**  
Structural Grade: **3**  
O&M Grade: **0**  
Clock Start/From: **12**  
Clock To: **12**  
1st Value:  
2nd Value:  
Value Percent:  
Step: **NO**  
Remarks:

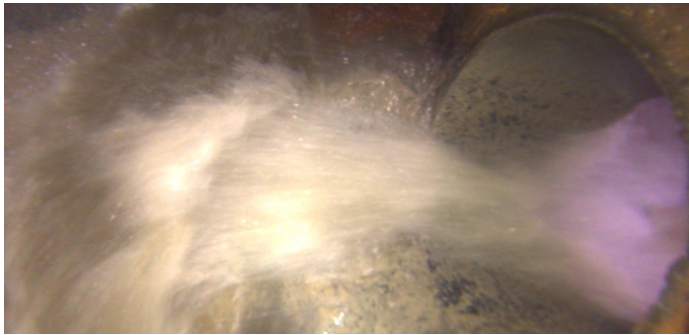
Code:	<b>MGO</b>
Description:	<b>General Observation</b>
Distance (ft):	<b>12.9</b>
Structural Grade:	<b>0</b>
O&M Grade:	<b>0</b>
Clock Start/From:	
Clock To:	
1st Value:	
2nd Value:	
Value Percent:	
Step:	<b>NO</b>
Remarks:	<b>END SURVEY</b>
