Manhole Inspection Report

Date:	05/04/2018	Weather:		Coding:	RZMACP
MH#:	M-705-063	Owner:	NA	Len. Surveyed:	14.4
P.O.#:		Surveyor:	Jen Costello	Rim to Invert:	18.5
Customer:		Cert. #:	U-907-5518	Wall Material:	Concrete (reinforced)

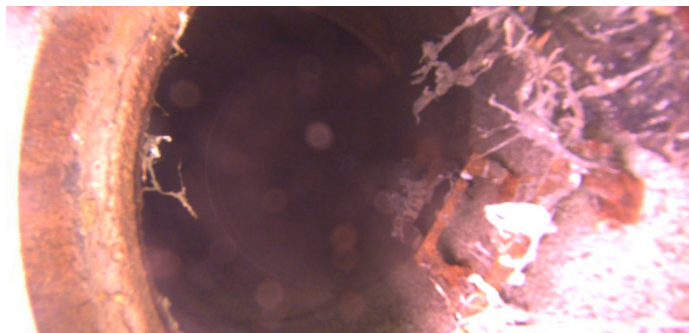
Code: **MGP**
Description: **General Photo**

Distance (ft): **.0**
Structural Grade: **0**
O&M Grade: **0**
Clock Start/From:
Clock To:
1st Value:
2nd Value:
Value Percent:
Step: **NO**
Remarks: **ACCESS MH**

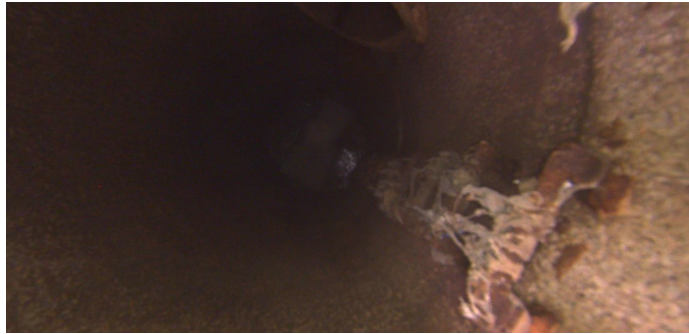
Code: **SAV**
Description: **Surface Aggregate Visible**

Distance (ft): **1.9**
Structural Grade: **3**
O&M Grade: **0**
Clock Start/From: **12**
Clock To: **12**
1st Value:
2nd Value:
Value Percent:
Step: **NO**
Remarks:

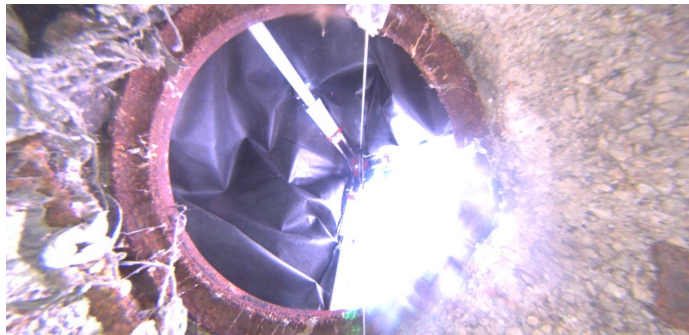
Code: **MGO**
Description: **General Observation**

Distance (ft): **1.9**
Structural Grade: **0**
O&M Grade: **0**
Clock Start/From:
Clock To:
1st Value:
2nd Value:
Value Percent:
Step: **NO**
Remarks: **UNDERSIDE OF FRAME**

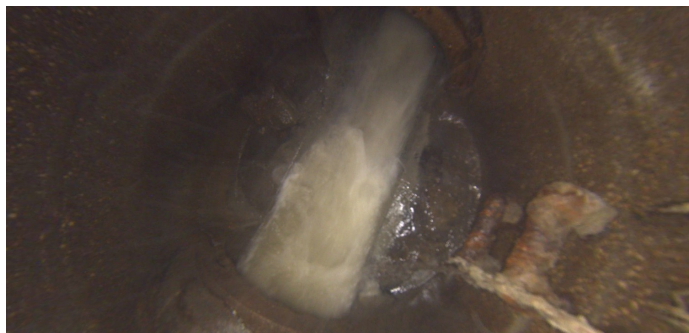
Code: **MGO**
Description: **General Observation**

Distance (ft): **14.4**
Structural Grade: **0**
O&M Grade: **0**
Clock Start/From:
Clock To:
1st Value:
2nd Value:
Value Percent:
Step: **NO**
Remarks: **END SURVEY**

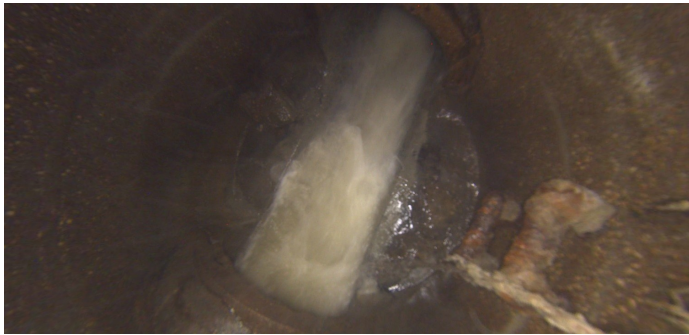
Code:	SAV
Description:	Surface Aggregate Visible
Distance (ft):	14.4
Structural Grade:	3
O&M Grade:	0
Clock Start/From:	12
Clock To:	12
1st Value:	
2nd Value:	
Value Percent:	
Step:	NO
Remarks:
