Manhole Inspection Report

Date:	05/04/2018	Weather:		Coding:	RZMACP
MH#:	M-705-073	Owner:	NA	Len. Surveyed:	12.1
P.O.#:		Surveyor:	Jen Costello	Rim to Invert:	13.7
Customer:		Cert. #:	U-907-5518	Wall Material:	Concrete (reinforced)

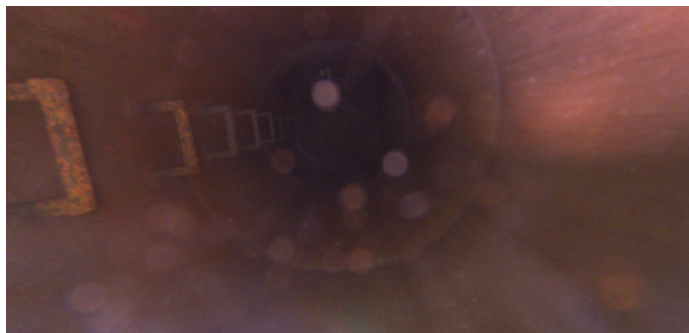
Code: **MGO**
Description: **General Observation**

Distance (ft): **.0**
Structural Grade: **0**
O&M Grade: **0**
Clock Start/From:
Clock To:
1st Value:
2nd Value:
Value Percent:
Step: **NO**
Remarks: **ACCESS MH**

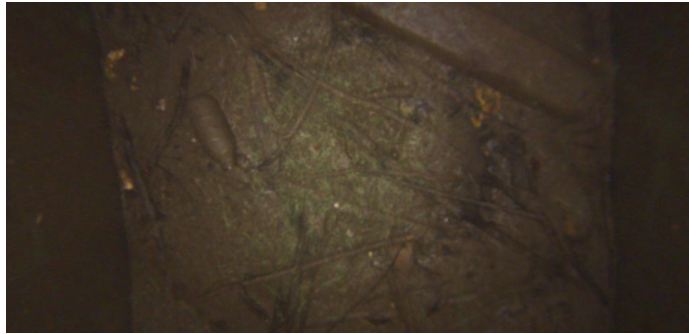
Code: **OBZ**
Description: **Obstacle Other**

Distance (ft): **11.6**
Structural Grade: **0**
O&M Grade: **2**
Clock Start/From: **12**
Clock To: **12**
1st Value:
2nd Value:
Value Percent: **10.000**
Step: **NO**
Remarks: **MISC**

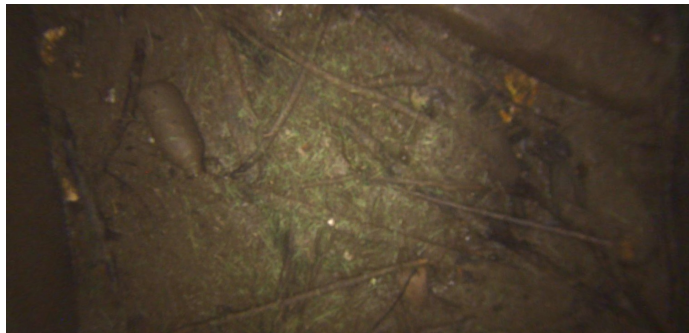
Code: **MGO**
Description: **General Observation**

Distance (ft): **12.1**
Structural Grade: **0**
O&M Grade: **0**
Clock Start/From:
Clock To:
1st Value:
2nd Value:
Value Percent:
Step: **NO**
Remarks: **END SURVEY**
