Manhole Inspection Report

Date:	05/06/2018	Weather:		Coding:	RZMACP
MH#:	M-705-074	Owner:	NA	Len. Surveyed:	9.6
P.O.#:		Surveyor:	Jen Costello	Rim to Invert:	15.1
Customer:		Cert. #:	U-907-5518	Wall Material:	Concrete (reinforced)

Street:	Entrance to Park on Cleveland Ave.	Project:	Hobart, IN
City:	Hobart, IN	GPS Northing:	2905230.566
Location:		GPS Easting:	2905230.566
Drain Area:	West	GPS Accuracy:	Sub-Meter
Cover Shape:	Circular	Evidence of Surcharge:	No
Cover Size:	22.5	Potential for Runoff:	None
Comments:

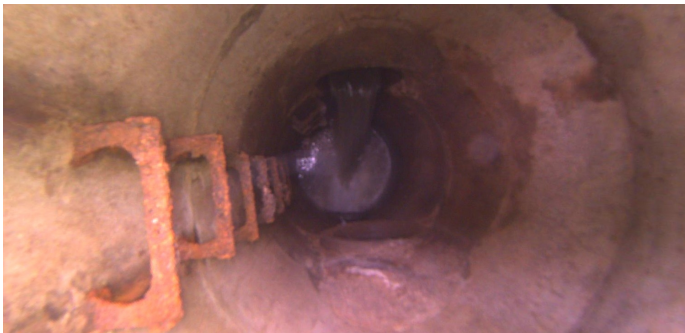
Code:	MGP
Description:	General Photo
Distance (ft):	.0
Structural Grade:	0
O&M Grade:	0
Clock Start/From:	
Clock To:	
1st Value:	
2nd Value:	
Value Percent:	
Step:	NO
Remarks:	ACCESS MH

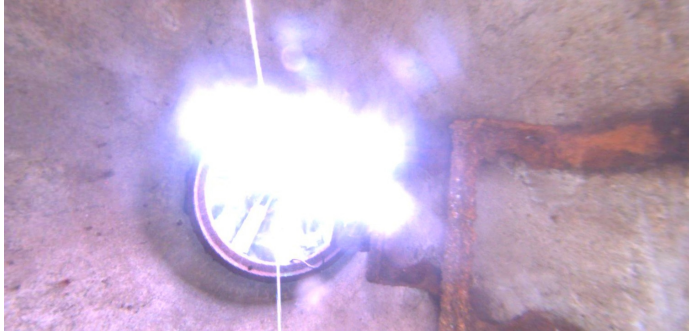
Code:	MGO
Description:	General Observation
Distance (ft):	3.8
Structural Grade:	0
O&M Grade:	0
Clock Start/From:	
Clock To:	
1st Value:	
2nd Value:	
Value Percent:	
Step:	NO
Remarks:	UNDERSIDE OF FRAME

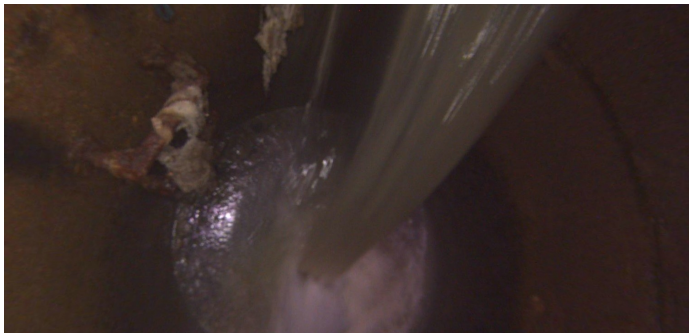
Code:	MSA
Description:	Abandoned Survey
Distance (ft):	9.6
Structural Grade:	0
O&M Grade:	0
Clock Start/From:	
Clock To:	
1st Value:	
2nd Value:	
Value Percent:	
Step:	NO
Remarks:	INTRUDING LINES
