# Manhole Inspection Report

Date:	05/04/2018	Weather:		Coding:	RZMACP
MH#:	M-705-076	Owner:	NA	Len. Surveyed:	7.2
P.O.#:		Surveyor:	Jen Costello	Rim to Invert:	7.8
Customer:		Cert. #:	U-907-5518	Wall Material:	Brick

Street:	Old Ridge Road. West of Main L/S.	Project:	Hobart, IN
City:	Hobart, IN	GPS Northing:	41.5358429
Location:		GPS Easting:	-87.25641632
Drain Area:	West	GPS Accuracy:	Nearest Meter
Cover Shape:	Circular	Evidence of Surcharge:	No
Cover Size:	22.5	Potential for Runoff:	None
Comments:

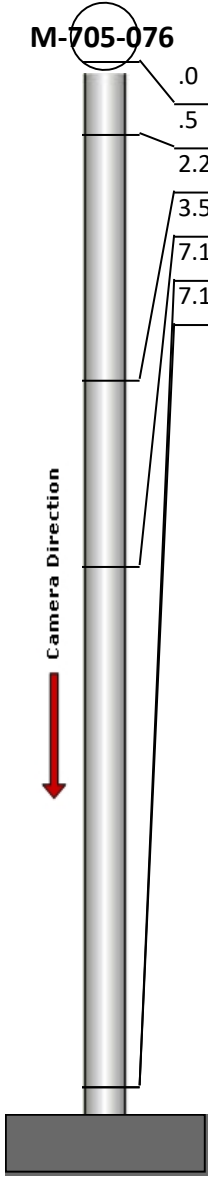
.0	MGP	General Photo	10	NA
	.5	FM	Fracture Multiple	22	S 4
	2.2	MGO	General Observation	39	NA
	3.5	OBM	Obstacle Pipe Material	54	M 2
	7.1	DSF	Deposits Settled Fine	73	M 2
	7.1	MGO	General Observation	83	NA

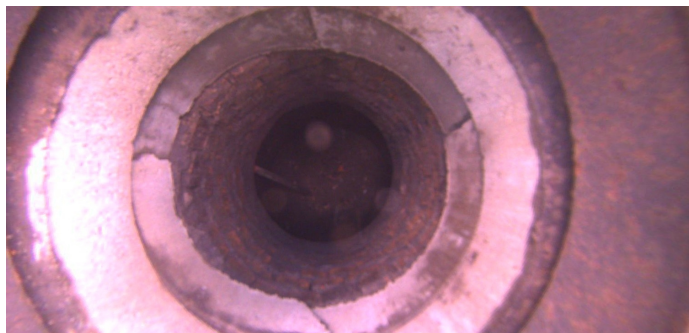
Code: **MGP**  
Description: **General Photo**

Distance (ft): **.0**  
Structural Grade: **0**  
O&M Grade: **0**  
Clock Start/From:  
Clock To:  
1st Value:  
2nd Value:  
Value Percent:  
Step: **NO**  
Remarks: **access MH**

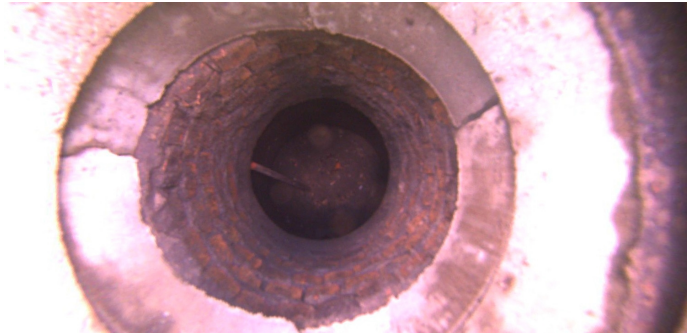
Code: **FM**  
Description: **Fracture Multiple**

Distance (ft): **.5**  
Structural Grade: **4**  
O&M Grade: **0**  
Clock Start/From: **12**  
Clock To: **12**  
1st Value:  
2nd Value:  
Value Percent:  
Step: **NO**  
Remarks:

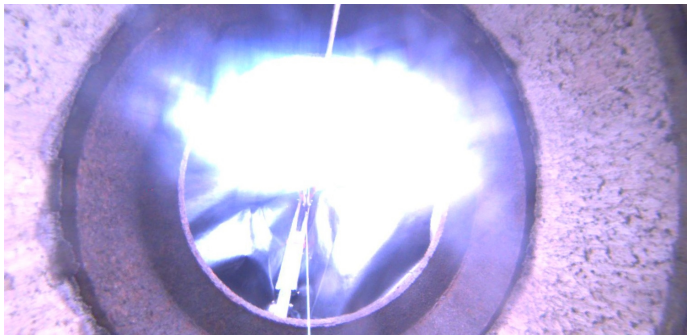
Code: **MGO**  
Description: **General Observation**

Distance (ft): **2.2**  
Structural Grade: **0**  
O&M Grade: **0**  
Clock Start/From:  
Clock To:  
1st Value:  
2nd Value:  
Value Percent:  
Step: **NO**  
Remarks: **UNDERSIDE OF FRAME**

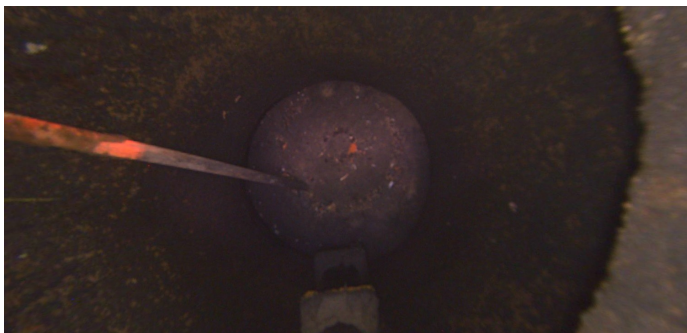
Code: **OBM**  
Description: **Obstacle Pipe Material**

Distance (ft): **3.5**  
Structural Grade: **0**  
O&M Grade: **2**  
Clock Start/From: **9**  
Clock To:  
1st Value:  
2nd Value:  
Value Percent: **5.000**  
Step: **NO**  
Remarks:

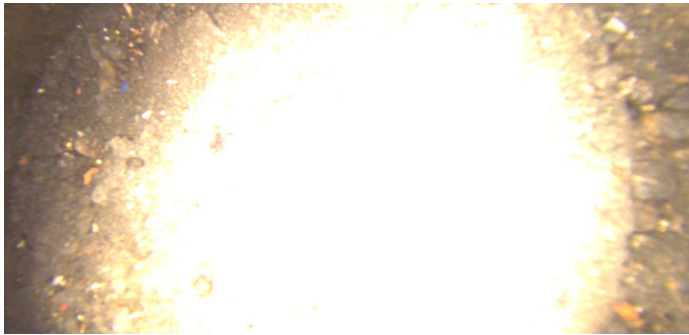
Code: **DSF**  
Description: **Deposits Settled Fine**

Distance (ft): **7.1**  
Structural Grade: **0**  
O&M Grade: **2**  
Clock Start/From: **12**  
Clock To: **12**  
1st Value:  
2nd Value:  
Value Percent: **10.000**  
Step: **NO**  
Remarks:

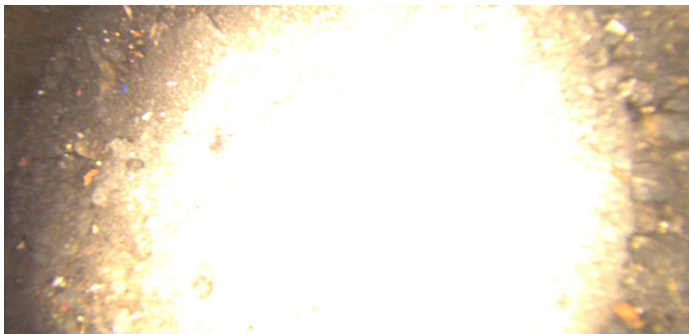
Code: **MGO**  
Description: **General Observation**

Distance (ft): **7.1**  
Structural Grade: **0**  
O&M Grade: **0**  
Clock Start/From:  
Clock To:  
1st Value:  
2nd Value:  
Value Percent:  
Step: **NO**  
Remarks: **END SURVEY**
