Manhole Inspection Report

Date:	04/28/2018	Weather:		Coding:	RZMACP
MH#:	M-706-006	Owner:	NA	Len. Surveyed:	15.3
P.O.#:		Surveyor:	Jen Costello	Rim to Invert:	14.3
Customer:		Cert. #:	U-907-5518	Wall Material:	Concrete (reinforced)

Street:	Intersection of Linda St. and 8th St.	Project:	Hobart, IN
City:	Hobart, IN	GPS Northing:	41.52527618
Location:		GPS Easting:	-87.2497406
Drain Area:	Southeast	GPS Accuracy:	Nearest Meter
Cover Shape:	Circular	Evidence of Surcharge:	No
Cover Size:	22.5	Potential for Runoff:	None
Comments:

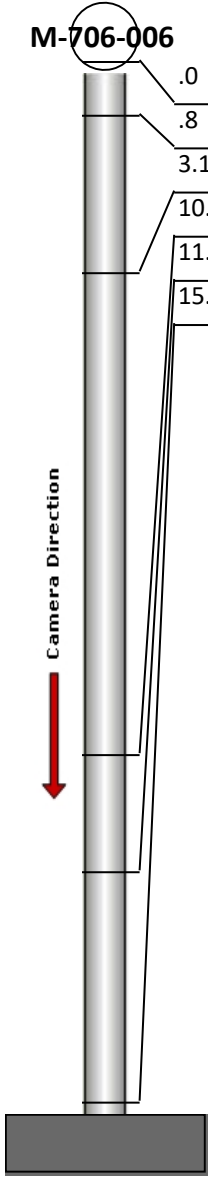
.0	MGO	General Observation	10	NA
	.8	SAP	Surface Aggregate Projecting	23	S 3
	3.1	MGP	General Photo	41	NA
	10.2	IW	Infil Weeper	69	M 2
	11.9	IW	Infil Weeper	84	M 2
	15.3	MGO	General Observation	102	NA

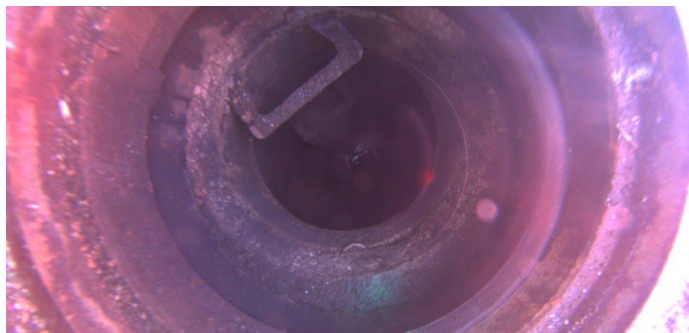
Code: **MGO**
Description: **General Observation**

Distance (ft): **.0**
Structural Grade: **0**
O&M Grade: **0**
Clock Start/From:
Clock To:
1st Value:
2nd Value:
Value Percent:
Step: **NO**
Remarks: **ACCESS MH**

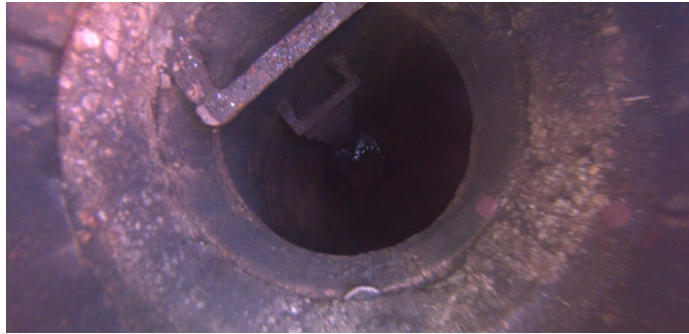
Code:	SAP
Description:	Surface Aggregate Projecting
Distance (ft):	.8
Structural Grade:	3
O&M Grade:	0
Clock Start/From:	12
Clock To:	12
1st Value:	
2nd Value:	
Value Percent:	
Step:	NO
Remarks:

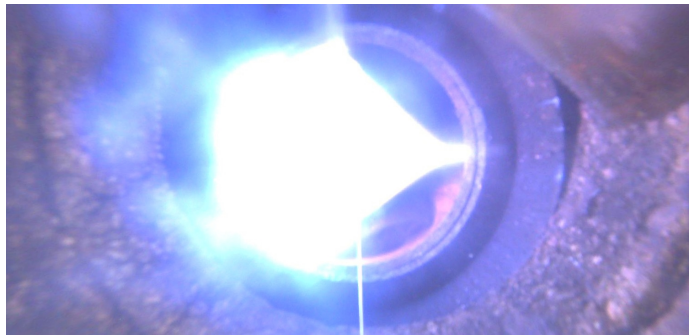
Code:	MGP
Description:	General Photo
Distance (ft):	3.1
Structural Grade:	0
O&M Grade:	0
Clock Start/From:	
Clock To:	
1st Value:	
2nd Value:	
Value Percent:	
Step:	NO
Remarks:	UNDERSIDE OF FRAME

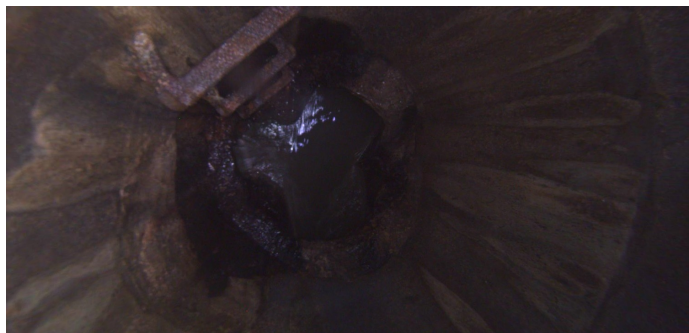
Code:	IW
Description:	Infil Weeper
Distance (ft):	10.2
Structural Grade:	0
O&M Grade:	2
Clock Start/From:	12
Clock To:	12
1st Value:	
2nd Value:	
Value Percent:	
Step:	NO
Remarks:

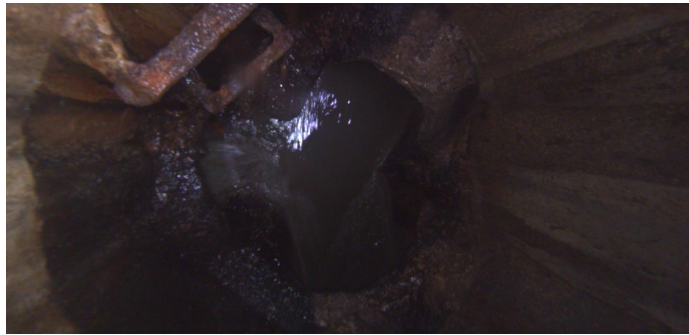
Code: **IW**
Description: **Infil Weeper**

Distance (ft): **11.9**
Structural Grade: **0**
O&M Grade: **2**
Clock Start/From: **12**
Clock To: **12**
1st Value:
2nd Value:
Value Percent:
Step: **NO**
Remarks:

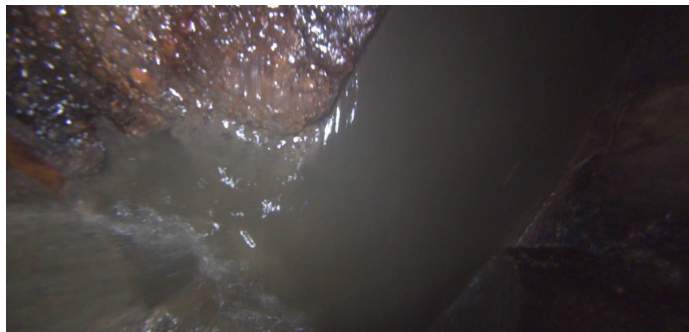
Code: **MGO**
Description: **General Observation**

Distance (ft): **15.3**
Structural Grade: **0**
O&M Grade: **0**
Clock Start/From:
Clock To:
1st Value:
2nd Value:
Value Percent:
Step: **NO**
Remarks: **END SURVEY**
