Manhole Inspection Report

Date:	04/24/2018	Weather:		Coding:	RZMACP
MH#:	M-706-007.1	Owner:	NA	Len. Surveyed:	8.8
P.O.#:		Surveyor:	Jen Costello	Rim to Invert:	8.8
Customer:	8.7	Cert. #:	U-907-5518	Wall Material:	Brick

Street:	Intersection of 8th Pl. and Linda St.	Project:	Hobart, IN
City:	Hobart, IN	GPS Northing:	0.0
Location:		GPS Easting:	0.0
Drain Area:	Southeast	GPS Accuracy:	Nearest Meter
Cover Shape:	Circular	Evidence of Surcharge:	No
Cover Size:	22.5	Potential for Runoff:	None
Comments:

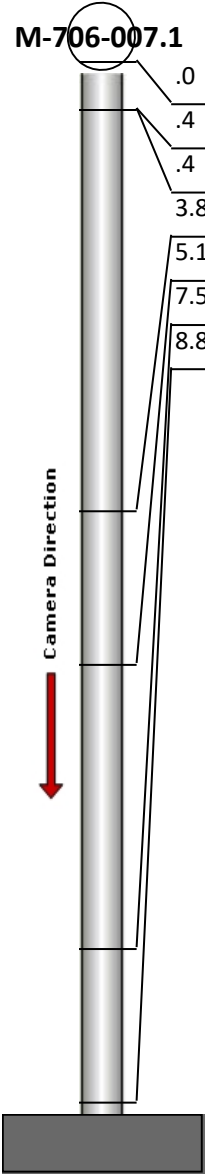
.0	MGO	General Observation	10	NA
	.4	MMM	Mortar Missing Medium	21	S 3
	.4	RFB	Roots Fine Barrel	31	M 2
	3.8	RFB	Roots Fine Barrel	49	M 2
	5.1	RFB	Roots Fine Barrel	62	M 2
	7.5	DSF	Deposits Settled Fine	77	M 2
	8.8	MGO	General Observation	90	NA

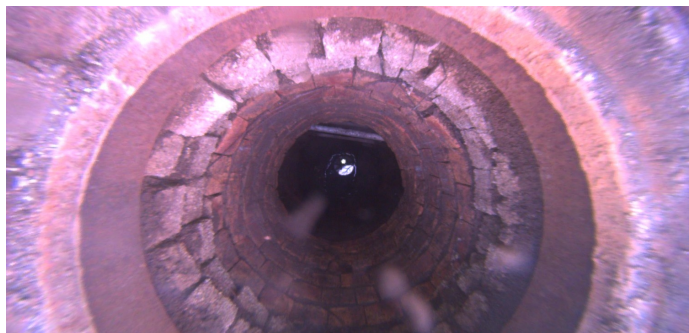
Code: **MGO**
Description: **General Observation**

Distance (ft): **.0**
Structural Grade: **0**
O&M Grade: **0**
Clock Start/From:
Clock To:
1st Value:
2nd Value:
Value Percent:
Step: **NO**
Remarks: **access MH**

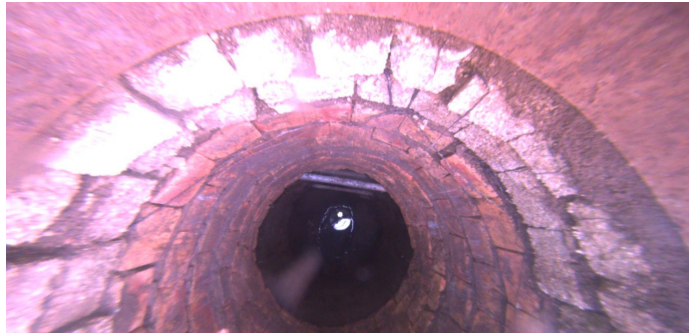
Code: **MMM**
Description: **Mortar Missing Medium**

Distance (ft): **.4**
Structural Grade: **3**
O&M Grade: **0**
Clock Start/From: **12**
Clock To: **12**
1st Value:
2nd Value:
Value Percent:
Step: **NO**
Remarks:

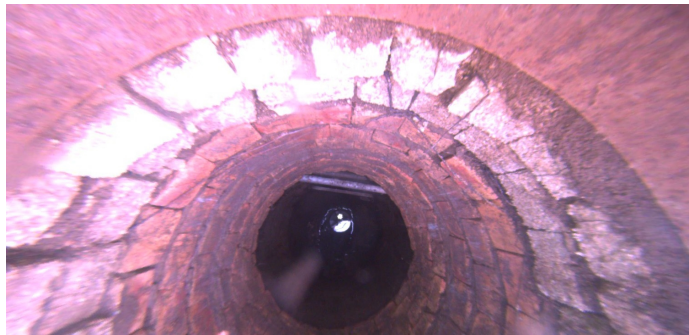
Code: **RFB**
Description: **Roots Fine Barrel**

Distance (ft): **.4**
Structural Grade: **0**
O&M Grade: **2**
Clock Start/From: **12**
Clock To: **1**
1st Value:
2nd Value:
Value Percent:
Step: **NO**
Remarks:

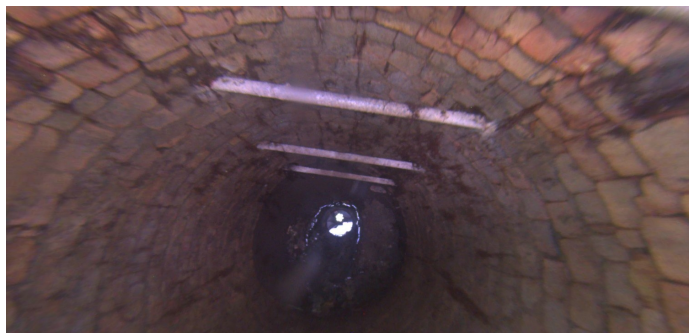
Code: **RFB**
Description: **Roots Fine Barrel**

Distance (ft): **3.8**
Structural Grade: **0**
O&M Grade: **2**
Clock Start/From: **10**
Clock To: **2**
1st Value:
2nd Value:
Value Percent:
Step: **NO**
Remarks:

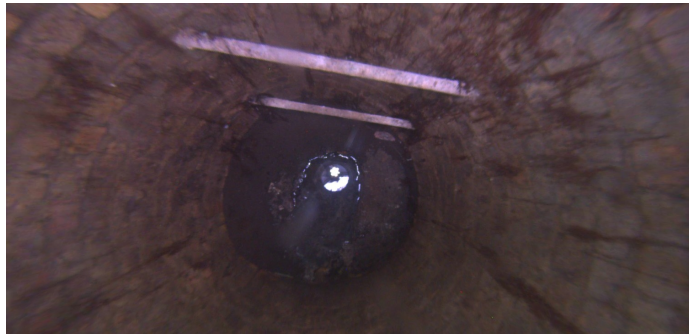
Code: **RFB**
Description: **Roots Fine Barrel**

Distance (ft): **5.1**
Structural Grade: **0**
O&M Grade: **2**
Clock Start/From: **12**
Clock To: **12**
1st Value:
2nd Value:
Value Percent:
Step: **NO**
Remarks:

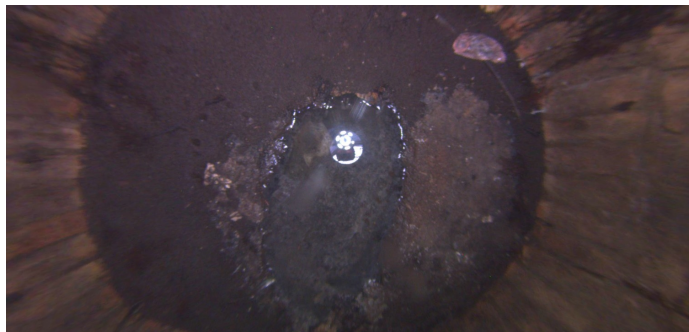
Code: **DSF**
Description: **Deposits Settled Fine**

Distance (ft): **7.5**
Structural Grade: **0**
O&M Grade: **2**
Clock Start/From: **12**
Clock To: **12**
1st Value:
2nd Value:
Value Percent: **10.000**
Step: **NO**
Remarks:

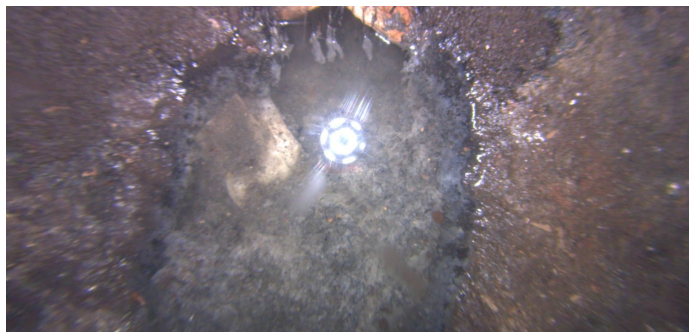
Code: **MGO**
Description: **General Observation**

Distance (ft): **8.8**
Structural Grade: **0**
O&M Grade: **0**
Clock Start/From:
Clock To:
1st Value:
2nd Value:
Value Percent:
Step: **NO**
Remarks: **END SURVEY**
