# Manhole Inspection Report

Date:	<b>04/28/2018</b>	Weather:		Coding:	<b>RZMACP</b>
MH#:	<b>M-706-007</b>	Owner:	<b>NA</b>	Len. Surveyed:	<b>15.3</b>
P.O.#:		Surveyor:	<b>Jen Costello</b>	Rim to Invert:	<b>14.7</b>
Customer:		Cert. #:	<b>U-907-5518</b>	Wall Material:	<b>Concrete (reinforced)</b>

Street:	<b>Intersection of Linda St. and 8th St. t</b>	Project:	<b>Hobart, IN</b>
City:	<b>Hobart, IN</b>	GPS Northing:	<b>41.525383</b>
Location:		GPS Easting:	<b>-87.24985504</b>
Drain Area:	<b>Southeast</b>	GPS Accuracy:	<b>Nearest Meter</b>
Cover Shape:	<b>Circular</b>	Evidence of Surcharge:	<b>No</b>
Cover Size:	<b>22.5</b>	Potential for Runoff:	<b>None</b>
Comments:

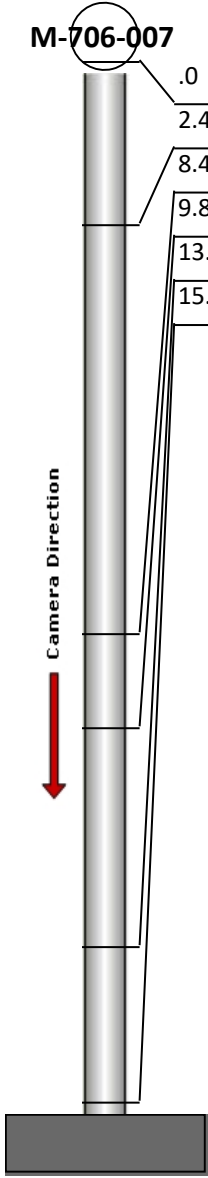
.0	MGO	General Observation	10	NA
	2.4	MGP	General Photo	28	NA
	8.4	SAV	Surface Aggregate Visible	54	S 3
	9.8	IW	Infil Weeper	68	M 2
	13.0	SAP	Surface Aggregate Projecting	86	S 3
	15.3	MGO	General Observation	103	NA

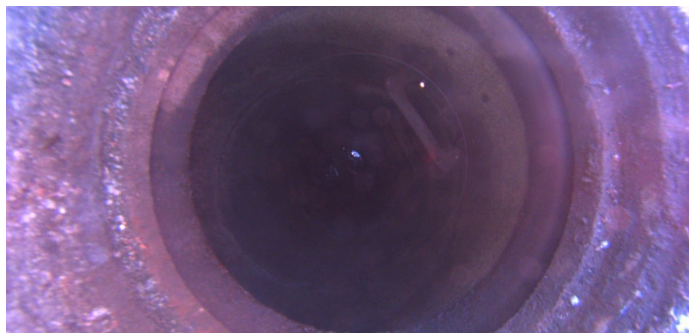
Code: **MGO**  
Description: **General Observation**

Distance (ft): **.0**  
Structural Grade: **0**  
O&M Grade: **0**  
Clock Start/From:  
Clock To:  
1st Value:  
2nd Value:  
Value Percent:  
Step: **NO**  
Remarks: **ACCESS MH**

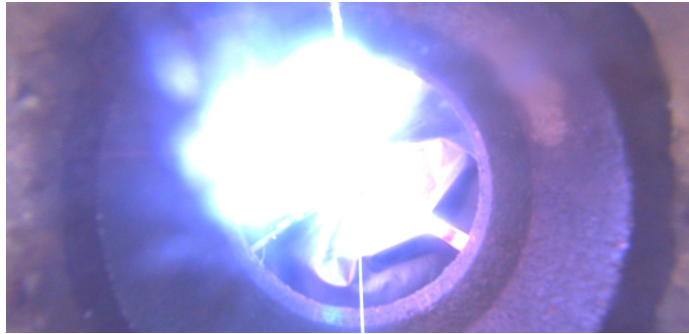
Code:	<b>MGP</b>
Description:	<b>General Photo</b>
Distance (ft):	<b>2.4</b>
Structural Grade:	<b>0</b>
O&M Grade:	<b>0</b>
Clock Start/From:	
Clock To:	
1st Value:	
2nd Value:	
Value Percent:	
Step:	<b>NO</b>
Remarks:	<b>UNDERSIDE OF FRAME</b>

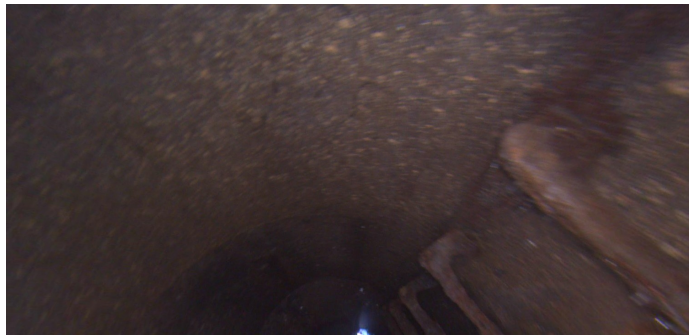
Code:	<b>SAV</b>
Description:	<b>Surface Aggregate Visible</b>
Distance (ft):	<b>8.4</b>
Structural Grade:	<b>3</b>
O&M Grade:	<b>0</b>
Clock Start/From:	<b>12</b>
Clock To:	<b>12</b>
1st Value:	
2nd Value:	
Value Percent:	
Step:	<b>NO</b>
Remarks:

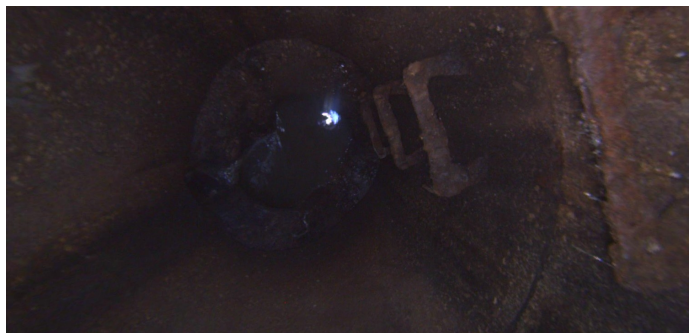
Code:	<b>IW</b>
Description:	<b>Infil Weeper</b>
Distance (ft):	<b>9.8</b>
Structural Grade:	<b>0</b>
O&M Grade:	<b>2</b>
Clock Start/From:	<b>12</b>
Clock To:	<b>12</b>
1st Value:	
2nd Value:	
Value Percent:	
Step:	<b>NO</b>
Remarks:

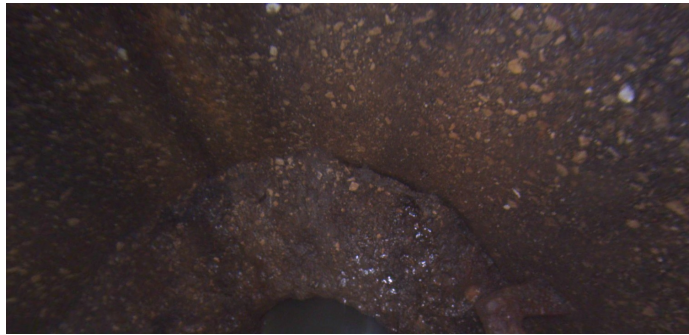
Code: **SAP**  
Description: **Surface Aggregate Projecting**

Distance (ft): **13.0**  
Structural Grade: **3**  
O&M Grade: **0**  
Clock Start/From: **12**  
Clock To: **12**  
1st Value:  
2nd Value:  
Value Percent:  
Step: **NO**  
Remarks:

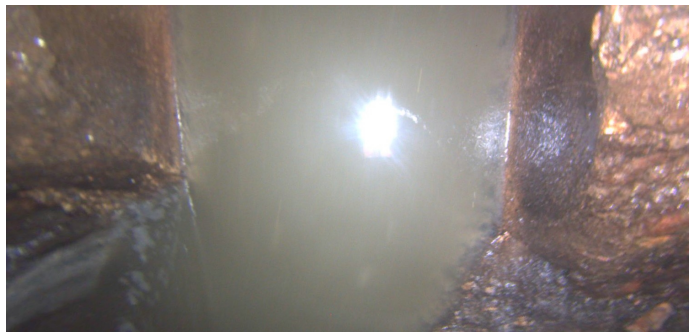
Code: **MGO**  
Description: **General Observation**

Distance (ft): **15.3**  
Structural Grade: **0**  
O&M Grade: **0**  
Clock Start/From:  
Clock To:  
1st Value:  
2nd Value:  
Value Percent:  
Step: **NO**  
Remarks: **END SURVEY**
