Manhole Inspection Report

Date:	04/24/2018	Weather:		Coding:	RZMACP
MH#:	M-706-008.1	Owner:	NA	Len. Surveyed:	8.3
P.O.#:		Surveyor:	Jen Costello	Rim to Invert:	7.8
Customer:	8.7	Cert. #:	U-907-5518	Wall Material:	Concrete (reinforced)

Street:	Intersection of 8th Pl. and Garfield S	Project:	Hobart, IN
City:	Hobart, IN	GPS Northing:	0.0
Location:		GPS Easting:	0.0
Drain Area:	Southeast	GPS Accuracy:	Nearest Meter
Cover Shape:	Circular	Evidence of Surcharge:	No
Cover Size:	22.5	Potential for Runoff:	None
Comments:

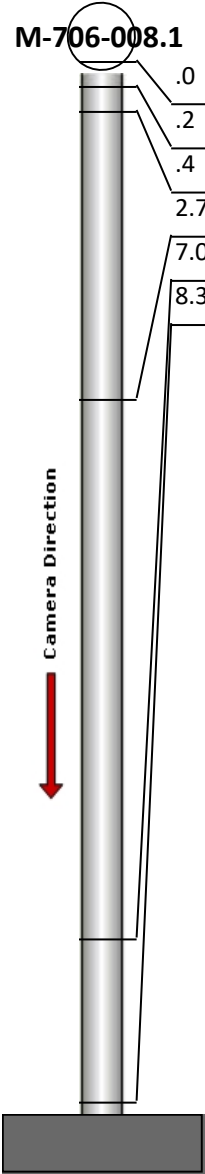
Position	Code	Observation	Video (sec)	Grade
M-706-008.1

.0	MGO	General Observation	10	NA
	.2	DSGV	Deposits Settled Gravel	22	M 2
	.4	DB	Displaced Brick	34	S 3
	2.7	MGP	General Photo	52	NA
	7.0	DSF	Deposits Settled Fine	74	M 2
	8.3	MGO	General Observation	88	NA

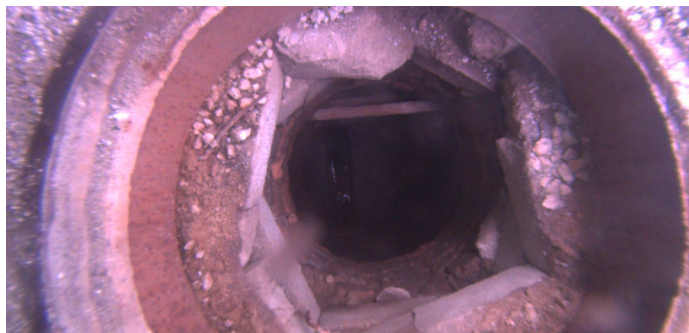
Code: **MGO**
Description: **General Observation**

Distance (ft): **.0**
Structural Grade: **0**
O&M Grade: **0**
Clock Start/From:
Clock To:
1st Value:
2nd Value:
Value Percent:
Step: **NO**
Remarks: **access MH**

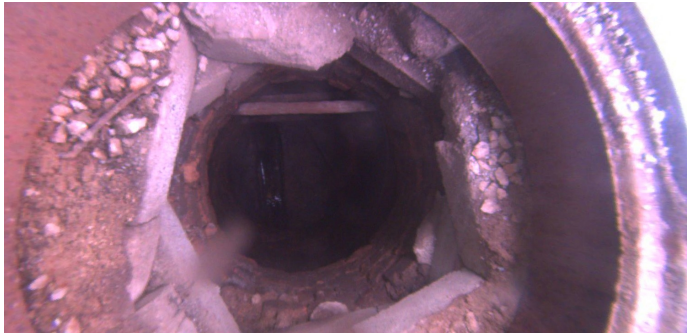
Code: **DSGV**
Description: **Deposits Settled Gravel**

Distance (ft): **.2**
Structural Grade: **0**
O&M Grade: **2**
Clock Start/From: **12**
Clock To: **12**
1st Value:
2nd Value:
Value Percent: **5.000**
Step: **NO**
Remarks:

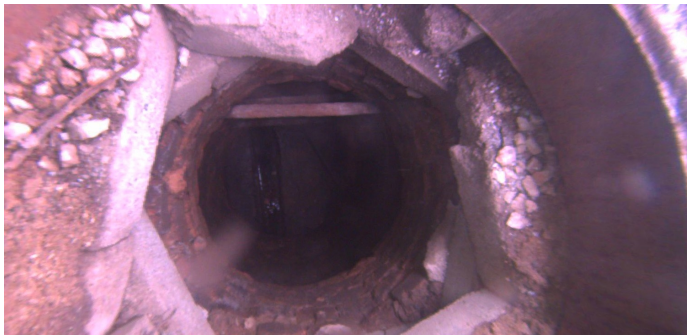
Code: **DB**
Description: **Displaced Brick**

Distance (ft): **.4**
Structural Grade: **3**
O&M Grade: **0**
Clock Start/From: **12**
Clock To: **12**
1st Value:
2nd Value:
Value Percent:
Step: **NO**
Remarks:

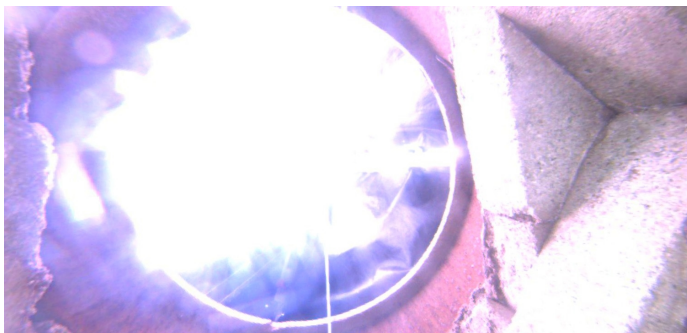
Code: **MGP**
Description: **General Photo**

Distance (ft): **2.7**
Structural Grade: **0**
O&M Grade: **0**
Clock Start/From:
Clock To:
1st Value:
2nd Value:
Value Percent:
Step: **NO**
Remarks: **UNDERSIDE OF FRAME**

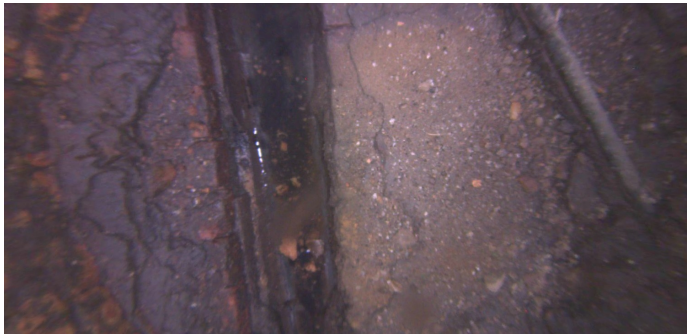
Code: **DSF**
Description: **Deposits Settled Fine**

Distance (ft): **7.0**
Structural Grade: **0**
O&M Grade: **2**
Clock Start/From: **12**
Clock To: **12**
1st Value:
2nd Value:
Value Percent: **5.000**
Step: **NO**
Remarks:

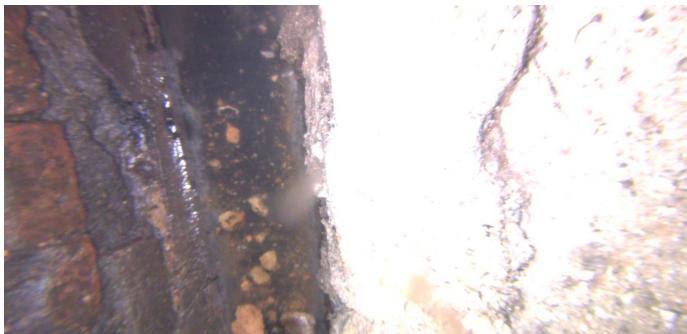
Code: **MGO**
Description: **General Observation**

Distance (ft): **8.3**
Structural Grade: **0**
O&M Grade: **0**
Clock Start/From:
Clock To:
1st Value:
2nd Value:
Value Percent:
Step: **NO**
Remarks: **END SURVEY**
