Manhole Inspection Report

Date:	04/24/2018	Weather:		Coding:	RZMACP
MH#:	M-706-008.2	Owner:	NA	Len. Surveyed:	8.2
P.O.#:		Surveyor:	Jen Costello	Rim to Invert:	7.5
Customer:	8.7	Cert. #:	U-907-5518	Wall Material:	Brick

Street:	Garfield St. 129' North of 9th St.	Project:	Hobart, IN
City:	Hobart, IN	GPS Northing:	0.0
Location:		GPS Easting:	0.0
Drain Area:	Southeast	GPS Accuracy:	Nearest Meter
Cover Shape:	Circular	Evidence of Surcharge:	No
Cover Size:	22.5	Potential for Runoff:	None
Comments:

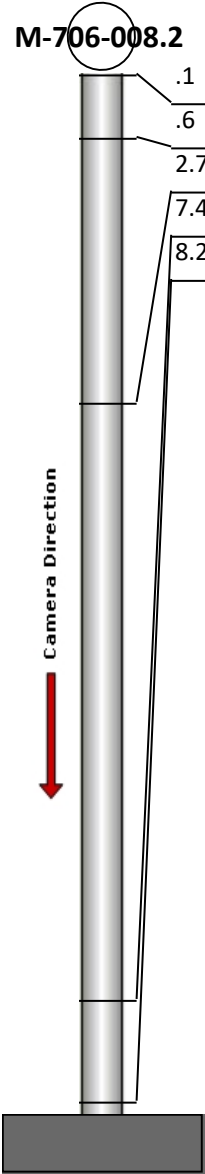
Position	Code	Observation	Video (sec)	Grade
M-706-008.2

.1	MGO	General Observation	10	NA
	.6	MMM	Mortar Missing Medium	23	S 3
	2.7	MGO	General Observation	40	NA
	7.4	DSF	Deposits Settled Fine	62	M 2
	8.2	MGO	General Observation	75	NA

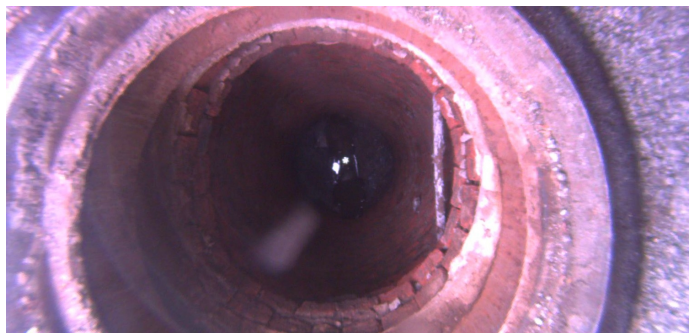
Code: **MGO**
Description: **General Observation**

Distance (ft): **.1**
Structural Grade: **0**
O&M Grade: **0**
Clock Start/From:
Clock To:
1st Value:
2nd Value:
Value Percent:
Step: **NO**
Remarks: **ACCESS MH**

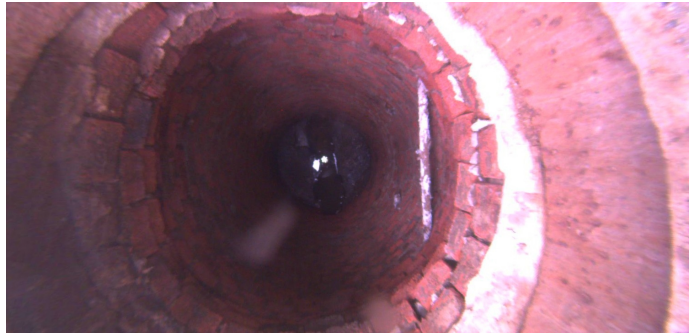
Code: **MMM**
Description: **Mortar Missing Medium**

Distance (ft): **.6**
Structural Grade: **3**
O&M Grade: **0**
Clock Start/From: **12**
Clock To: **12**
1st Value:
2nd Value:
Value Percent:
Step: **NO**
Remarks:

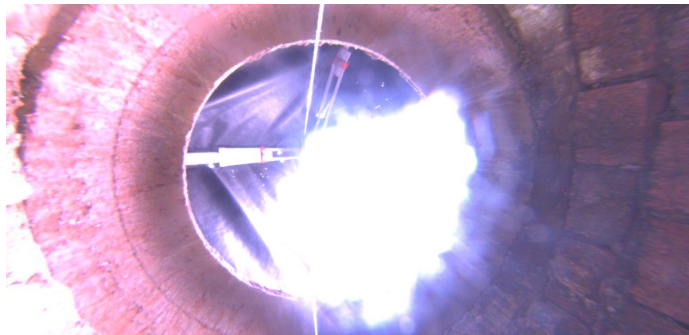
Code: **MGO**
Description: **General Observation**

Distance (ft): **2.7**
Structural Grade: **0**
O&M Grade: **0**
Clock Start/From:
Clock To:
1st Value:
2nd Value:
Value Percent:
Step: **NO**
Remarks: **UNDERSIDE OF FRAME**

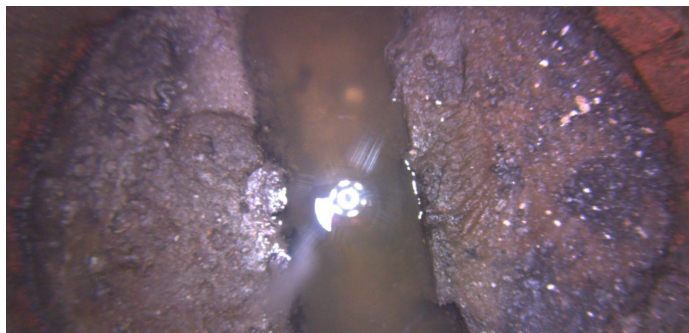
Code: **DSF**
Description: **Deposits Settled Fine**

Distance (ft): **7.4**
Structural Grade: **0**
O&M Grade: **2**
Clock Start/From: **12**
Clock To: **12**
1st Value:
2nd Value:
Value Percent: **5.000**
Step: **NO**
Remarks:

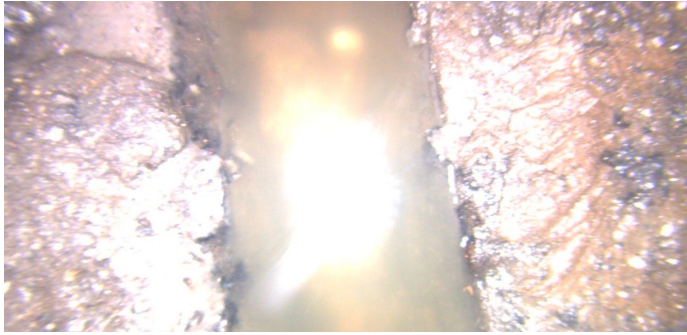
Code: **MGO**
Description: **General Observation**

Distance (ft): **8.2**
Structural Grade: **0**
O&M Grade: **0**
Clock Start/From:
Clock To:
1st Value:
2nd Value:
Value Percent:
Step: **NO**
Remarks: **END SURVEY**
