Manhole Inspection Report

Date:	04/23/2018	Weather:		Coding:	RZMACP
MH#:	M-706-008.7	Owner:	NA	Len. Surveyed:	7.9
P.O.#:		Surveyor:	Jen Costello	Rim to Invert:	7.7
Customer:	8.7	Cert. #:	U-907-5518	Wall Material:	Concrete (reinforced)

Street:	Garfield St. 219' North of 10th St.	Project:	Hobart, IN
City:	Hobart, IN	GPS Northing:	0.0
Location:		GPS Easting:	0.0
Drain Area:	Southeast	GPS Accuracy:	Nearest Meter
Cover Shape:	Circular	Evidence of Surcharge:	No
Cover Size:	22.5	Potential for Runoff:	None
Comments:

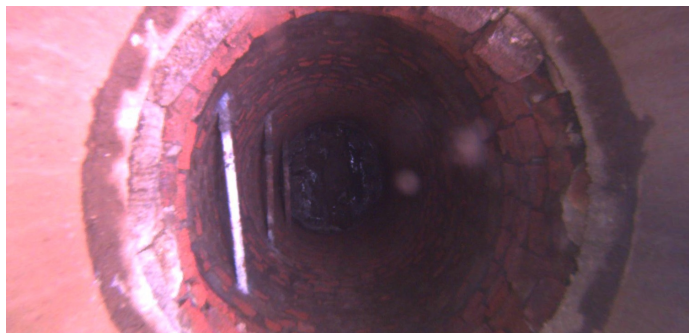
Code: **MGO**
Description: **General Observation**

Distance (ft): **.0**
Structural Grade: **0**
O&M Grade: **0**
Clock Start/From:
Clock To:
1st Value:
2nd Value:
Value Percent:
Step: **NO**
Remarks: **access mh**

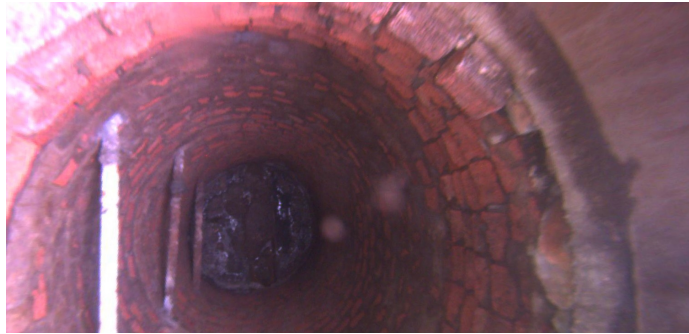
Code: **DB**
Description: **Displaced Brick**

Distance (ft): **.5**
Structural Grade: **3**
O&M Grade: **0**
Clock Start/From: **12**
Clock To: **3**
1st Value:
2nd Value:
Value Percent:
Step: **NO**
Remarks:

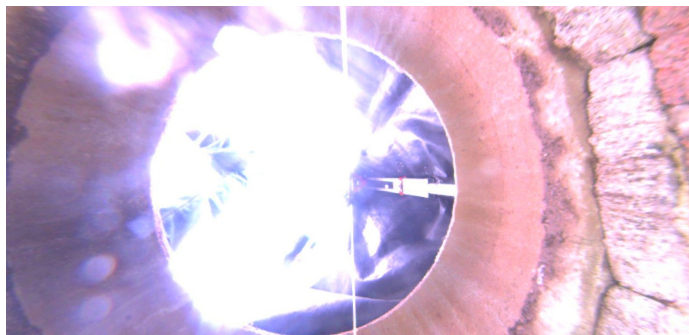
Code: **MGP**
Description: **General Photo**

Distance (ft): **2.1**
Structural Grade: **0**
O&M Grade: **0**
Clock Start/From:
Clock To:
1st Value:
2nd Value:
Value Percent:
Step: **NO**
Remarks: **underside of frame**

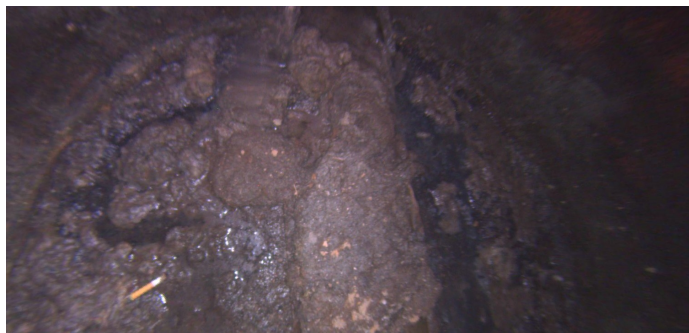
Code: **DSF**
Description: **Deposits Settled Fine**

Distance (ft): **7.0**
Structural Grade: **0**
O&M Grade: **5**
Clock Start/From: **3**
Clock To: **9**
1st Value:
2nd Value:
Value Percent: **50.000**
Step: **NO**
Remarks:

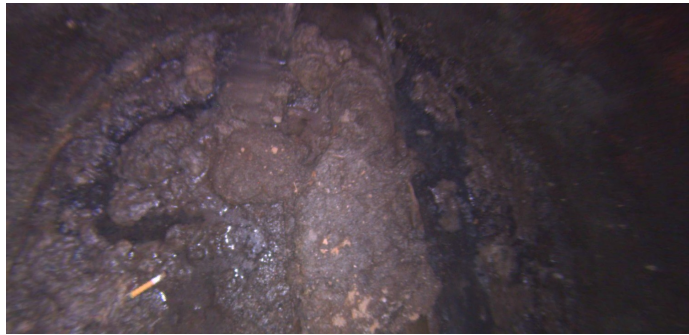
Code:	DSF
Description:	Deposits Settled Fine
Distance (ft):	7.0
Structural Grade:	0
O&M Grade:	2
Clock Start/From:	12
Clock To:	12
1st Value:	
2nd Value:	
Value Percent:	5.000
Step:	NO
Remarks:

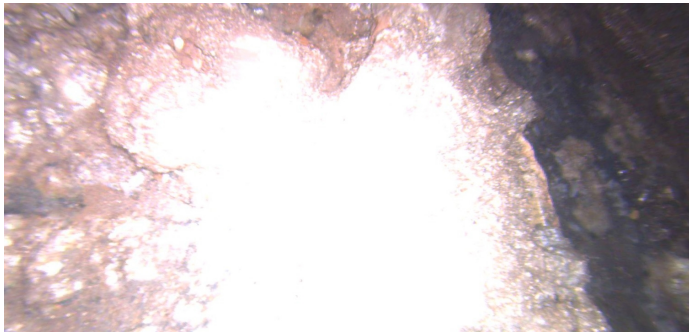
Code:	MGO
Description:	General Observation
Distance (ft):	7.9
Structural Grade:	0
O&M Grade:	0
Clock Start/From:	
Clock To:	
1st Value:	
2nd Value:	
Value Percent:	
Step:	NO
Remarks:	end survey
