# Manhole Inspection Report

Date:	<b>04/28/2018</b>	Weather:		Coding:	<b>RZMACP</b>
MH#:	<b>M-706-009</b>	Owner:	<b>NA</b>	Len. Surveyed:	<b>14.2</b>
P.O.#:		Surveyor:	<b>Jen Costello</b>	Rim to Invert:	<b>14.8</b>
Customer:		Cert. #:	<b>U-907-5518</b>	Wall Material:	<b>Concrete (reinforced)</b>

Street:	<b>Intersection of 8th St. and Hwy 51.</b>	Project:	<b>Hobart, IN</b>
City:	<b>Hobart, IN</b>	GPS Northing:	<b>41.52535629</b>
Location:		GPS Easting:	<b>-87.25218201</b>
Drain Area:	<b>Southeast</b>	GPS Accuracy:	<b>Nearest Meter</b>
Cover Shape:	<b>Circular</b>	Evidence of Surcharge:	<b>No</b>
Cover Size:	<b>22.5</b>	Potential for Runoff:	<b>None</b>
Comments:

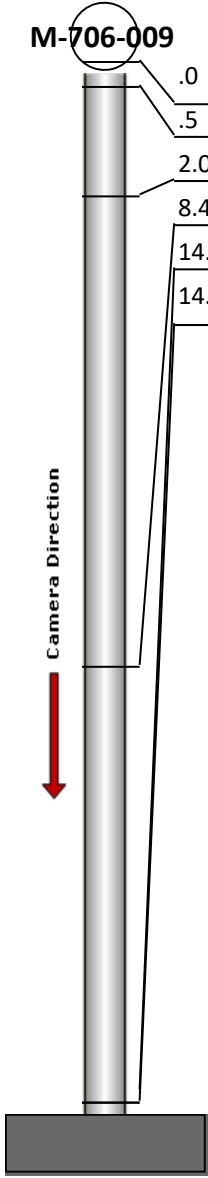
.0	MGO	General Observation	10	NA
	.5	SAP	Surface Aggregate Projecting	22	S 3
	2.0	MGO	General Observation	39	NA
	8.4	IW	Infil Weeper	65	M 2
	14.2	MGO	General Observation	88	NA
	14.2	SAP	Surface Aggregate Projecting	99	S 3

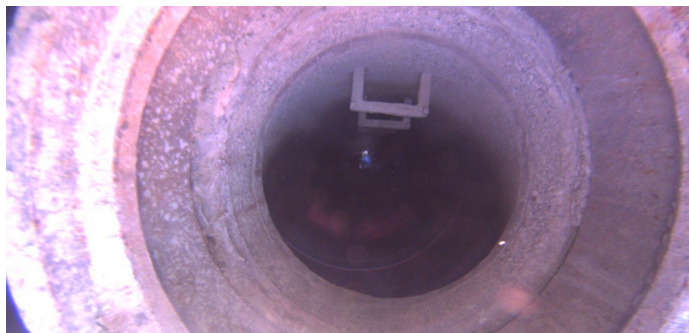
Code: **MGO**  
Description: **General Observation**

Distance (ft): **.0**  
Structural Grade: **0**  
O&M Grade: **0**  
Clock Start/From:  
Clock To:  
1st Value:  
2nd Value:  
Value Percent:  
Step: **NO**  
Remarks: **ACCESS MH**

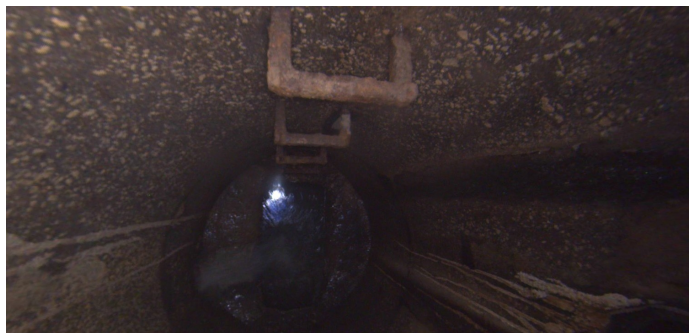
Code: **IW**  
Description: **Infil Weeper**

Distance (ft): **8.4**  
Structural Grade: **0**  
O&M Grade: **2**  
Clock Start/From: **2**  
Clock To:  
1st Value:  
2nd Value:  
Value Percent:  
Step: **NO**  
Remarks:

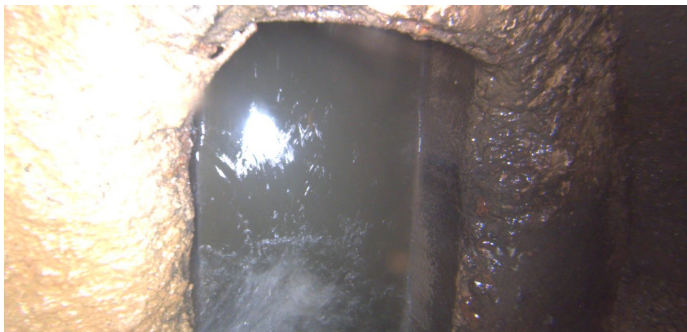
Code: **SAP**  
Description: **Surface Aggregate Projecting**

Distance (ft): **14.2**  
Structural Grade: **3**  
O&M Grade: **0**  
Clock Start/From: **12**  
Clock To: **12**  
1st Value:  
2nd Value:  
Value Percent:  
Step: **NO**  
Remarks:
