Manhole Inspection Report

| MH#: | M-706-010 | Owner: | NA | Len. Surveyed: | 13.9 |

| Street: | Intersection of 8th St. and State St. | Project: | Hobart, IN |

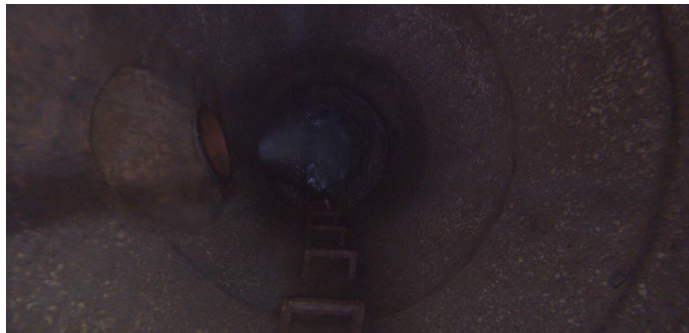
| Code: | MGP |
| Description: | General Photo |
| Distance (ft): | 2.6 |
| Remarks: | UNDERSIDE OF FRAME |

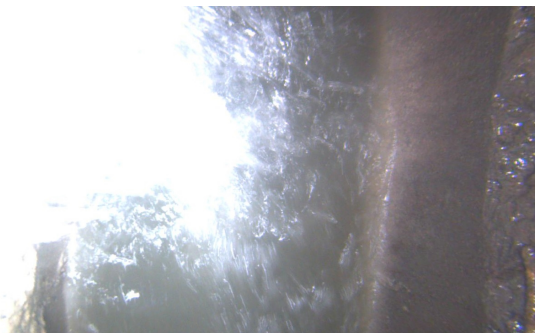
| Code: | SAP |
| Description: | Surface Aggregate Projecting |
| Distance (ft): | 5.4 |
| Structural Grade: | 3 |
| Clock Start/From: | 12 |
