# Manhole Inspection Report

Date:	<b>04/27/2018</b>	Weather:		Coding:	<b>RZMACP</b>
MH#:	<b>M-706-011</b>	Owner:	<b>NA</b>	Len. Surveyed:	<b>12.6</b>
P.O.#:		Surveyor:	<b>Jen Costello</b>	Rim to Invert:	<b>12.6</b>
Customer:		Cert. #:	<b>U-907-5518</b>	Wall Material:	<b>Concrete (reinforced)</b>

Street:	<b>Intersection of 8th St. and Lake St.</b>	Project:	<b>Hobart, IN</b>
City:	<b>Hobart, IN</b>	GPS Northing:	<b>41.52486801</b>
Location:		GPS Easting:	<b>-87.25465393</b>
Drain Area:	<b>Southeast</b>	GPS Accuracy:	<b>Nearest Meter</b>
Cover Shape:	<b>Circular</b>	Evidence of Surcharge:	<b>No</b>
Cover Size:	<b>22.5</b>	Potential for Runoff:	<b>None</b>
Comments:

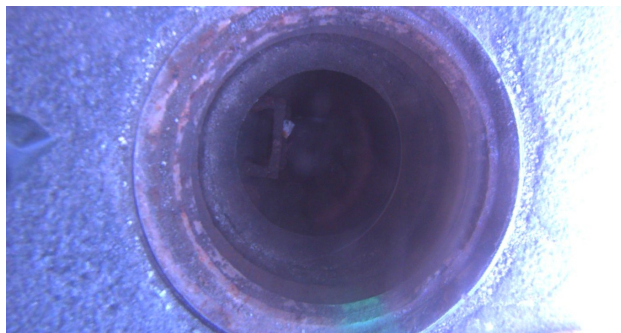
Code: **MGO**  
Description: **General Observation**

Distance (ft): **.0**  
Structural Grade: **0**  
O&M Grade: **0**  
Clock Start/From:  
Clock To:  
1st Value:  
2nd Value:  
Value Percent:  
Step: **NO**  
Remarks: **ACCESS MH**

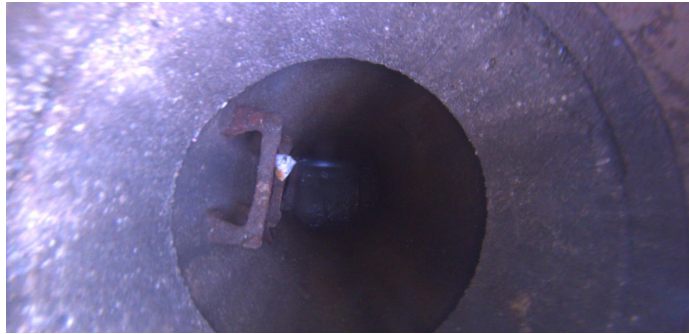
Code: **SAV**  
Description: **Surface Aggregate Visible**

Distance (ft): **1.6**  
Structural Grade: **3**  
O&M Grade: **0**  
Clock Start/From: **12**  
Clock To: **12**  
1st Value:  
2nd Value:  
Value Percent:  
Step: **NO**  
Remarks:

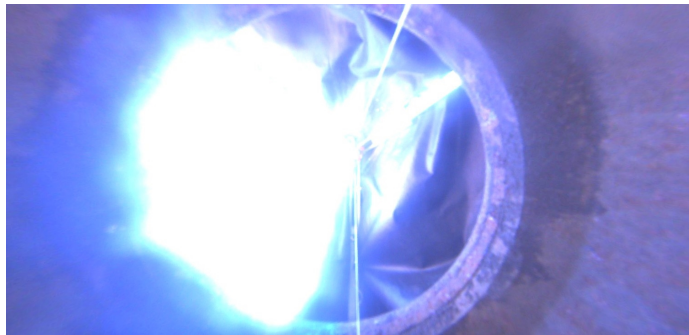
Code: **MGO**  
Description: **General Observation**

Distance (ft): **2.6**  
Structural Grade: **0**  
O&M Grade: **0**  
Clock Start/From:  
Clock To:  
1st Value:  
2nd Value:  
Value Percent:  
Step: **NO**  
Remarks: **UNDERSIDE OF FRAME**

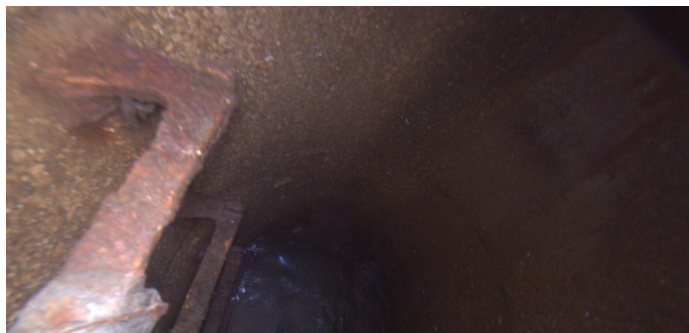
Code: **SAP**  
Description: **Surface Aggregate Projecting**

Distance (ft): **6.7**  
Structural Grade: **3**  
O&M Grade: **0**  
Clock Start/From: **12**  
Clock To: **12**  
1st Value:  
2nd Value:  
Value Percent:  
Step: **NO**  
Remarks:

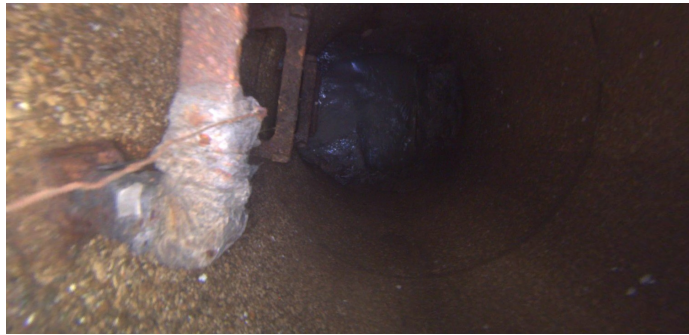
Code:	<b>DAR</b>
Description:	<b>Deposits Attached Ragging</b>
Distance (ft):	<b>6.7</b>
Structural Grade:	<b>0</b>
O&M Grade:	<b>2</b>
Clock Start/From:	<b>8</b>
Clock To:	<b>9</b>
1st Value:	
2nd Value:	
Value Percent:	<b>5.000</b>
Step:	<b>YES</b>
Remarks:

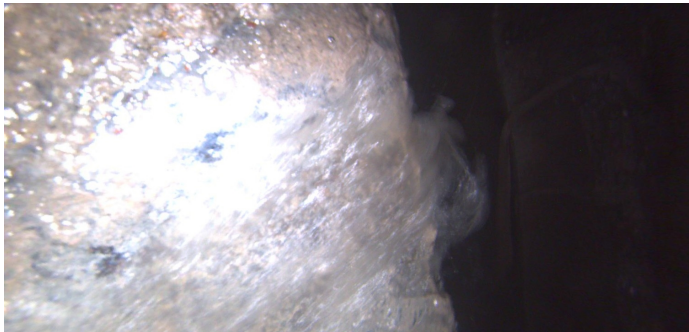
Code:	<b>MGO</b>
Description:	<b>General Observation</b>
Distance (ft):	<b>12.6</b>
Structural Grade:	<b>0</b>
O&M Grade:	<b>0</b>
Clock Start/From:	
Clock To:	
1st Value:	
2nd Value:	
Value Percent:	
Step:	<b>NO</b>
Remarks:	<b>END SURVEY</b>
