# Manhole Inspection Report

Date:	<b>04/23/2018</b>	Weather:		Coding:	<b>RZMACP</b>
MH#:	<b>M-706-013.2</b>	Owner:	<b>NA</b>	Len. Surveyed:	<b>7.1</b>
P.O.#:		Surveyor:	<b>Jen Costello</b>	Rim to Invert:	<b>7.4</b>
Customer:	<b>8.7</b>	Cert. #:	<b>U-907-5518</b>	Wall Material:	<b>Concrete (reinforced)</b>

Street:	<b>Water St. 518' South of 8th St.</b>	Project:	<b>Hobart, IN</b>
City:	<b>Hobart, IN</b>	GPS Northing:	<b>0.0</b>
Location:		GPS Easting:	<b>0.0</b>
Drain Area:	<b>Southeast</b>	GPS Accuracy:	<b>Nearest Meter</b>
Cover Shape:	<b>Circular</b>	Evidence of Surcharge:	<b>No</b>
Cover Size:	<b>22.5</b>	Potential for Runoff:	<b>None</b>
Comments:

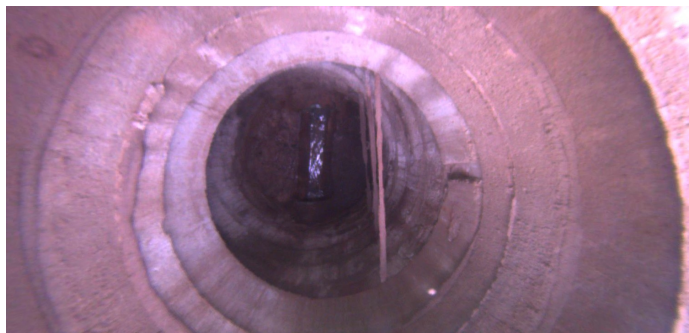
Code: **MGO**  
Description: **General Observation**

Distance (ft): **.0**  
Structural Grade: **0**  
O&M Grade: **0**  
Clock Start/From:  
Clock To:  
1st Value:  
2nd Value:  
Value Percent:  
Step: **NO**  
Remarks: **ACCESS MH**

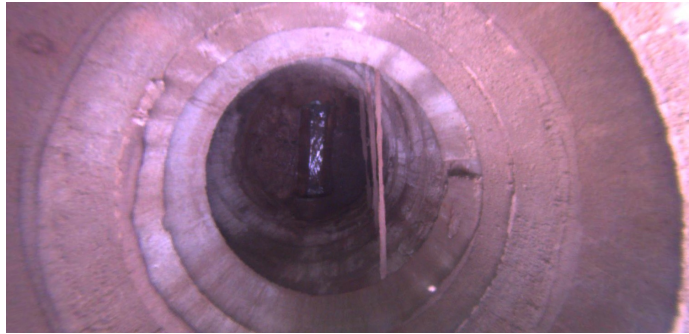
Code: **MGO**  
Description: **General Observation**

Distance (ft): **.0**  
Structural Grade: **0**  
O&M Grade: **0**  
Clock Start/From:  
Clock To:  
1st Value:  
2nd Value:  
Value Percent:  
Step: **NO**  
Remarks: **ACCESS MH**

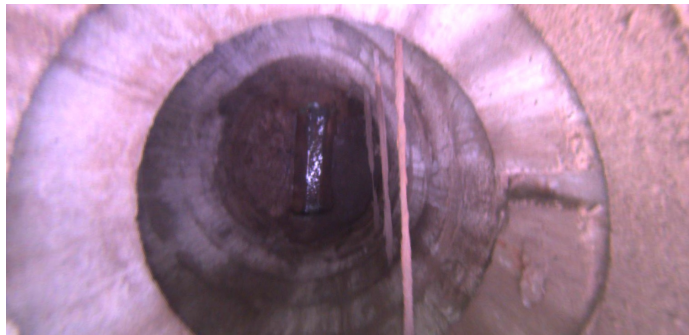
Code: **FL**  
Description: **Fracture Longitudinal**

Distance (ft): **1.0**  
Structural Grade: **3**  
O&M Grade: **0**  
Clock Start/From: **3**  
Clock To:  
1st Value:  
2nd Value:  
Value Percent:  
Step: **NO**  
Remarks:

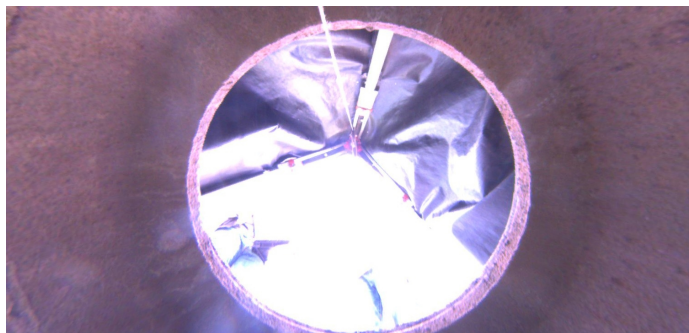
Code: **MGO**  
Description: **General Observation**

Distance (ft): **1.7**  
Structural Grade: **0**  
O&M Grade: **0**  
Clock Start/From:  
Clock To:  
1st Value:  
2nd Value:  
Value Percent:  
Step: **NO**  
Remarks: **UNDERSIDE OF FRAME**

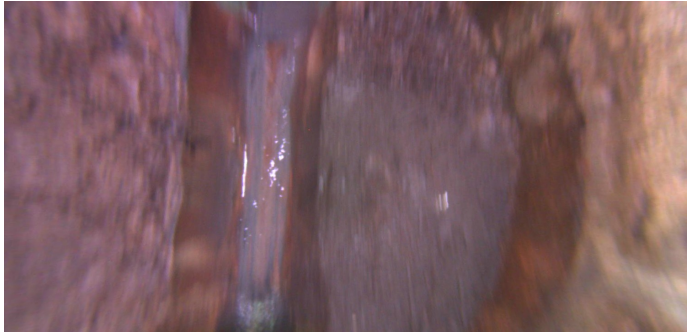
Code: **DSF**  
Description: **Deposits Settled Fine**

Distance (ft): **5.7**  
Structural Grade: **0**  
O&M Grade: **2**  
Clock Start/From: **12**  
Clock To: **12**  
1st Value:  
2nd Value:  
Value Percent: **5.000**  
Step: **NO**  
Remarks:

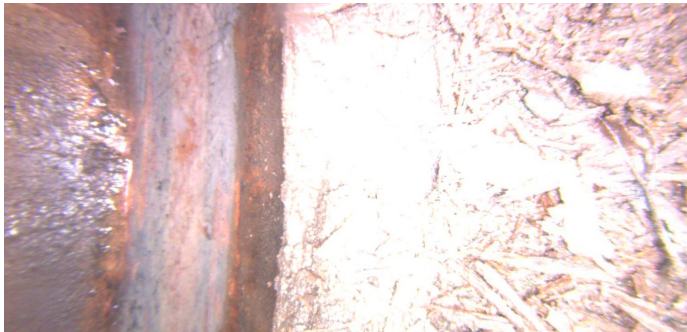
Code: **MGO**  
Description: **General Observation**

Distance (ft): **7.1**  
Structural Grade: **0**  
O&M Grade: **0**  
Clock Start/From:  
Clock To:  
1st Value:  
2nd Value:  
Value Percent:  
Step: **NO**  
Remarks: **END SURVEY**
