# Manhole Inspection Report

Date:	<b>04/23/2018</b>	Weather:		Coding:	<b>RZMACP</b>
MH#:	<b>M-706-013.3</b>	Owner:	<b>NA</b>	Len. Surveyed:	<b>7.7</b>
P.O.#:		Surveyor:	<b>Jen Costello</b>	Rim to Invert:	<b>7.8</b>
Customer:	<b>8.7</b>	Cert. #:	<b>U-907-5518</b>	Wall Material:	<b>Brick</b>

**M-706-013.3**

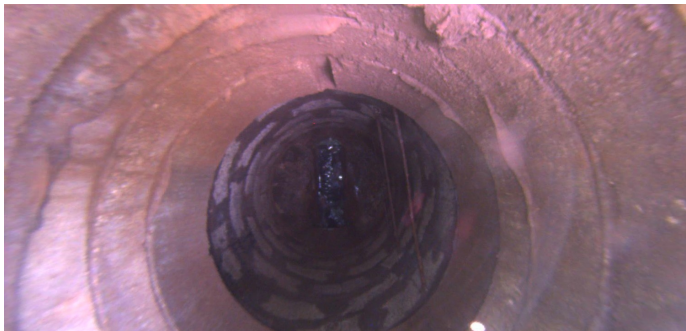
Code:	MGO
Description:	General Observation
Distance (ft):	.0
Structural Grade:	0
O&M Grade:	0
Clock Start/From:	
Clock To:	
1st Value:	
2nd Value:	
Value Percent:	
Step:	NO
Remarks:	ACCESS MH

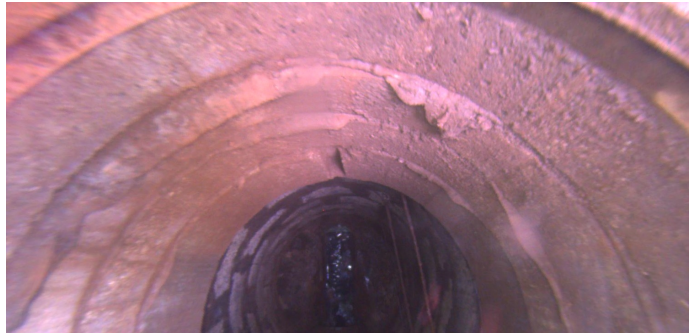
Code:	<b>SRI</b>
Description:	<b>Surface Roughness Increased</b>
Distance (ft):	<b>.0</b>
Structural Grade:	<b>1</b>
O&M Grade:	<b>0</b>
Clock Start/From:	<b>12</b>
Clock To:	<b>12</b>
1st Value:	
2nd Value:	
Value Percent:	
Step:	<b>NO</b>
Remarks:

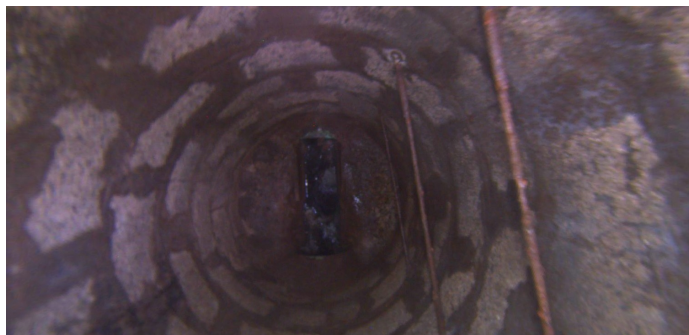
Code:	<b>SAV</b>
Description:	<b>Surface Aggregate Visible</b>
Distance (ft):	<b>2.4</b>
Structural Grade:	<b>3</b>
O&M Grade:	<b>0</b>
Clock Start/From:	<b>12</b>
Clock To:	<b>12</b>
1st Value:	
2nd Value:	
Value Percent:	
Step:	<b>NO</b>
Remarks:

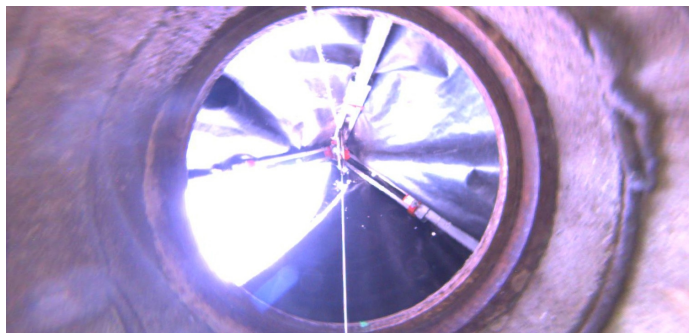
Code:	<b>MGP</b>
Description:	<b>General Photo</b>
Distance (ft):	<b>2.4</b>
Structural Grade:	<b>0</b>
O&M Grade:	<b>0</b>
Clock Start/From:	
Clock To:	
1st Value:	
2nd Value:	
Value Percent:	
Step:	<b>NO</b>
Remarks:	<b>UNDERSIDE OF FRAME</b>

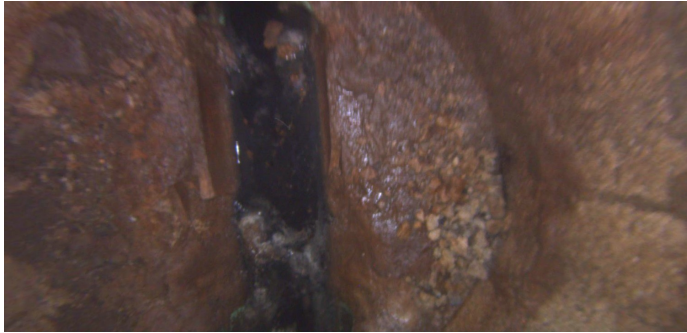
Code:	<b>DSGV</b>
Description:	<b>Deposits Settled Gravel</b>
Distance (ft):	<b>6.1</b>
Structural Grade:	<b>0</b>
O&M Grade:	<b>2</b>
Clock Start/From:	<b>12</b>
Clock To:	<b>12</b>
1st Value:	
2nd Value:	
Value Percent:	<b>5.000</b>
Step:	<b>NO</b>
Remarks:

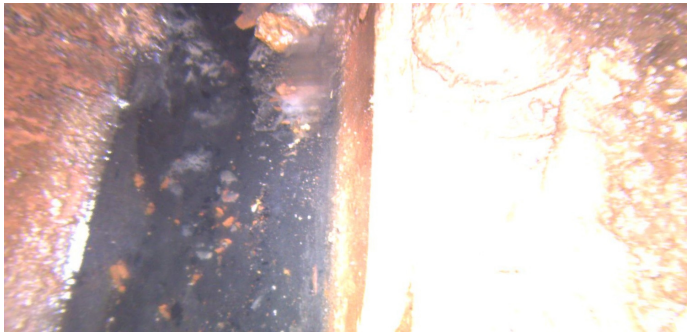
Code:	<b>MGO</b>
Description:	<b>General Observation</b>
Distance (ft):	<b>7.7</b>
Structural Grade:	<b>0</b>
O&M Grade:	<b>0</b>
Clock Start/From:	
Clock To:	
1st Value:	
2nd Value:	
Value Percent:	
Step:	<b>NO</b>
Remarks:	<b>END SURVEY</b>
