Manhole Inspection Report

Date:	04/27/2018	Weather:		Coding:	RZMACP
MH#:	M-706-015	Owner:	NA	Len. Surveyed:	11.2
P.O.#:		Surveyor:	Jen Costello	Rim to Invert:	10.8
Customer:		Cert. #:	U-907-5518	Wall Material:	Concrete (reinforced)

Street:	Intersection of 8th St. and Water St.	Project:	Hobart, IN
City:	Hobart, IN	GPS Northing:	41.52537155
Location:		GPS Easting:	-87.25595093
Drain Area:	Southeast	GPS Accuracy:	Nearest Meter
Cover Shape:	Circular	Evidence of Surcharge:	No
Cover Size:	22.5	Potential for Runoff:	None
Comments:

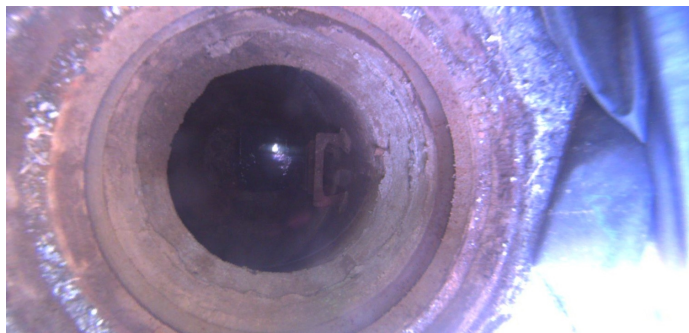
Code: **MGO**
Description: **General Observation**

Distance (ft): **.0**
Structural Grade: **0**
O&M Grade: **0**
Clock Start/From:
Clock To:
1st Value:
2nd Value:
Value Percent:
Step: **NO**
Remarks: **ACCESS MH**

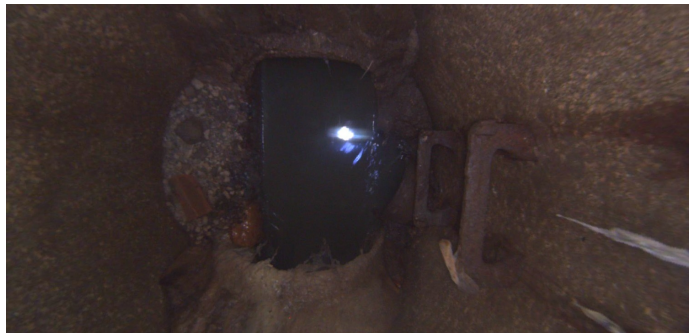
Code:	SAP
Description:	Surface Aggregate Projecting
Distance (ft):	7.3
Structural Grade:	3
O&M Grade:	0
Clock Start/From:	12
Clock To:	12
1st Value:	
2nd Value:	
Value Percent:	
Step:	NO
Remarks:

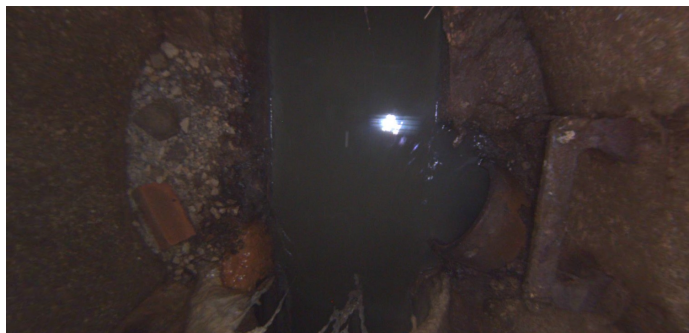
Code:	OBR
Description:	Obstacle Rocks
Distance (ft):	8.9
Structural Grade:	0
O&M Grade:	2
Clock Start/From:	8
Clock To:	
1st Value:	
2nd Value:	
Value Percent:	5.000
Step:	NO
Remarks:

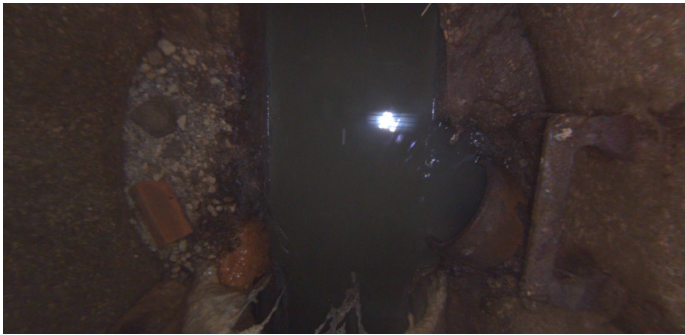
Code:	DSGV
Description:	Deposits Settled Gravel

Distance (ft):	8.9
Structural Grade:	0
O&M Grade:	2
Clock Start/From:	8
Clock To:	10
1st Value:	
2nd Value:	
Value Percent:	5.000
Step:	NO
Remarks:

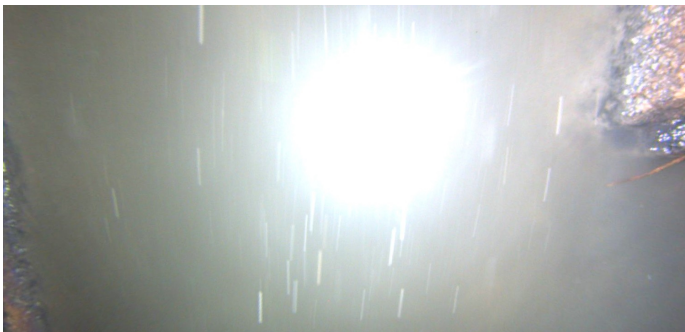
Code:	MGO
Description:	General Observation

Distance (ft):	11.2
Structural Grade:	0
O&M Grade:	0
Clock Start/From:	
Clock To:	
1st Value:	
2nd Value:	
Value Percent:	
Step:	NO
Remarks:	END SURVEY
