Manhole Inspection Report

Date:	04/29/2018	Weather:		Coding:	RZMACP
MH#:	M-706-018	Owner:	NA	Len. Surveyed:	5.9
P.O.#:		Surveyor:	Jen Costello	Rim to Invert:	8.4
Customer:		Cert. #:	U-907-5518	Wall Material:	Brick

Street:	Intersection of Garfield St. and Main	Project:	Hobart, IN
City:	Hobart, IN	GPS Northing:	41.52668762
Location:		GPS Easting:	-87.25095367
Drain Area:	South	GPS Accuracy:	Nearest Meter
Cover Shape:	Circular	Evidence of Surcharge:	No
Cover Size:	22.5	Potential for Runoff:	None
Comments:

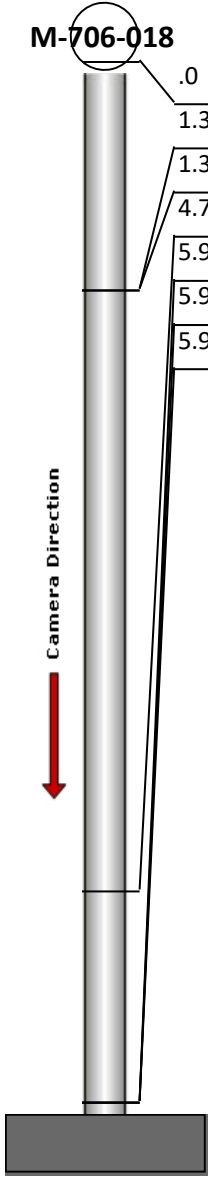
Position	Code	Observation	Video (sec)	Grade

.0	MGO	General Observation	10	NA
	1.3	MGP	General Photo	26	NA
	1.3	MGO	General Observation	39	NA
	4.7	DSF	Deposits Settled Fine	57	M 2
	5.9	HVV	Hole Void Visible	71	S 5
	5.9	DB	Displaced Brick	83	S 3
	5.9	MGO	General Observation	94	NA

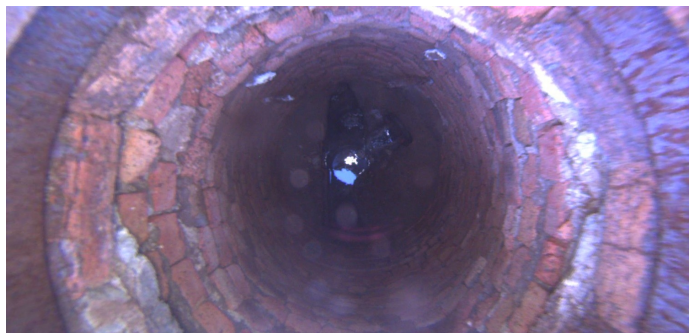
Code: **MGO**
Description: **General Observation**

Distance (ft): **.0**
Structural Grade: **0**
O&M Grade: **0**
Clock Start/From:
Clock To:
1st Value:
2nd Value:
Value Percent:
Step: **NO**
Remarks: **ACCESS MH**

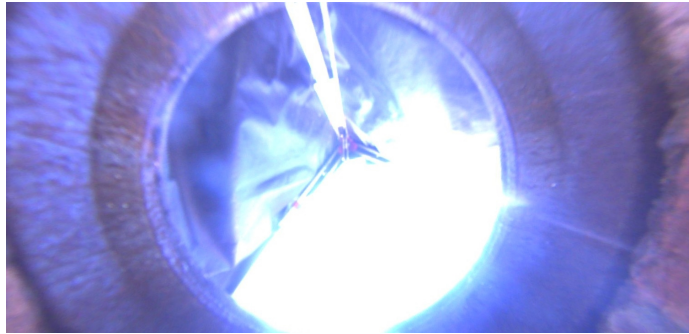
Code:	MGP
Description:	General Photo
Distance (ft):	1.3
Structural Grade:	0
O&M Grade:	0
Clock Start/From:	
Clock To:	
1st Value:	
2nd Value:	
Value Percent:	
Step:	NO
Remarks:	UNDERSIDE OF FRAME

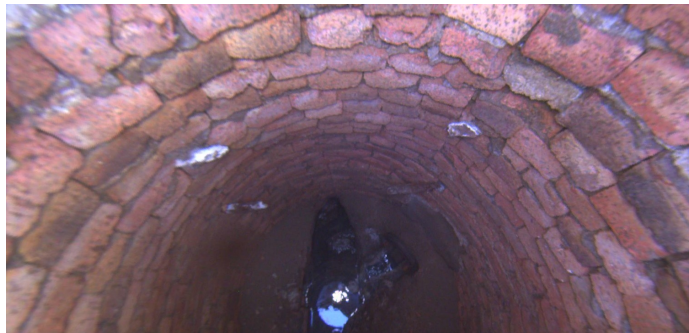
Code:	MGO
Description:	General Observation
Distance (ft):	1.3
Structural Grade:	0
O&M Grade:	0
Clock Start/From:	
Clock To:	
1st Value:	
2nd Value:	
Value Percent:	
Step:	NO
Remarks:	MISSING AND BROKEN STEPS

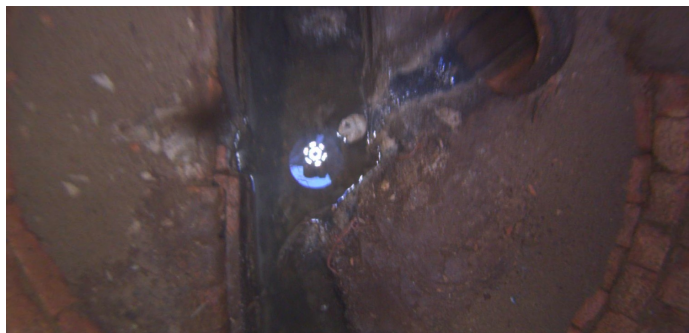
Code:	DSF
Description:	Deposits Settled Fine
Distance (ft):	4.7
Structural Grade:	0
O&M Grade:	2
Clock Start/From:	12
Clock To:	12
1st Value:	
2nd Value:	
Value Percent:	5.000
Step:	NO
Remarks:

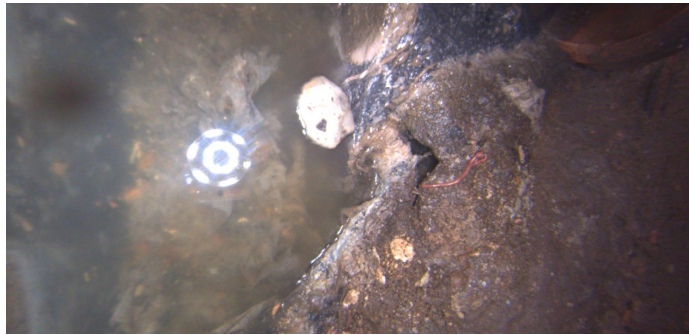
Code: **HVV**
Description: **Hole Void Visible**

Distance (ft): **5.9**
Structural Grade: **5**
O&M Grade: **0**
Clock Start/From: **3**
Clock To:
1st Value:
2nd Value:
Value Percent:
Step: **NO**
Remarks:

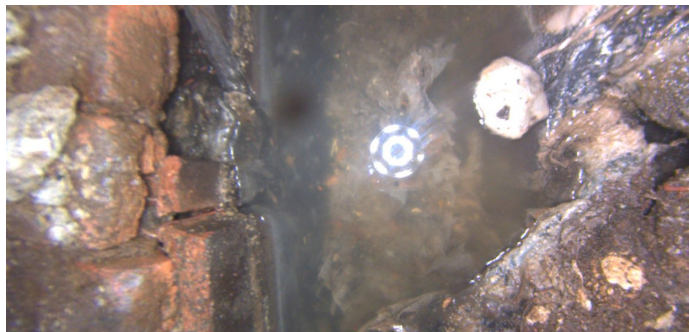
Code: **DB**
Description: **Displaced Brick**

Distance (ft): **5.9**
Structural Grade: **3**
O&M Grade: **0**
Clock Start/From: **9**
Clock To: **10**
1st Value:
2nd Value:
Value Percent:
Step: **NO**
Remarks:

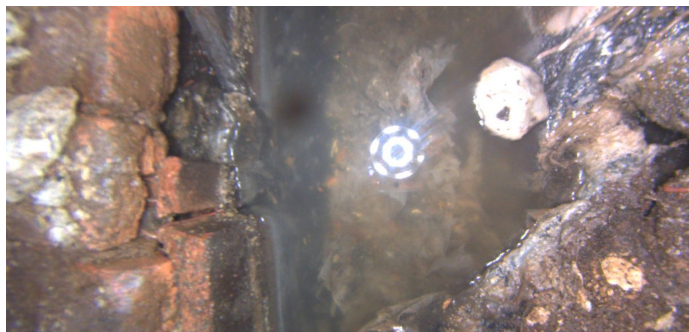
Code: **MGO**
Description: **General Observation**

Distance (ft): **5.9**
Structural Grade: **0**
O&M Grade: **0**
Clock Start/From:
Clock To:
1st Value:
2nd Value:
Value Percent:
Step: **NO**
Remarks: **END SURVEY**
