Manhole Inspection Report

Date:	04/28/2018	Weather:		Coding:	RZMACP
MH#:	M-706-021	Owner:	NA	Len. Surveyed:	6.9
P.O.#:		Surveyor:	Jen Costello	Rim to Invert:	6.3
Customer:		Cert. #:	U-907-5518	Wall Material:	Brick

Street:	Intersection of Hwy 51. and 7th St.	Project:	Hobart, IN
City:	Hobart, IN	GPS Northing:	41.52714157
Location:		GPS Easting:	-87.2522583
Drain Area:	South	GPS Accuracy:	Nearest Meter
Cover Shape:	Circular	Evidence of Surcharge:	No
Cover Size:	22.5	Potential for Runoff:	None
Comments:

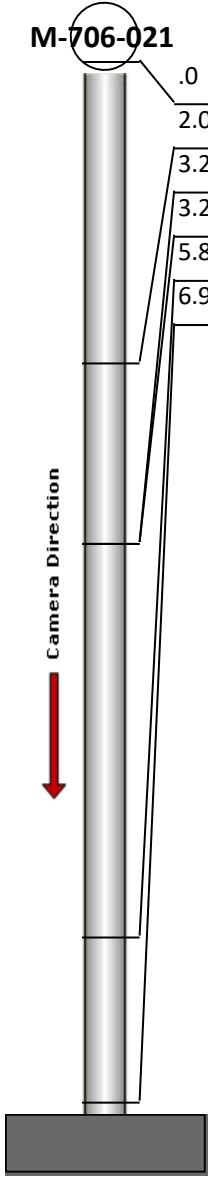
Position	Code	Observation	Video (sec)	Grade

.0	MGO	General Observation	10	NA
	2.0	MGO	General Observation	27	NA
	3.2	IW	Infil Weeper	42	M 2
	3.2	MMC	Material Change	54	NA
	5.8	DSF	Deposits Settled Fine	70	M 2
	6.9	MGO	General Observation	84	NA

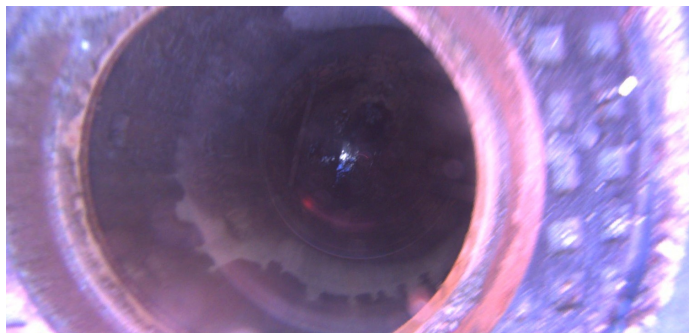
Code: **MGO**
Description: **General Observation**

Distance (ft): **.0**
Structural Grade: **0**
O&M Grade: **0**
Clock Start/From:
Clock To:
1st Value:
2nd Value:
Value Percent:
Step: **NO**
Remarks: **ACCESS MH**

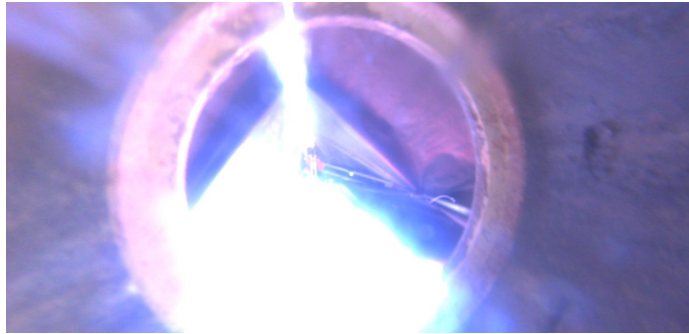
Code:	MGO
Description:	General Observation
Distance (ft):	2.0
Structural Grade:	0
O&M Grade:	0
Clock Start/From:	
Clock To:	
1st Value:	
2nd Value:	
Value Percent:	
Step:	NO
Remarks:	UNDERSIDE OF FRAME

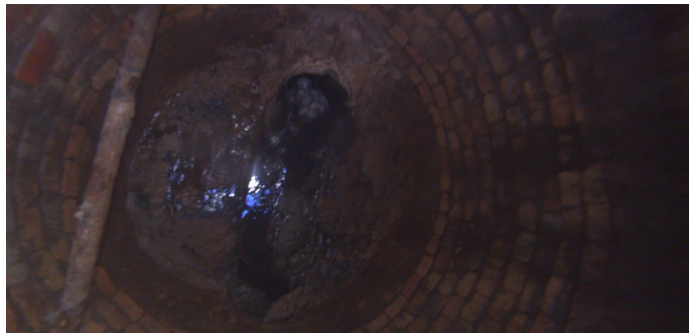
Code:	IW
Description:	Infil Weeper
Distance (ft):	3.2
Structural Grade:	0
O&M Grade:	2
Clock Start/From:	2
Clock To:	4
1st Value:	
2nd Value:	
Value Percent:	
Step:	NO
Remarks:

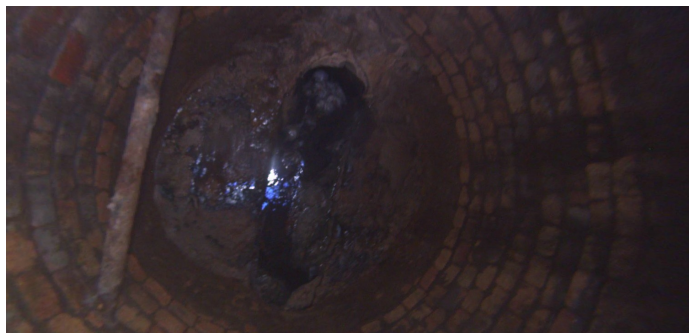
Code:	MMC
Description:	Material Change
Distance (ft):	3.2
Structural Grade:	0
O&M Grade:	0
Clock Start/From:	
Clock To:	
1st Value:	
2nd Value:	
Value Percent:	
Step:	NO
Remarks:	BRICK

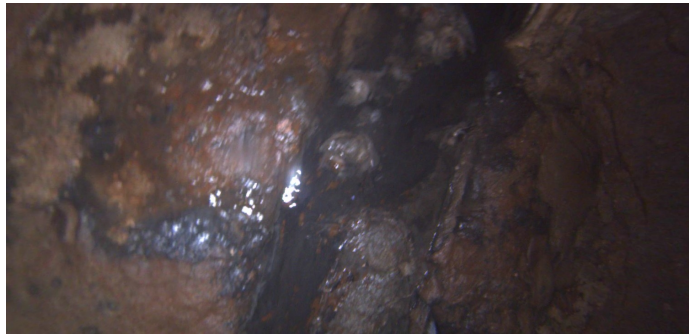
Code: **DSF**
Description: **Deposits Settled Fine**

Distance (ft): **5.8**
Structural Grade: **0**
O&M Grade: **2**
Clock Start/From: **12**
Clock To: **12**
1st Value:
2nd Value:
Value Percent: **5.000**
Step: **NO**
Remarks:

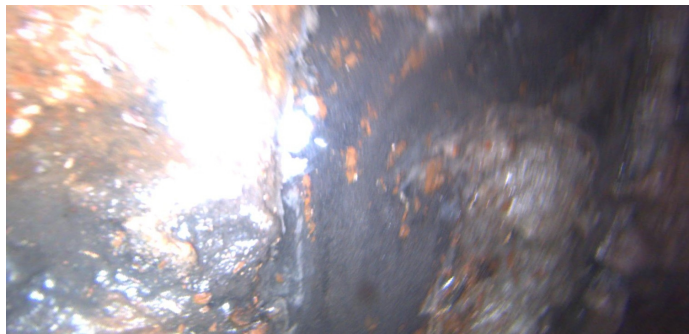
Code: **MGO**
Description: **General Observation**

Distance (ft): **6.9**
Structural Grade: **0**
O&M Grade: **0**
Clock Start/From:
Clock To:
1st Value:
2nd Value:
Value Percent:
Step: **NO**
Remarks: **END SURVEY**
