Manhole Inspection Report

Date:	04/27/2018	Weather:		Coding:	RZMACP
MH#:	M-706-034	Owner:	NA	Len. Surveyed:	8.4
P.O.#:		Surveyor:	Jen Costello	Rim to Invert:	6.9
Customer:		Cert. #:	U-907-5518	Wall Material:	Brick

Street:	Lake St. 154' North of 7th St.	Project:	Hobart, IN
City:	Hobart, IN	GPS Northing:	41.52770615
Location:		GPS Easting:	-87.25470734
Drain Area:	South	GPS Accuracy:	Nearest Meter
Cover Shape:	Circular	Evidence of Surcharge:	No
Cover Size:	22.5	Potential for Runoff:	None
Comments:

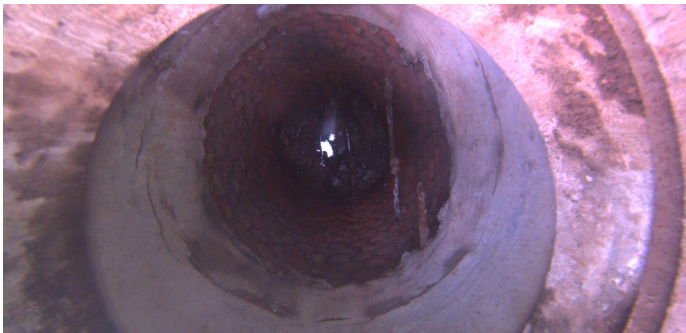
Code:	MGO
Description:	General Observation

Distance (ft):	.8
Structural Grade:	0
O&M Grade:	0
Clock Start/From:	
Clock To:	
1st Value:	
2nd Value:	
Value Percent:	
Step:	NO
Remarks:	ac

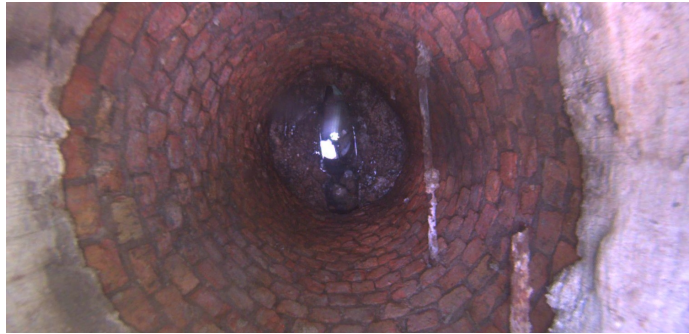
Code: **MMC**
Description: **Material Change**

Distance (ft): **2.5**
Structural Grade: **0**
O&M Grade: **0**
Clock Start/From:
Clock To:
1st Value:
2nd Value:
Value Percent:
Step: **NO**
Remarks: **BRICK**

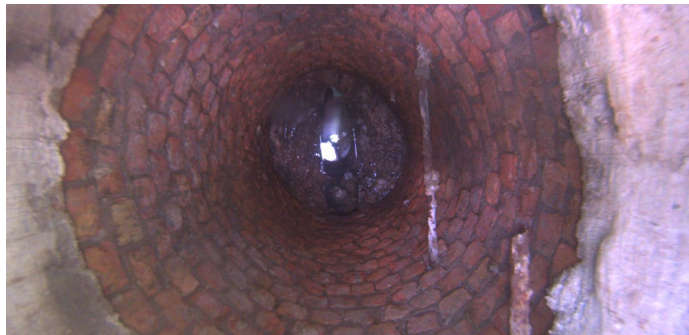
Code: **MGO**
Description: **General Observation**

Distance (ft): **2.5**
Structural Grade: **0**
O&M Grade: **0**
Clock Start/From:
Clock To:
1st Value:
2nd Value:
Value Percent:
Step: **NO**
Remarks: **BROKEN STEP**

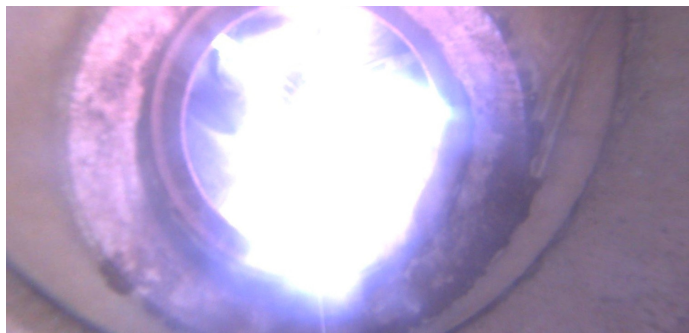
Code: **MGP**
Description: **General Photo**

Distance (ft): **3.2**
Structural Grade: **0**
O&M Grade: **0**
Clock Start/From:
Clock To:
1st Value:
2nd Value:
Value Percent:
Step: **NO**
Remarks: **UNDERSIDE OF FRAME**

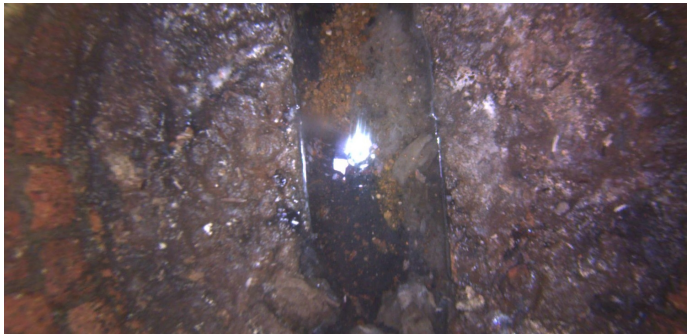
Code: **DSF**
Description: **Deposits Settled Fine**

Distance (ft): **7.1**
Structural Grade: **0**
O&M Grade: **2**
Clock Start/From: **12**
Clock To: **12**
1st Value:
2nd Value:
Value Percent: **5.000**
Step: **NO**
Remarks:

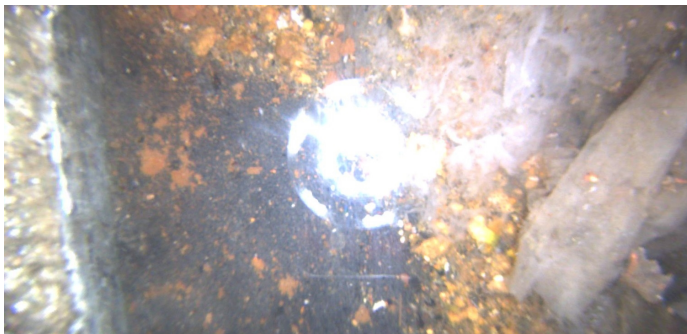
Code: **MGO**
Description: **General Observation**

Distance (ft): **8.4**
Structural Grade: **0**
O&M Grade: **0**
Clock Start/From:
Clock To:
1st Value:
2nd Value:
Value Percent:
Step: **NO**
Remarks: **END SURVEY**
