# Manhole Inspection Report

Date:	<b>04/27/2018</b>	Weather:		Coding:	<b>RZMACP</b>
MH#:	<b>M-706-035.5</b>	Owner:	<b>NA</b>	Len. Surveyed:	<b>7.1</b>
P.O.#:		Surveyor:	<b>Jen Costello</b>	Rim to Invert:	<b>6.8</b>
Customer:		Cert. #:	<b>U-907-5518</b>	Wall Material:	<b>Brick</b>

Street:	<b>Lake St. 172' South of 7th St.</b>	Project:	<b>Hobart, IN</b>
City:	<b>Hobart, IN</b>	GPS Northing:	<b>41.52669144</b>
Location:		GPS Easting:	<b>-87.2547226</b>
Drain Area:	<b>South</b>	GPS Accuracy:	<b>Nearest Meter</b>
Cover Shape:	<b>Circular</b>	Evidence of Surcharge:	<b>No</b>
Cover Size:	<b>22.5</b>	Potential for Runoff:	<b>None</b>
Comments:

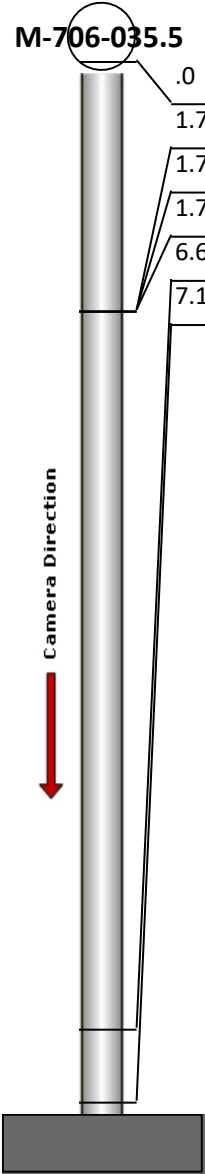
M-706-035.5				
	.0	MGO	General Observation	10	NA
	1.7	MMC	Material Change	25	NA
	1.7	MGO	General Observation	38	NA
	1.7	DB	Displaced Brick	51	S 3
	6.6	DSF	Deposits Settled Fine	72	M 2
	7.1	MGO	General Observation	84	NA

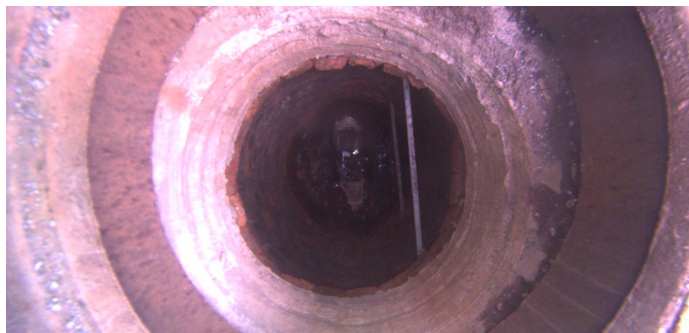
Code:	<b>MGO</b>
Description:	<b>General Observation</b>
Distance (ft):	<b>.0</b>
Structural Grade:	<b>0</b>
O&M Grade:	<b>0</b>
Clock Start/From:	
Clock To:	
1st Value:	
2nd Value:	
Value Percent:	
Step:	<b>NO</b>
Remarks:	<b>ACCESS MH</b>

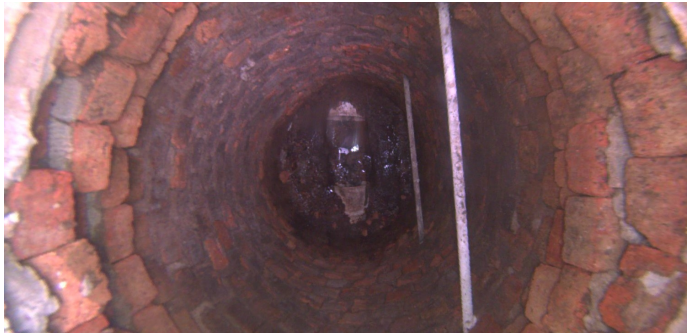
Code: **MMC**  
Description: **Material Change**

Distance (ft): **1.7**  
Structural Grade: **0**  
O&M Grade: **0**  
Clock Start/From:  
Clock To:  
1st Value:  
2nd Value:  
Value Percent:  
Step: **NO**  
Remarks: **BRICK**

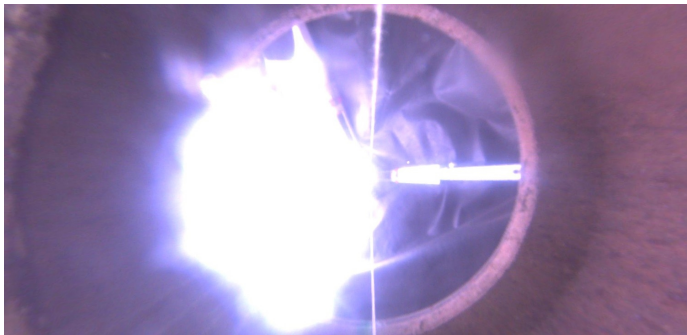
Code: **MGO**  
Description: **General Observation**

Distance (ft): **1.7**  
Structural Grade: **0**  
O&M Grade: **0**  
Clock Start/From:  
Clock To:  
1st Value:  
2nd Value:  
Value Percent:  
Step: **NO**  
Remarks: **UNDERSIDE OF FRAME**

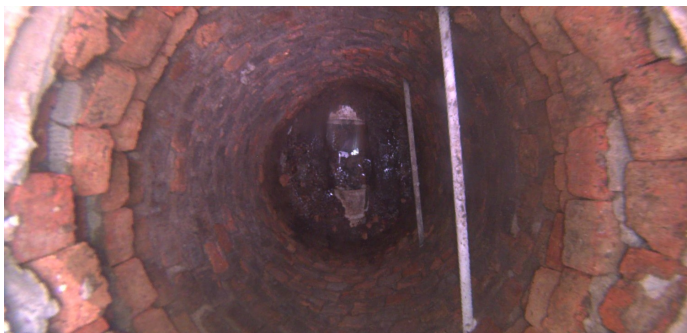
Code: **DB**  
Description: **Displaced Brick**

Distance (ft): **1.7**  
Structural Grade: **3**  
O&M Grade: **0**  
Clock Start/From: **8**  
Clock To: **10**  
1st Value:  
2nd Value:  
Value Percent:  
Step: **NO**  
Remarks:

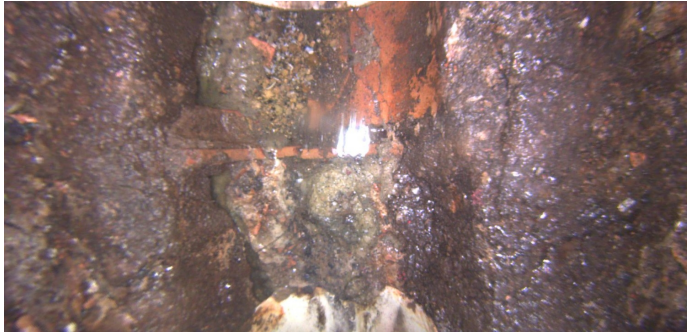
Code: **DSF**  
Description: **Deposits Settled Fine**

Distance (ft): **6.6**  
Structural Grade: **0**  
O&M Grade: **2**  
Clock Start/From: **12**  
Clock To: **12**  
1st Value:  
2nd Value:  
Value Percent: **10.000**  
Step: **NO**  
Remarks:

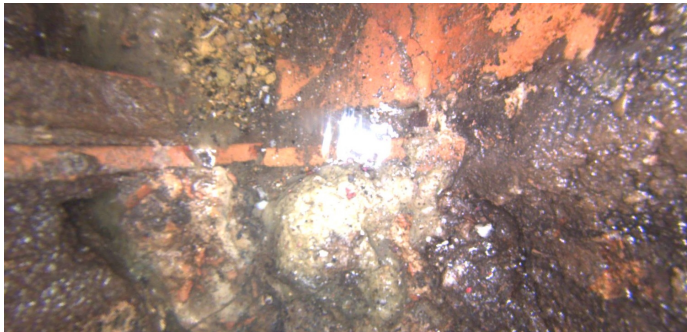
Code: **MGO**  
Description: **General Observation**

Distance (ft): **7.1**  
Structural Grade: **0**  
O&M Grade: **0**  
Clock Start/From:  
Clock To:  
1st Value:  
2nd Value:  
Value Percent:  
Step: **NO**  
Remarks: **END SURVEY**
