Manhole Inspection Report

Date:	04/27/2018	Weather:		Coding:	RZMACP
MH#:	M-706-040	Owner:	NA	Len. Surveyed:	7.6
P.O.#:		Surveyor:	Jen Costello	Rim to Invert:	7.3
Customer:		Cert. #:	U-907-5518	Wall Material:	Concrete (reinforced)

Street:	Water St. 329' North of 7th St.	Project:	Hobart, IN
City:	Hobart, IN	GPS Northing:	41.52809906
Location:		GPS Easting:	-87.25592041
Drain Area:	South	GPS Accuracy:	Nearest Meter
Cover Shape:	Circular	Evidence of Surcharge:	No
Cover Size:	22.5	Potential for Runoff:	None
Comments:

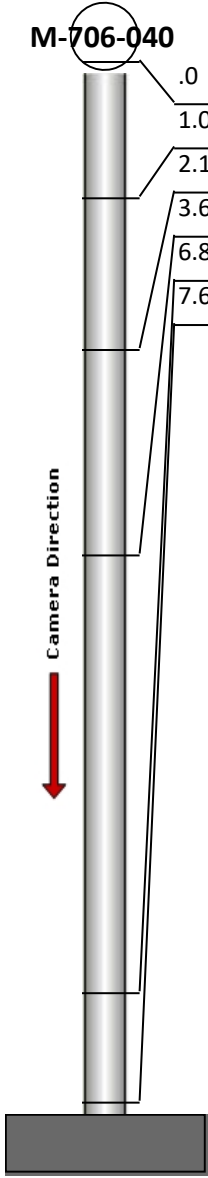
.0	MGO	General Observation	10	NA
	1.0	DAZ	Deposits Attached Other	24	M 2
	2.1	MGP	General Photo	39	NA
	3.6	CL	Crack Longitudinal	56	S 2
	6.8	DSGV	Deposits Settled Gravel	73	M 2
	7.6	MGO	General Observation	86	NA

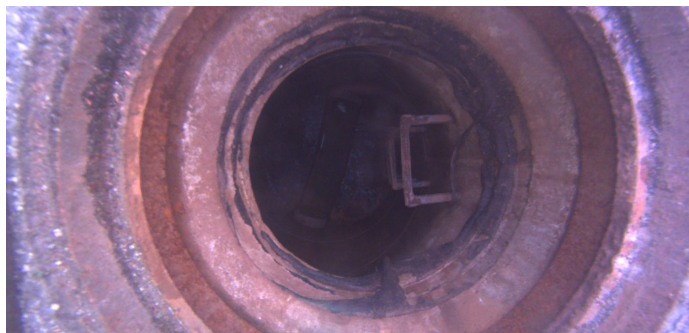
Code: **MGO**
 Description: **General Observation**

Distance (ft): **.0**
 Structural Grade: **0**
 O&M Grade: **0**
 Clock Start/From:
 Clock To:
 1st Value:
 2nd Value:
 Value Percent:
 Step: **NO**
 Remarks: **ACCESS MH**

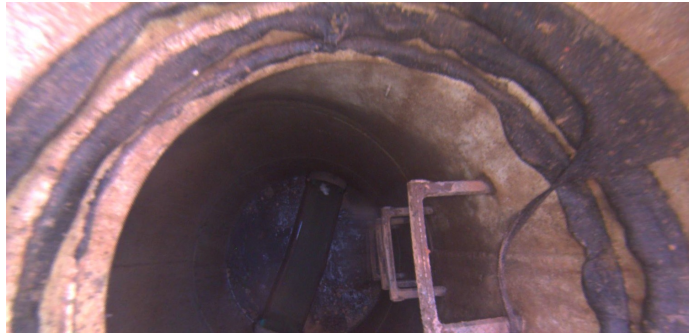
Code:	DAZ
Description:	Deposits Attached Other
Distance (ft):	1.0
Structural Grade:	0
O&M Grade:	2
Clock Start/From:	12
Clock To:	12
1st Value:	
2nd Value:	
Value Percent:	5.000
Step:	NO
Remarks:	SEALANT

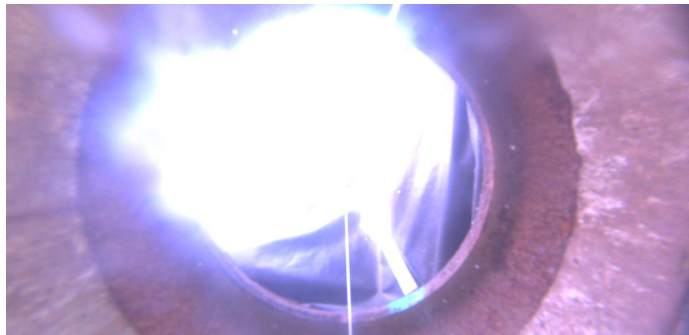
Code:	MGP
Description:	General Photo
Distance (ft):	2.1
Structural Grade:	0
O&M Grade:	0
Clock Start/From:	
Clock To:	
1st Value:	
2nd Value:	
Value Percent:	
Step:	NO
Remarks:	UNDERSIDE OF FRAME

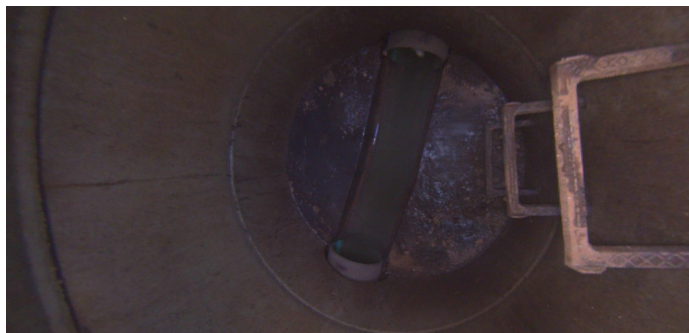
Code:	CL
Description:	Crack Longitudinal
Distance (ft):	3.6
Structural Grade:	2
O&M Grade:	0
Clock Start/From:	9
Clock To:	
1st Value:	
2nd Value:	
Value Percent:	
Step:	NO
Remarks:

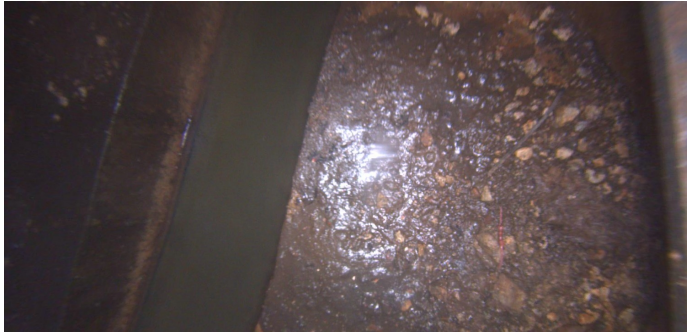
Code:	DSGV
Description:	Deposits Settled Gravel
Distance (ft):	6.8
Structural Grade:	0
O&M Grade:	2
Clock Start/From:	12
Clock To:	12
1st Value:	
2nd Value:	
Value Percent:	5.000
Step:	NO
Remarks:

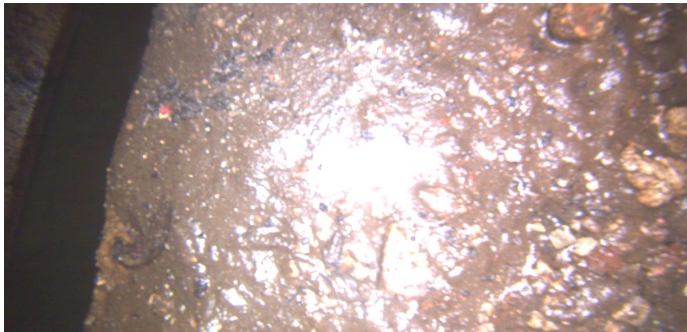
Code:	MGO
Description:	General Observation
Distance (ft):	7.6
Structural Grade:	0
O&M Grade:	0
Clock Start/From:	
Clock To:	
1st Value:	
2nd Value:	
Value Percent:	
Step:	NO
Remarks:	END SURVEY
