Manhole Inspection Report

Date:	04/27/2018	Weather:		Coding:	RZMACP
MH#:	M-706-042	Owner:	NA	Len. Surveyed:	7.4
P.O.#:		Surveyor:	Jen Costello	Rim to Invert:	7.3
Customer:		Cert. #:	U-907-5518	Wall Material:	Concrete (reinforced)

Street:	Intersection of 7th St. and Water St.	Project:	Hobart, IN
City:	Hobart, IN	GPS Northing:	41.52715683
Location:		GPS Easting:	-87.25584412
Drain Area:	South	GPS Accuracy:	Nearest Meter
Cover Shape:	Circular	Evidence of Surcharge:	No
Cover Size:	22.5	Potential for Runoff:	None
Comments:

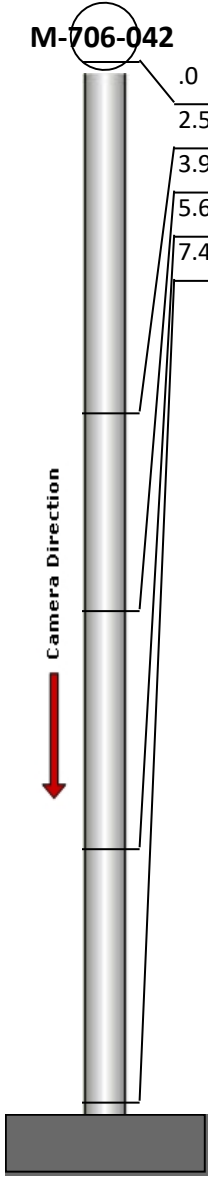
Position	Code	Observation	Video (sec)	Grade

.0	MGO	General Observation	10	NA
	2.5	SAV	Surface Aggregate Visible	26	S 3
	3.9	RFJ	Roots Fine Joint	41	M 1
	5.6	DSGV	Deposits Settled Gravel	56	M 2
	7.4	MGO	General Observation	71	NA

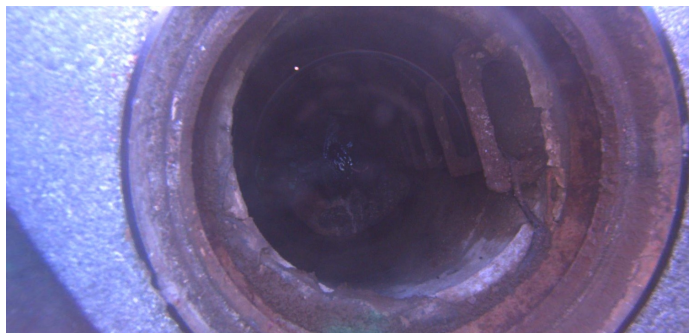
Code: **MGO**
Description: **General Observation**

Distance (ft): **.0**
Structural Grade: **0**
O&M Grade: **0**
Clock Start/From:
Clock To:
1st Value:
2nd Value:
Value Percent:
Step: **NO**
Remarks: **ACCESS MH**

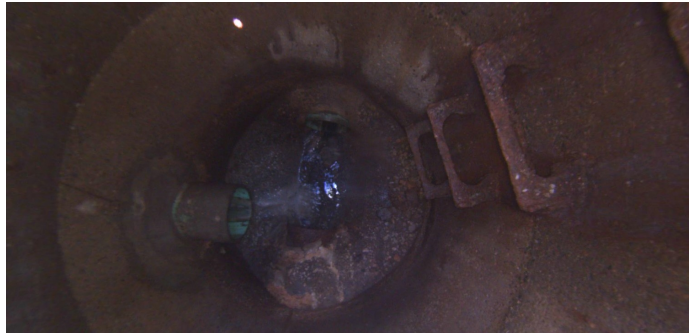
Code: **SAV**
Description: **Surface Aggregate Visible**

Distance (ft): **2.5**
Structural Grade: **3**
O&M Grade: **0**
Clock Start/From: **12**
Clock To: **12**
1st Value:
2nd Value:
Value Percent:
Step: **NO**
Remarks:

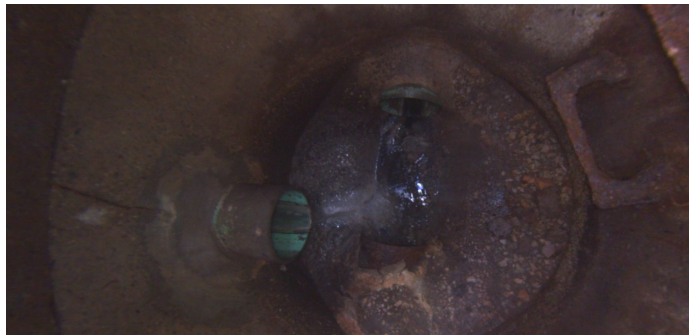
Code: **RFJ**
Description: **Roots Fine Joint**

Distance (ft): **3.9**
Structural Grade: **0**
O&M Grade: **1**
Clock Start/From: **9**
Clock To:
1st Value:
2nd Value:
Value Percent:
Step: **NO**
Remarks:

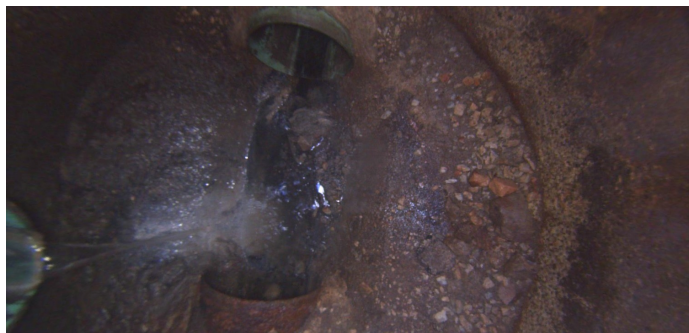
Code: **DSGV**
Description: **Deposits Settled Gravel**

Distance (ft): **5.6**
Structural Grade: **0**
O&M Grade: **2**
Clock Start/From: **12**
Clock To: **12**
1st Value:
2nd Value:
Value Percent: **10.000**
Step: **NO**
Remarks:

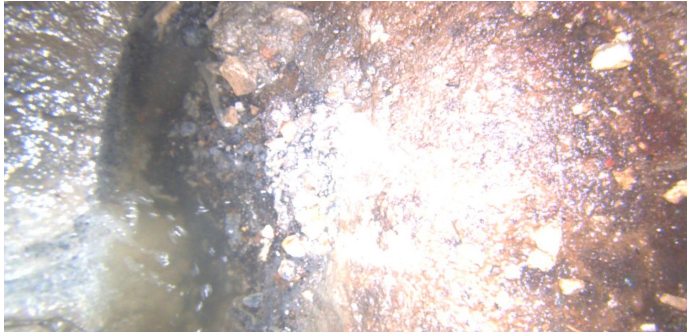
Code:	MGO
Description:	General Observation
Distance (ft):	7.4
Structural Grade:	0
O&M Grade:	0
Clock Start/From:	
Clock To:	
1st Value:	
2nd Value:	
Value Percent:	
Step:	NO
Remarks:	END SURVEY
