Manhole Inspection Report

Date:	04/29/2018	Weather:		Coding:	RZMACP
MH#:	M-706-048	Owner:	NA	Len. Surveyed:	5.9
P.O.#:		Surveyor:	Jen Costello	Rim to Invert:	6.4
Customer:		Cert. #:	U-907-5518	Wall Material:	Concrete (reinforced)

Street:	Main St. 265' South of 6th St.	Project:	Hobart, IN
City:	Hobart, IN	GPS Northing:	41.52839661
Location:		GPS Easting:	-87.25261688
Drain Area:	South	GPS Accuracy:	Nearest Meter
Cover Shape:	Circular	Evidence of Surcharge:	No
Cover Size:	22.5	Potential for Runoff:	None
Comments:

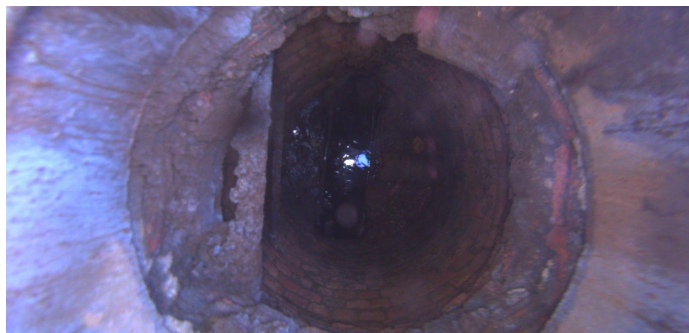
Code: **MGO**
Description: **General Observation**

Distance (ft): **.0**
Structural Grade: **0**
O&M Grade: **0**
Clock Start/From:
Clock To:
1st Value:
2nd Value:
Value Percent:
Step: **NO**
Remarks: **ACCESS MH**

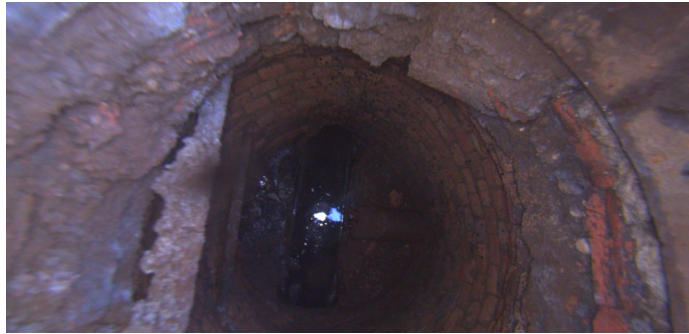
Code:	DAE
Description:	Deposits Attached Encrustation
Distance (ft):	.6
Structural Grade:	0
O&M Grade:	2
Clock Start/From:	12
Clock To:	12
1st Value:	
2nd Value:	
Value Percent:	10.000
Step:	NO
Remarks:

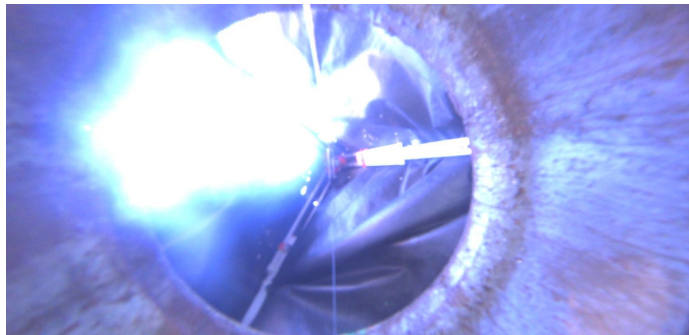
Code:	MGO
Description:	General Observation
Distance (ft):	1.6
Structural Grade:	0
O&M Grade:	0
Clock Start/From:	
Clock To:	
1st Value:	
2nd Value:	
Value Percent:	
Step:	NO
Remarks:	UNDERSIDE OF FRAME

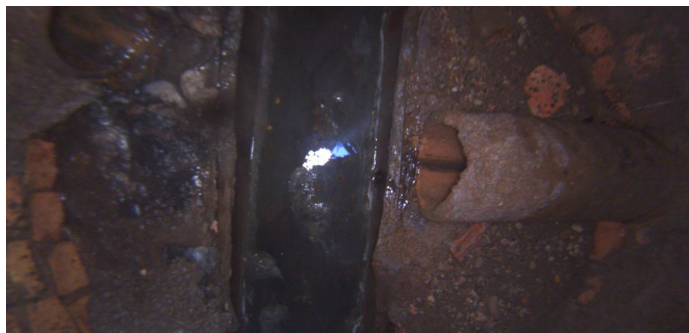
Code:	DSF
Description:	Deposits Settled Fine
Distance (ft):	4.3
Structural Grade:	0
O&M Grade:	2
Clock Start/From:	12
Clock To:	12
1st Value:	
2nd Value:	
Value Percent:	5.000
Step:	NO
Remarks:

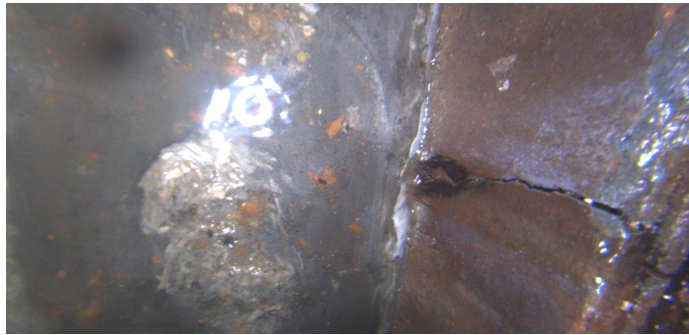
Code: **FC**
Description: **Fracture Circumferential**

Distance (ft): **5.9**
Structural Grade: **2**
O&M Grade: **0**
Clock Start/From: **3**
Clock To: **5**
1st Value:
2nd Value:
Value Percent:
Step: **NO**
Remarks:

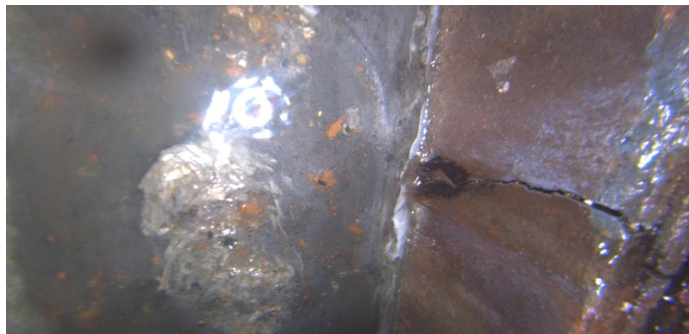
Code: **IW**
Description: **Infil Weeper**

Distance (ft): **5.9**
Structural Grade: **0**
O&M Grade: **2**
Clock Start/From: **5**
Clock To:
1st Value:
2nd Value:
Value Percent:
Step: **NO**
Remarks:

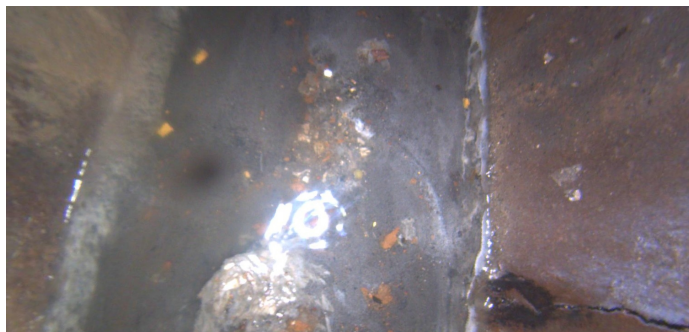
Code: **MGO**
Description: **General Observation**

Distance (ft): **5.9**
Structural Grade: **0**
O&M Grade: **0**
Clock Start/From:
Clock To:
1st Value:
2nd Value:
Value Percent:
Step: **NO**
Remarks: **END SURVEY**
