# Manhole Inspection Report

Date:	<b>04/23/2018</b>	Weather:		Coding:	<b>RZMACP</b>
MH#:	<b>M-707-013</b>	Owner:	<b>NA</b>	Len. Surveyed:	<b>12.9</b>
P.O.#:		Surveyor:	<b>John Kuglmaier</b>	Rim to Invert:	<b>13.8</b>
Customer:	<b>8.7</b>	Cert. #:	<b>U-1215-07002349</b>	Wall Material:	<b>Concrete (reinforced)</b>

Street:	<b>Intersection of 11th St. and Garfield</b>	Project:	<b>Hobart, IN</b>
City:	<b>Hobart, IN</b>	GPS Northing:	<b>0.0</b>
Location:		GPS Easting:	<b>0.0</b>
Drain Area:	<b>Southeast</b>	GPS Accuracy:	<b>Nearest Meter</b>
Cover Shape:	<b>Circular</b>	Evidence of Surcharge:	<b>Yes</b>
Cover Size:	<b>22.5</b>	Potential for Runoff:	<b>None</b>
Comments:

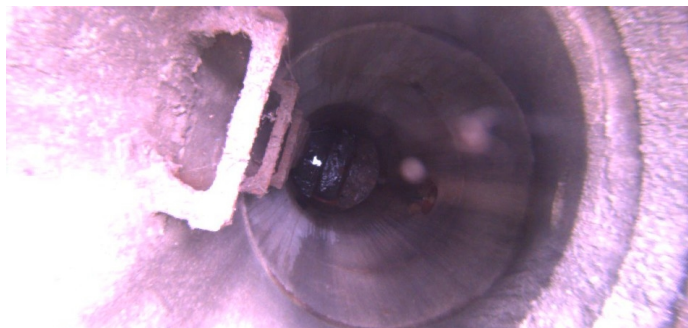
Code: **MGP**  
Description: **General Photo**

Distance (ft): **.0**  
Structural Grade: **0**  
O&M Grade: **0**  
Clock Start/From:  
Clock To:  
1st Value:  
2nd Value:  
Value Percent:  
Step: **NO**  
Remarks:

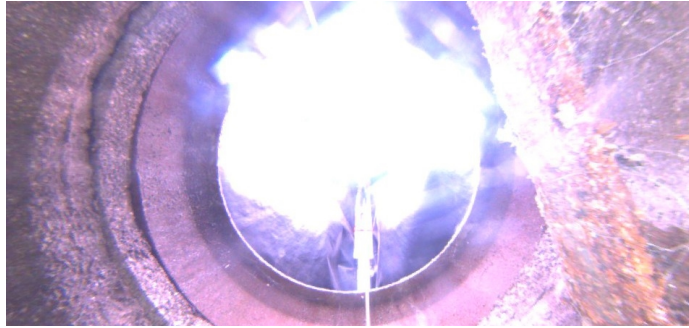
Code: **MGP**  
Description: **General Photo**

Distance (ft): **2.2**  
Structural Grade: **0**  
O&M Grade: **0**  
Clock Start/From:  
Clock To:  
1st Value:  
2nd Value:  
Value Percent:  
Step: **NO**  
Remarks:

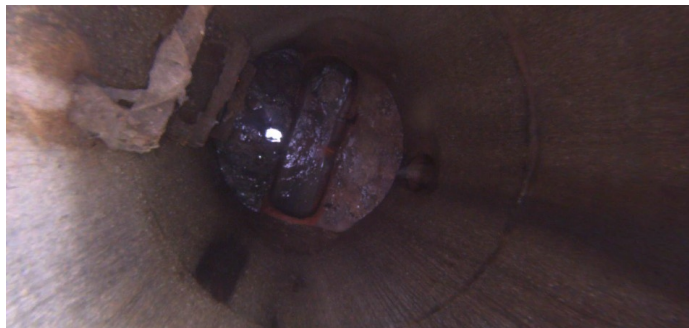
Code: **IS**  
Description: **Infil Stain**

Distance (ft): **7.4**  
Structural Grade: **0**  
O&M Grade: **0**  
Clock Start/From: **7**  
Clock To:  
1st Value:  
2nd Value:  
Value Percent:  
Step: **NO**  
Remarks:

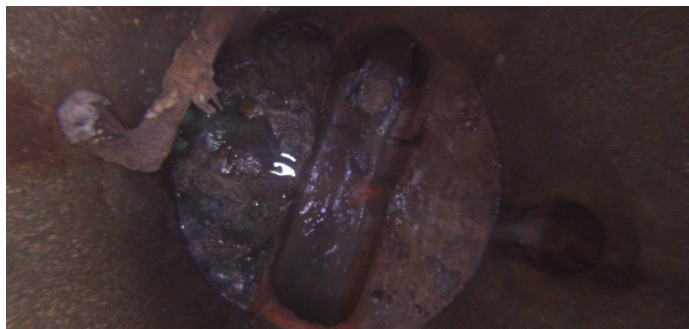
Code: **DAZ**  
Description: **Deposits Attached Other**

Distance (ft): **10.3**  
Structural Grade: **0**  
O&M Grade: **3**  
Clock Start/From: **12**  
Clock To: **12**  
1st Value:  
2nd Value:  
Value Percent: **15.000**  
Step: **NO**  
Remarks: **Mixed materials**

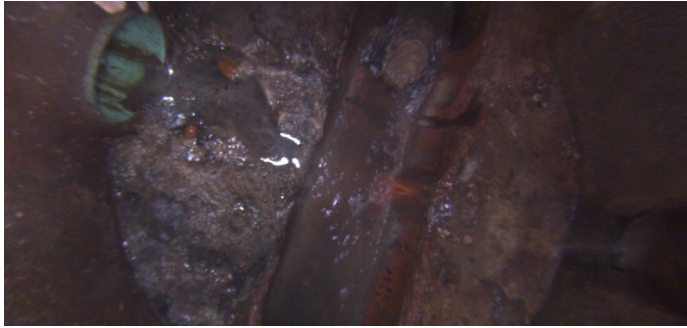
Code:	<b>MGO</b>
Description:	<b>General Observation</b>
Distance (ft):	<b>11.3</b>
Structural Grade:	<b>0</b>
O&M Grade:	<b>0</b>
Clock Start/From:	
Clock To:	
1st Value:	
2nd Value:	
Value Percent:	
Step:	<b>NO</b>
Remarks:	<b>Ins. Comp.</b>
