Manhole Inspection Report

Date:	04/23/2018	Weather:		Coding:	RZMACP
MH#:	M-707-015	Owner:	NA	Len. Surveyed:	13.7
P.O.#:		Surveyor:	John Kuglmaier	Rim to Invert:	13.5
Customer:	8.7	Cert. #:	U-1215-07002349	Wall Material:	Concrete (reinforced)

Street:	Garfield St. 239' North of 11th St.	Project:	Hobart, IN
City:	Hobart, IN	GPS Northing:	0.0
Location:		GPS Easting:	0.0
Drain Area:	Southeast	GPS Accuracy:	Nearest Meter
Cover Shape:	Circular	Evidence of Surcharge:	No
Cover Size:	22.5	Potential for Runoff:	None
Comments:

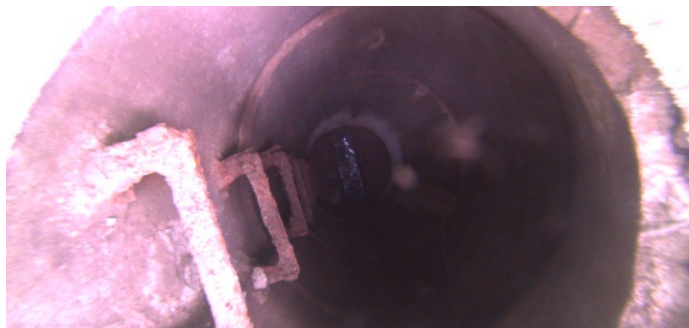
Code: **MGP**
Description: **General Photo**

Distance (ft): **.0**
Structural Grade: **0**
O&M Grade: **0**
Clock Start/From:
Clock To:
1st Value:
2nd Value:
Value Percent:
Step: **NO**
Remarks:

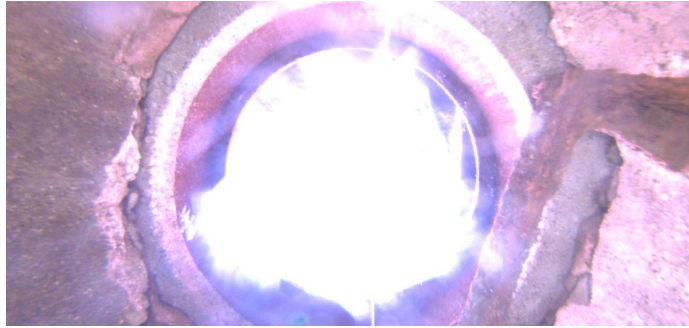
Code: **MGP**
Description: **General Photo**

Distance (ft): **2.4**
Structural Grade: **0**
O&M Grade: **0**
Clock Start/From:
Clock To:
1st Value:
2nd Value:
Value Percent:
Step: **NO**
Remarks:

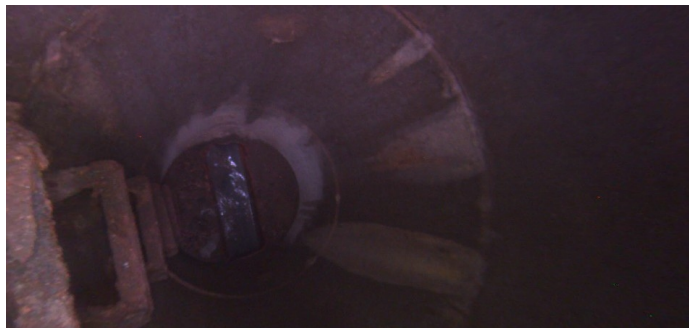
Code: **IS**
Description: **Infil Stain**

Distance (ft): **4.2**
Structural Grade: **0**
O&M Grade: **0**
Clock Start/From: **2**
Clock To: **4**
1st Value:
2nd Value:
Value Percent:
Step: **NO**
Remarks:

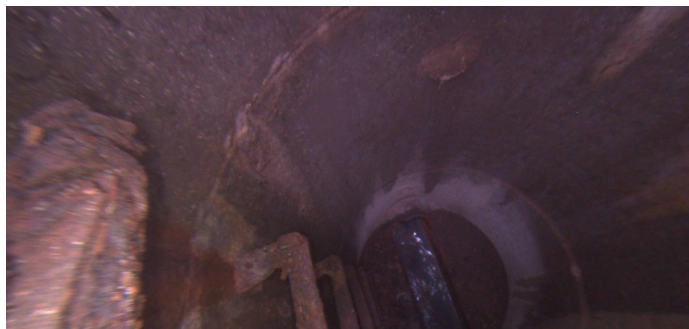
Code: **IS**
Description: **Infil Stain**

Distance (ft): **5.0**
Structural Grade: **0**
O&M Grade: **0**
Clock Start/From: **10**
Clock To:
1st Value:
2nd Value:
Value Percent:
Step: **NO**
Remarks:

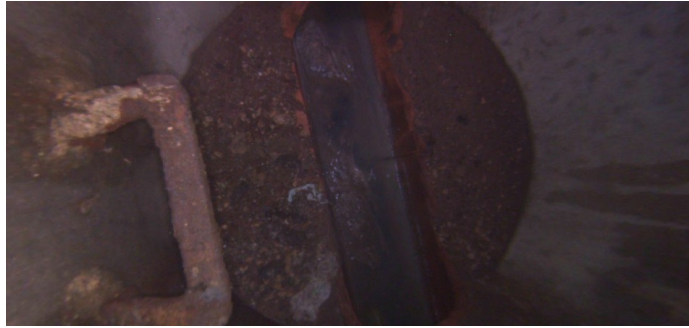
Code:	DAZ
Description:	Deposits Attached Other
Distance (ft):	10.9
Structural Grade:	0
O&M Grade:	2
Clock Start/From:	12
Clock To:	12
1st Value:	
2nd Value:	
Value Percent:	10.000
Step:	NO
Remarks:	Mixed materials

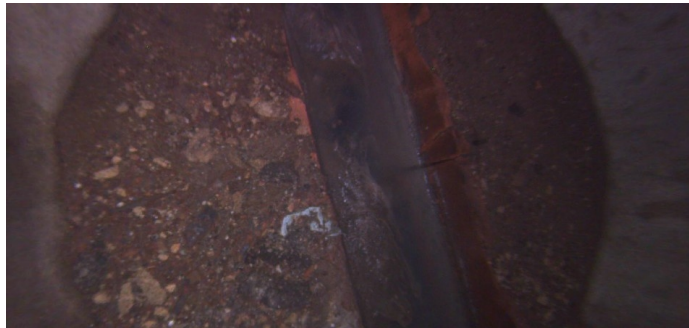
Code:	MGO
Description:	General Observation
Distance (ft):	12.1
Structural Grade:	0
O&M Grade:	0
Clock Start/From:	
Clock To:	
1st Value:	
2nd Value:	
Value Percent:	
Step:	NO
Remarks:	Ins. Comp.
