# Manhole Inspection Report

Date:	<b>04/17/2018</b>	Weather:		Coding:	<b>RZMACP</b>
MH#:	<b>M-707-038</b>	Owner:	<b>NA</b>	Len. Surveyed:	<b>7.7</b>
P.O.#:		Surveyor:	<b>John Kuglmaier</b>	Rim to Invert:	<b>7.8</b>
Customer:		Cert. #:	<b>U-1215-07002349</b>	Wall Material:	<b>Concrete (reinforced)</b>

Street:	<b>State St. 362' North of 12th St.</b>	Project:	<b>Hobart, IN</b>
City:	<b>Hobart, IN</b>	GPS Northing:	<b>2906210.24</b>
Location:		GPS Easting:	<b>2906210.24</b>
Drain Area:	<b>Southeast</b>	GPS Accuracy:	<b>Sub-Meter</b>
Cover Shape:	<b>Circular</b>	Evidence of Surcharge:	<b>No</b>
Cover Size:	<b>22.5</b>	Potential for Runoff:	<b>None</b>
Comments:

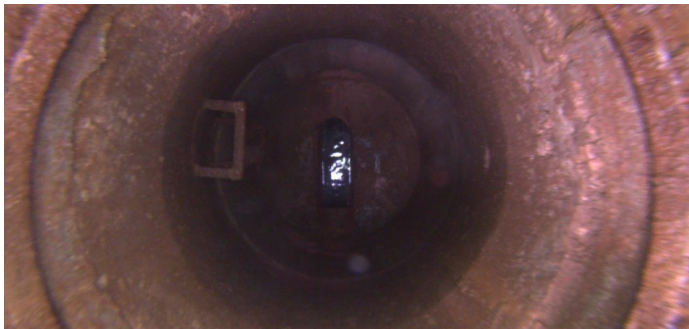
Code: **MGP**  
Description: **General Photo**

Distance (ft): **.0**  
Structural Grade: **0**  
O&M Grade: **0**  
Clock Start/From:  
Clock To:  
1st Value:  
2nd Value:  
Value Percent:  
Step: **NO**  
Remarks:

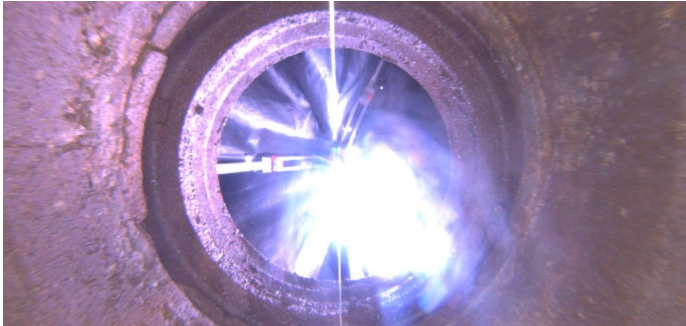
Code: **MGP**  
Description: **General Photo**

Distance (ft): **2.7**  
Structural Grade: **0**  
O&M Grade: **0**  
Clock Start/From:  
Clock To:  
1st Value:  
2nd Value:  
Value Percent:  
Step: **NO**  
Remarks:

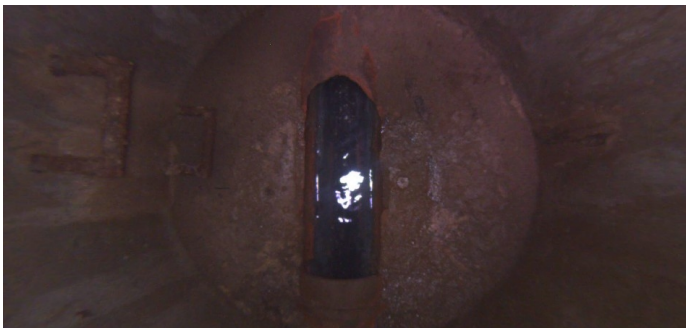
Code: **DSF**  
Description: **Deposits Settled Fine**

Distance (ft): **4.0**  
Structural Grade: **0**  
O&M Grade: **2**  
Clock Start/From: **12**  
Clock To: **12**  
1st Value:  
2nd Value:  
Value Percent: **10.000**  
Step: **NO**  
Remarks:

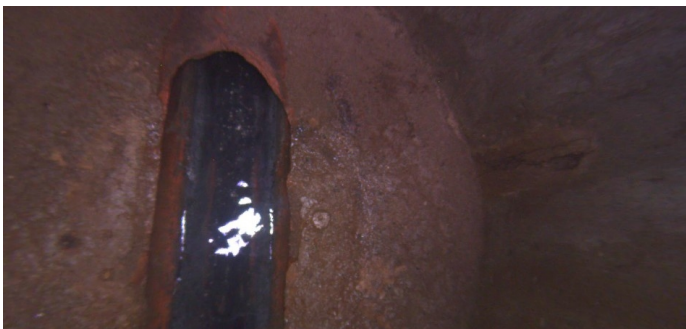
Code: **IS**  
Description: **Infil Stain**

Distance (ft): **5.1**  
Structural Grade: **0**  
O&M Grade: **0**  
Clock Start/From: **2**  
Clock To:  
1st Value:  
2nd Value:  
Value Percent:  
Step: **NO**  
Remarks:

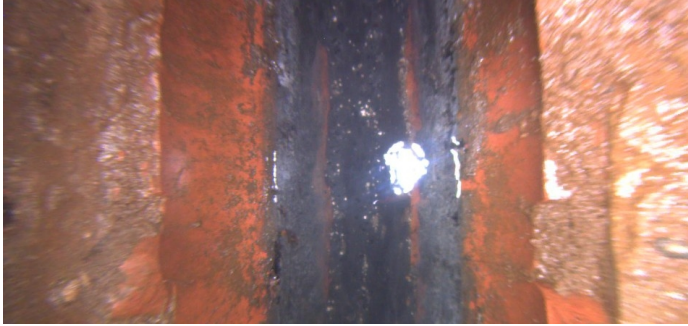
Code: **MGO**  
Description: **General Observation**

Distance (ft): **6.9**

Remarks: **Ins. Comp.**
