Manhole Inspection Report

| MH#: | M-707-039 | Owner: | NA | Len. Surveyed: | 7.7 |

| Street: | Intersection of 11th St. and State St. | Project: | Hobart, IN |

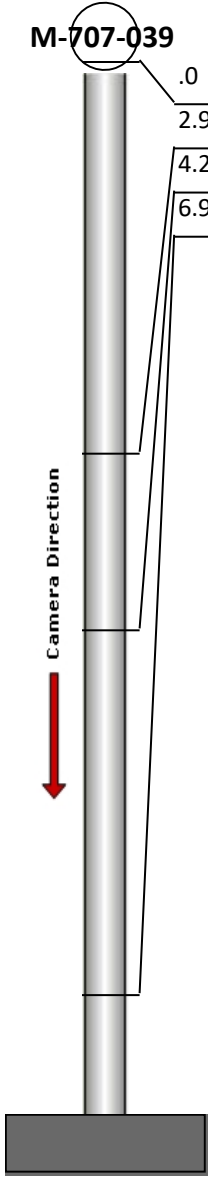
| | Position | Code | Observation | Video (sec) | Grade |
|--|---|---|---|---|---|
| | .0 | MGP | General Photo | 10 | NA |
| | 2.9 | MGP | General Photo | 30 | NA |
| | 4.2 | DSF | Deposits Settled Fine | 46 | M 2 |
| | 6.9 | MGO | General Observation | 63 | NA |

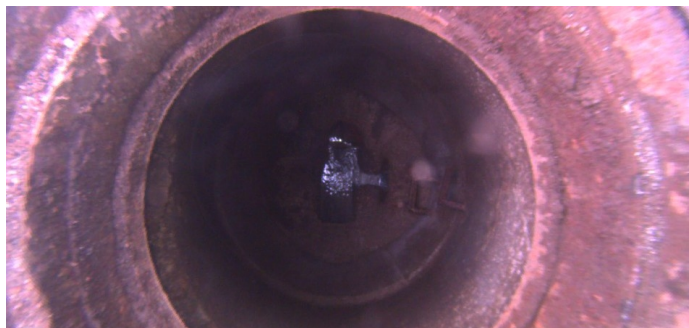
Code: **MGP**
 Description: **General Photo**

Distance (ft): **.0**
 Structural Grade: **0**
 O&M Grade: **0**
 Clock Start/From:
 Clock To:
 1st Value:
 2nd Value:
 Value Percent:
 Step: **NO**
 Remarks:

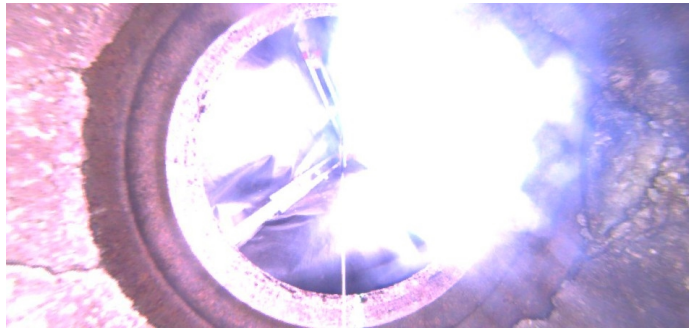
Code: **MGP**
Description: **General Photo**

Distance (ft): **2.9**
Structural Grade: **0**
O&M Grade: **0**
Clock Start/From:
Clock To:
1st Value:
2nd Value:
Value Percent:
Step: **NO**
Remarks:

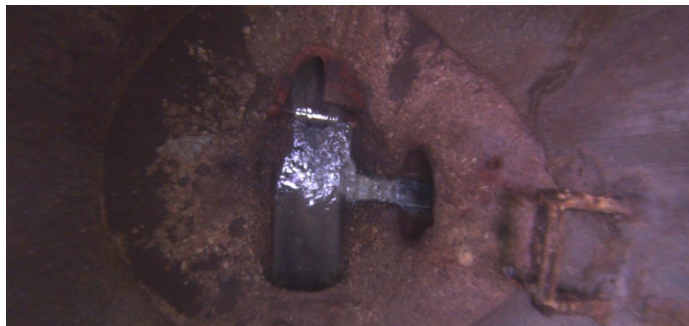
Code: **DSF**
Description: **Deposits Settled Fine**

Distance (ft): **4.2**
Structural Grade: **0**
O&M Grade: **2**
Clock Start/From: **7**
Clock To: **11**
1st Value:
2nd Value:
Value Percent: **5.000**
Step: **NO**
Remarks:

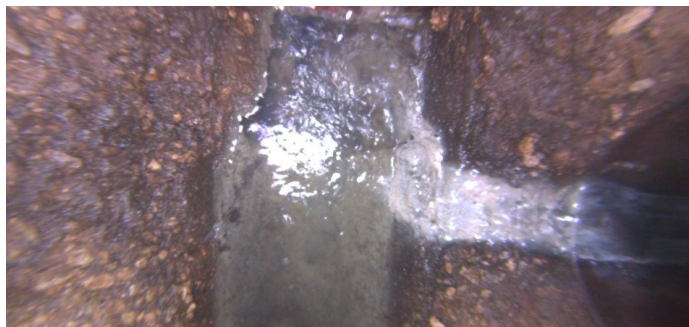
Code: **MGO**
Description: **General Observation**

Distance (ft): **6.9**
Structural Grade: **0**
O&M Grade: **0**
Clock Start/From:
Clock To:
1st Value:
2nd Value:
Value Percent:
Step: **NO**
Remarks: **Ins. Comp.**
