Manhole Inspection Report

Date:	04/16/2018	Weather:		Coding:	RZMACP
MH#:	M-707-047	Owner:	NA	Len. Surveyed:	8.7
P.O.#:		Surveyor:	John Kuglmaier	Rim to Invert:	9.2
Customer:		Cert. #:	U-1215-07002349	Wall Material:	Concrete (reinforced)

Street:	Intersection of 13th Pl. and Flemmin	Project:	Hobart, IN
City:	Hobart, IN	GPS Northing:	2905344.503
Location:		GPS Easting:	2905344.503
Drain Area:	Southwest	GPS Accuracy:	Sub-Meter
Cover Shape:	Circular	Evidence of Surcharge:	Yes
Cover Size:	29.0	Potential for Runoff:	None
Comments:

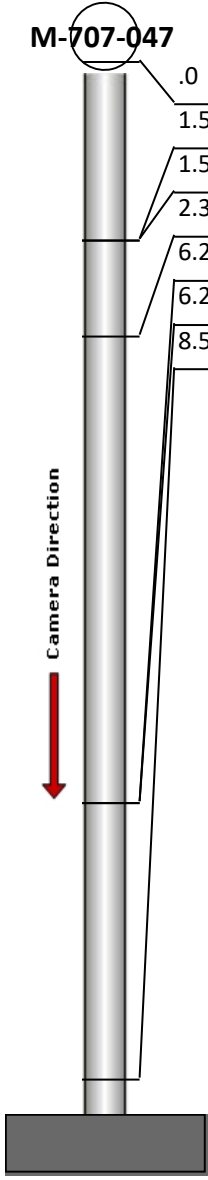
.0	MGP	General Photo	10	NA
	1.5	IS	Infil Stain	25	NA
	1.5	IS	Infil Stain	36	NA
	2.3	MGP	General Photo	51	NA
	6.2	DSF	Deposits Settled Fine	73	M 2
	6.2	IS	Infil Stain	84	NA
	8.5	MGO	General Observation	101	NA

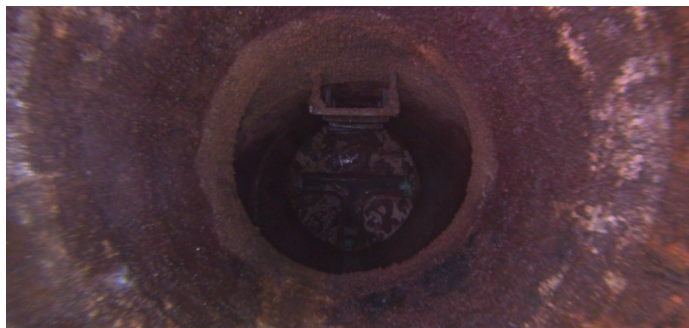
Code: **MGP**
Description: **General Photo**

Distance (ft): **.0**
Structural Grade: **0**
O&M Grade: **0**
Clock Start/From:
Clock To:
1st Value:
2nd Value:
Value Percent:
Step: **NO**
Remarks:

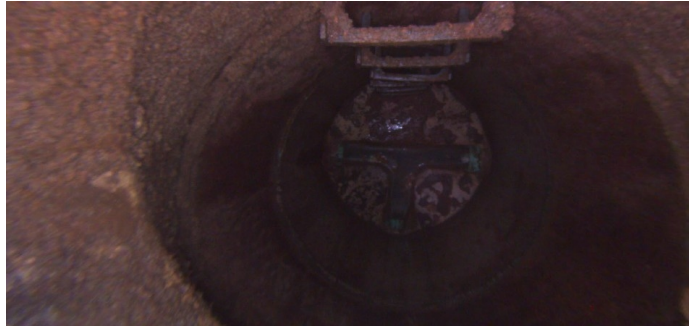
Code: **IS**
Description: **Infil Stain**

Distance (ft): **1.5**
Structural Grade: **0**
O&M Grade: **0**
Clock Start/From: **9**
Clock To: **10**
1st Value:
2nd Value:
Value Percent:
Step: **NO**
Remarks:

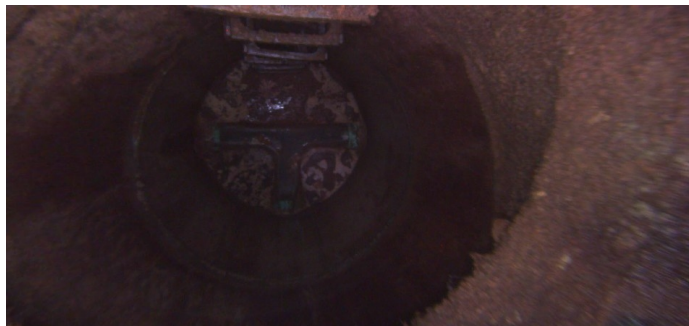
Code: **IS**
Description: **Infil Stain**

Distance (ft): **1.5**
Structural Grade: **0**
O&M Grade: **0**
Clock Start/From: **2**
Clock To: **6**
1st Value:
2nd Value:
Value Percent:
Step: **NO**
Remarks:

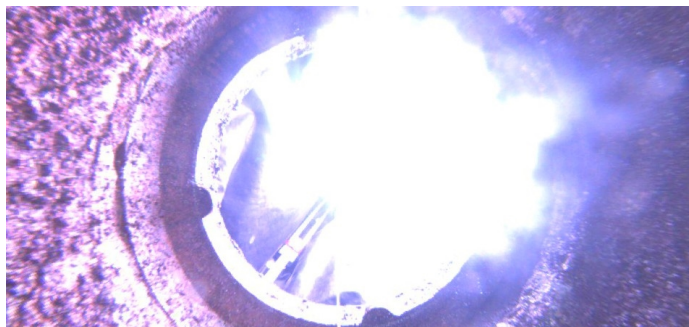
Code: **MGP**
Description: **General Photo**

Distance (ft): **2.3**
Structural Grade: **0**
O&M Grade: **0**
Clock Start/From:
Clock To:
1st Value:
2nd Value:
Value Percent:
Step: **NO**
Remarks:

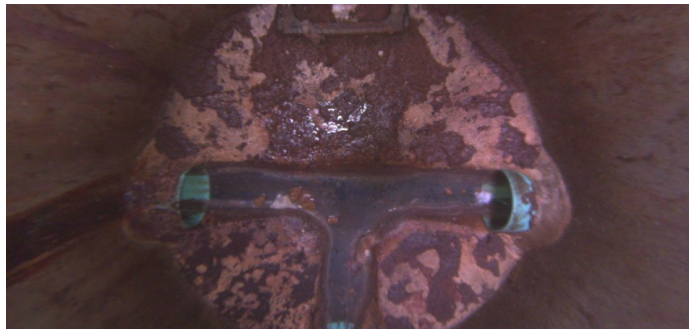
Code: **DSF**
Description: **Deposits Settled Fine**

Distance (ft): **6.2**
Structural Grade: **0**
O&M Grade: **2**
Clock Start/From: **12**
Clock To: **12**
1st Value:
2nd Value:
Value Percent: **5.000**
Step: **NO**
Remarks:

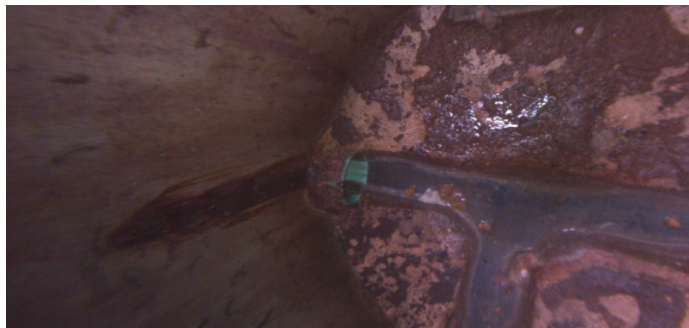
Code: **IS**
Description: **Infil Stain**

Distance (ft): **6.2**
Structural Grade: **0**
O&M Grade: **0**
Clock Start/From: **9**
Clock To:
1st Value:
2nd Value:
Value Percent:
Step: **NO**
Remarks:

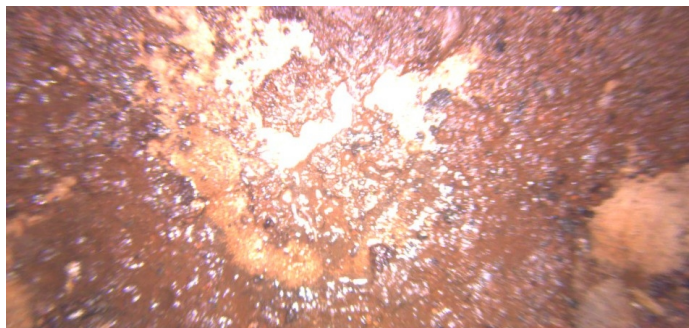
Code: **MGO**
Description: **General Observation**

Distance (ft): **8.5**
Structural Grade: **0**
O&M Grade: **0**
Clock Start/From:
Clock To:
1st Value:
2nd Value:
Value Percent:
Step: **NO**
Remarks: **Ins. Comp.**
