Manhole Inspection Report

Date:	04/23/2018	Weather:		Coding:	RZMACP
MH#:	M-707-069A	Owner:	NA	Len. Surveyed:	8.9
P.O.#:		Surveyor:	Jen Costello	Rim to Invert:	8.8
Customer:	8.7	Cert. #:	U-907-5518	Wall Material:	Concrete (reinforced)

Street:	Intersection of 10th St. and Water St	Project:	Hobart, IN
City:	Hobart, IN	GPS Northing:	0.0
Location:		GPS Easting:	0.0
Drain Area:	Southeast	GPS Accuracy:	Nearest Meter
Cover Shape:	Circular	Evidence of Surcharge:	No
Cover Size:	22.5	Potential for Runoff:	None
Comments:

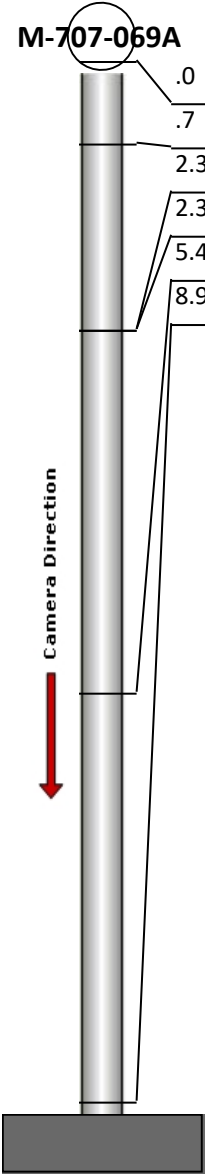
Position	Code	Observation	Video (sec)	Grade
M-707-069A

.0	MGO	General Observation	10	NA
	.7	DAE	Deposits Attached Encrustation	23	M 2
	2.3	IW	Infil Weeper	38	M 2
	2.3	MGO	General Observation	51	NA
	5.4	SSS	Surface Spalling	71	S 2
	8.9	MGO	General Observation	90	NA

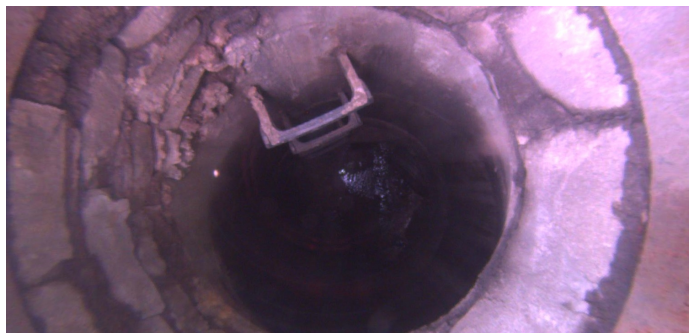
Code: **MGO**
Description: **General Observation**

Distance (ft): **.0**
Structural Grade: **0**
O&M Grade: **0**
Clock Start/From:
Clock To:
1st Value:
2nd Value:
Value Percent:
Step: **NO**
Remarks: **ACCESS MH**

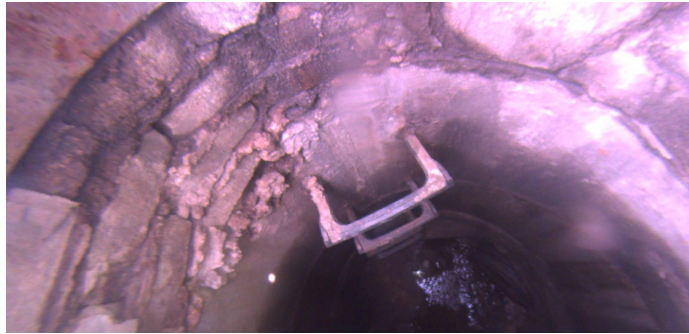
Code: **DAE**
Description: **Deposits Attached Encrustation**

Distance (ft): **.7**
Structural Grade: **0**
O&M Grade: **2**
Clock Start/From: **10**
Clock To: **12**
1st Value:
2nd Value:
Value Percent: **5.000**
Step: **NO**
Remarks:

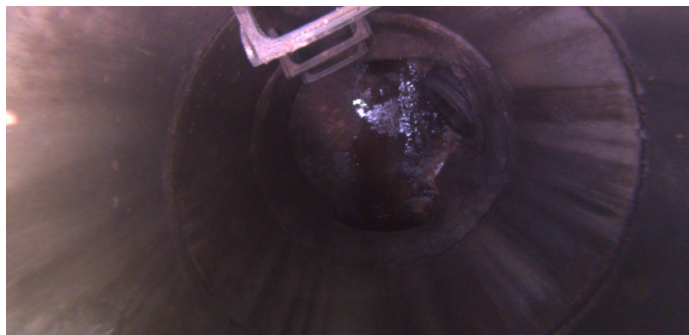
Code: **IW**
Description: **Infil Weeper**

Distance (ft): **2.3**
Structural Grade: **0**
O&M Grade: **2**
Clock Start/From: **12**
Clock To: **12**
1st Value:
2nd Value:
Value Percent:
Step: **NO**
Remarks:

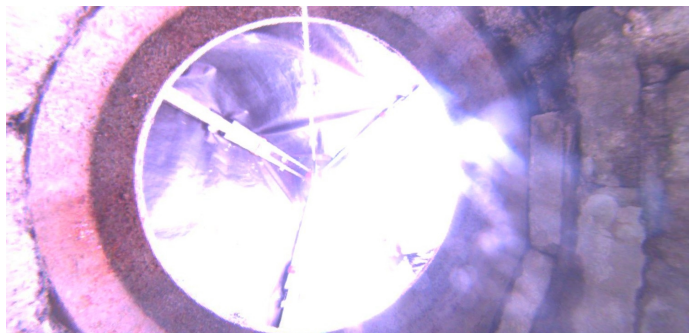
Code: **MGO**
Description: **General Observation**

Distance (ft): **2.3**
Structural Grade: **0**
O&M Grade: **0**
Clock Start/From:
Clock To:
1st Value:
2nd Value:
Value Percent:
Step: **NO**
Remarks: **UNDERSIDE OF FRAME**

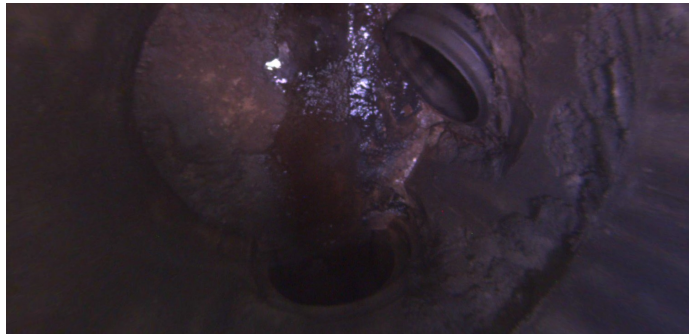
Code: **SSS**
Description: **Surface Spalling**

Distance (ft): **5.4**
Structural Grade: **2**
O&M Grade: **0**
Clock Start/From: **1**
Clock To: **4**
1st Value:
2nd Value:
Value Percent:
Step: **NO**
Remarks:

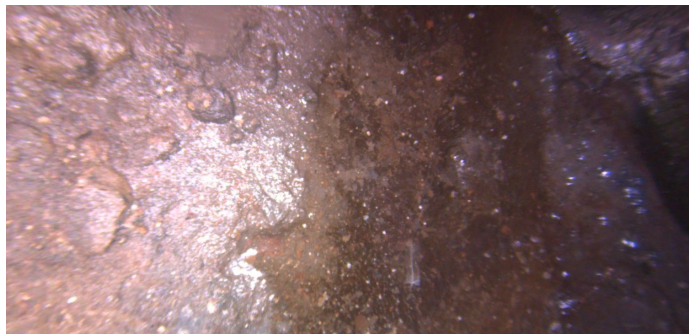
Code: **MGO**
Description: **General Observation**

Distance (ft): **8.9**
Structural Grade: **0**
O&M Grade: **0**
Clock Start/From:
Clock To:
1st Value:
2nd Value:
Value Percent:
Step: **NO**
Remarks: **END SURVEY**
