# Manhole Inspection Report

Date:	<b>04/17/2018</b>	Weather:		Coding:	<b>RZMACP</b>
MH#:	<b>M-707-071</b>	Owner:	<b>NA</b>	Len. Surveyed:	<b>4.7</b>
P.O.#:		Surveyor:	<b>John Kuglmaier</b>	Rim to Invert:	<b>4.9</b>
Customer:		Cert. #:	<b>U-1215-07002349</b>	Wall Material:	<b>Concrete (reinforced)</b>

Street:	<b>11th Pl. and 182' South of 11th St.</b>	Project:	<b>Hobart, IN</b>
City:	<b>Hobart, IN</b>	GPS Northing:	<b>2905821.607</b>
Location:		GPS Easting:	<b>2905821.607</b>
Drain Area:	<b>Southeast</b>	GPS Accuracy:	<b>Sub-Meter</b>
Cover Shape:	<b>Circular</b>	Evidence of Surcharge:	<b>No</b>
Cover Size:	<b>22.5</b>	Potential for Runoff:	<b>None</b>
Comments:

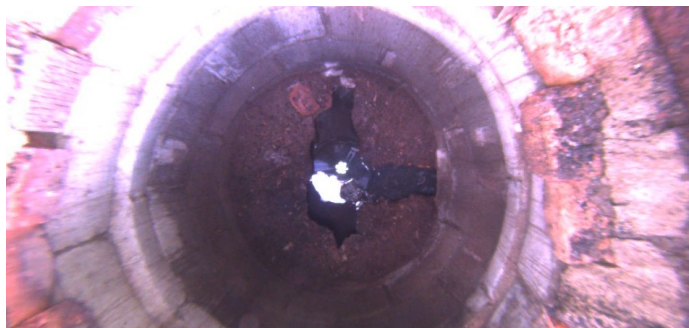
Code: **MGP**  
Description: **General Photo**

Distance (ft): **.0**  
Structural Grade: **0**  
O&M Grade: **0**  
Clock Start/From:  
Clock To:  
1st Value:  
2nd Value:  
Value Percent:  
Step: **NO**  
Remarks:

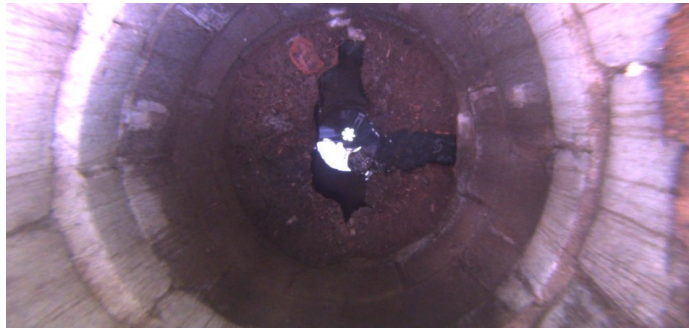
Code: **IS**  
Description: **Infil Stain**

Distance (ft): **.5**  
Structural Grade: **0**  
O&M Grade: **0**  
Clock Start/From: **12**  
Clock To: **12**  
1st Value:  
2nd Value:  
Value Percent:  
Step: **NO**  
Remarks:

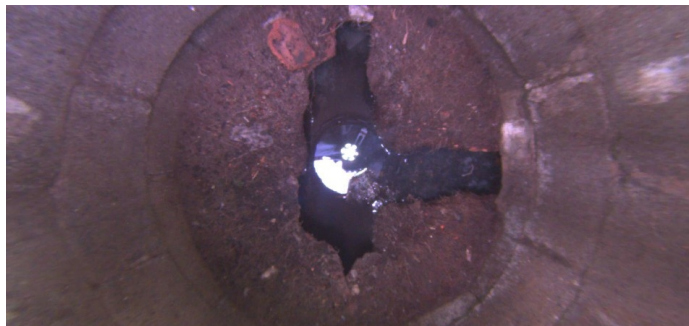
Code: **DAZ**  
Description: **Deposits Attached Other**

Distance (ft): **1.5**  
Structural Grade: **0**  
O&M Grade: **3**  
Clock Start/From: **12**  
Clock To: **12**  
1st Value:  
2nd Value:  
Value Percent: **15.000**  
Step: **NO**  
Remarks: **Mixed materials**

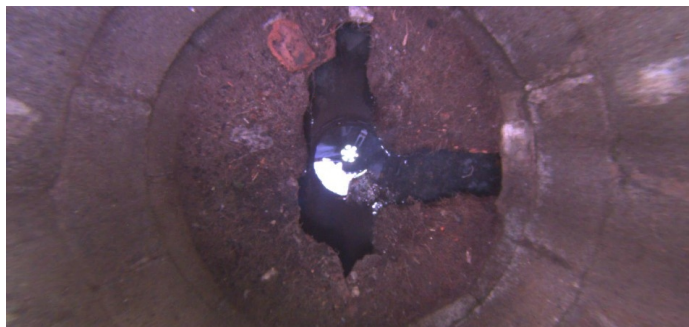
Code: **RMJ**  
Description: **Roots Medium Joint**

Distance (ft): **1.5**  
Structural Grade: **0**  
O&M Grade: **3**  
Clock Start/From: **12**  
Clock To: **12**  
1st Value:  
2nd Value:  
Value Percent: **5.000**  
Step: **NO**  
Remarks:

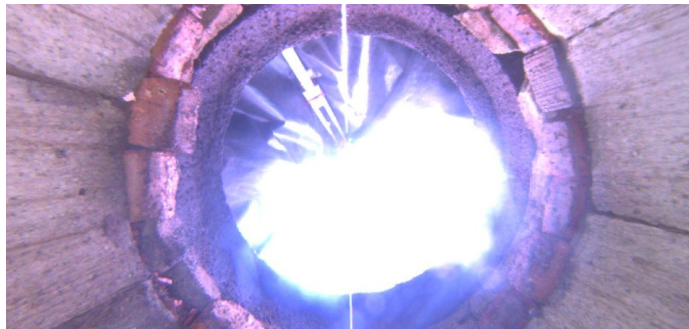
Code: **MGP**  
Description: **General Photo**

Distance (ft): **2.5**  
Structural Grade: **0**  
O&M Grade: **0**  
Clock Start/From:  
Clock To:  
1st Value:  
2nd Value:  
Value Percent:  
Step: **NO**  
Remarks:

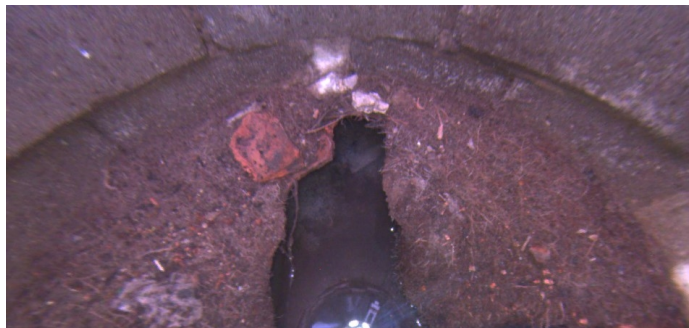
Code: **OBB**  
Description: **Obstacle Brick**

Distance (ft): **2.8**  
Structural Grade: **0**  
O&M Grade: **2**  
Clock Start/From: **11**  
Clock To:  
1st Value:  
2nd Value:  
Value Percent: **5.000**  
Step: **NO**  
Remarks:

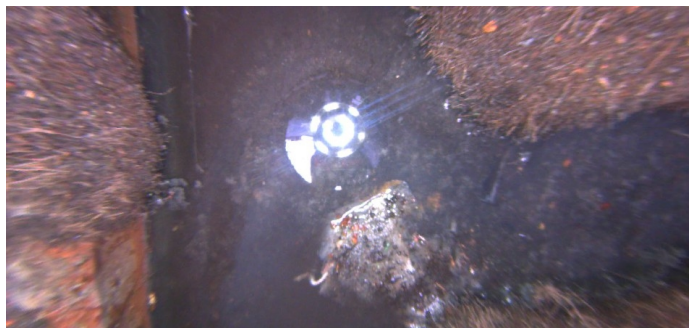
Code: **MGO**  
Description: **General Observation**

Distance (ft): **3.9**  
Structural Grade: **0**  
O&M Grade: **0**  
Clock Start/From:  
Clock To:  
1st Value:  
2nd Value:  
Value Percent:  
Step: **NO**  
Remarks: **Ins. Comp.**
