# Manhole Inspection Report

Date:	<b>04/16/2018</b>	Weather:		Coding:	<b>RZMACP</b>
MH#:	<b>M-707-077</b>	Owner:	<b>NA</b>	Len. Surveyed:	<b>4.3</b>
P.O.#:		Surveyor:	<b>John Kuglmaier</b>	Rim to Invert:	<b>4.4</b>
Customer:		Cert. #:	<b>U-1215-07002349</b>	Wall Material:	<b>Concrete (reinforced)</b>

Street:	<b>13th St. 442' West of State St.</b>	Project:	<b>Hobart, IN</b>
City:	<b>Hobart, IN</b>	GPS Northing:	<b>2905783.077</b>
Location:		GPS Easting:	<b>2905783.077</b>
Drain Area:	<b>Southeast</b>	GPS Accuracy:	<b>Sub-Meter</b>
Cover Shape:	<b>Circular</b>	Evidence of Surcharge:	<b>Yes</b>
Cover Size:	<b>29.0</b>	Potential for Runoff:	<b>None</b>
Comments:

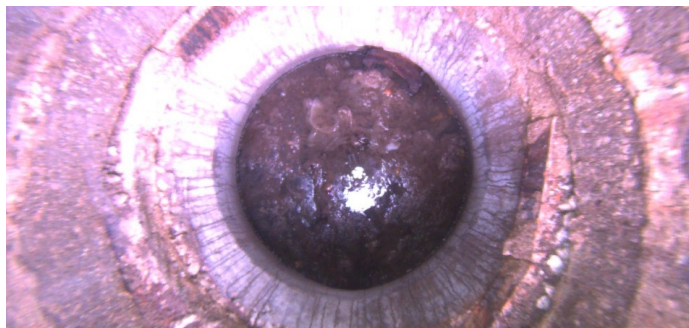
Code: **MGP**  
Description: **General Photo**

Distance (ft): **.0**  
Structural Grade: **0**  
O&M Grade: **0**  
Clock Start/From:  
Clock To:  
1st Value:  
2nd Value:  
Value Percent:  
Step: **NO**  
Remarks:

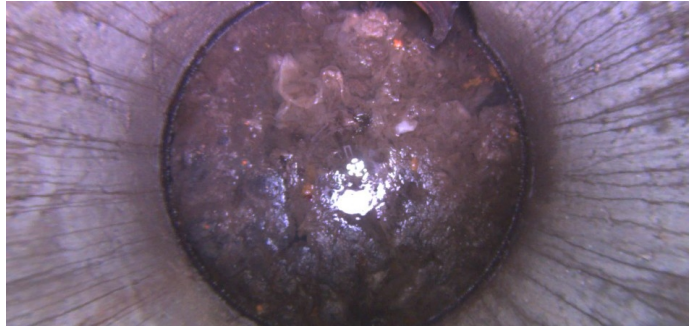
Code: **MGO**  
Description: **General Observation**

Distance (ft): **1.7**  
Structural Grade: **0**  
O&M Grade: **0**  
Clock Start/From:  
Clock To:  
1st Value:  
2nd Value:  
Value Percent:  
Step: **NO**  
Remarks: **Surcharge**

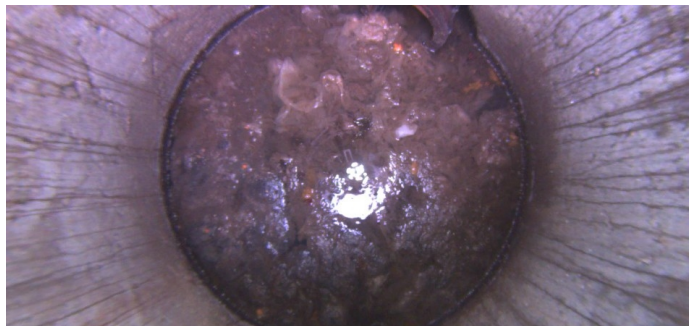
Code: **DAZ**  
Description: **Deposits Attached Other**

Distance (ft): **1.7**  
Structural Grade: **0**  
O&M Grade: **3**  
Clock Start/From: **12**  
Clock To: **12**  
1st Value:  
2nd Value:  
Value Percent: **15.000**  
Step: **NO**  
Remarks: **Mixed materials**

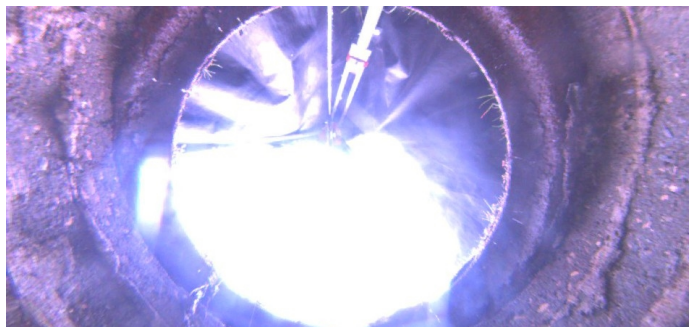
Code: **MGP**  
Description: **General Photo**

Distance (ft): **1.8**  
Structural Grade: **0**  
O&M Grade: **0**  
Clock Start/From:  
Clock To:  
1st Value:  
2nd Value:  
Value Percent:  
Step: **NO**  
Remarks:

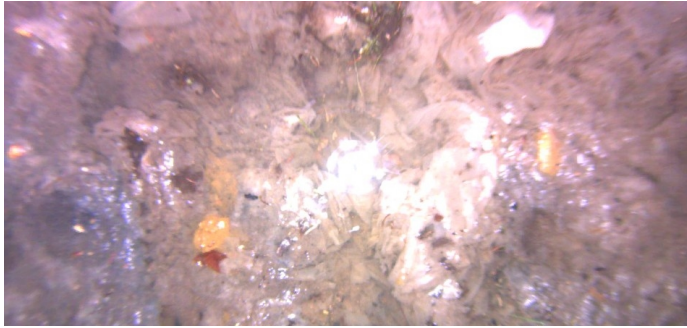
Code:	<b>MGO</b>
Description:	<b>General Observation</b>
Distance (ft):	<b>3.7</b>
Structural Grade:	<b>0</b>
O&M Grade:	<b>0</b>
Clock Start/From:	
Clock To:	
1st Value:	
2nd Value:	
Value Percent:	
Step:	<b>NO</b>
Remarks:	<b>Ins. Comp.</b>
