# Manhole Inspection Report

Date:	<b>04/18/2018</b>	Weather:		Coding:	<b>RZMACP</b>
MH#:	<b>M-708-005</b>	Owner:	<b>NA</b>	Len. Surveyed:	<b>4.9</b>
P.O.#:		Surveyor:	<b>John Kuglmaier</b>	Rim to Invert:	<b>5.4</b>
Customer:		Cert. #:	<b>U-1215-07002349</b>	Wall Material:	<b>Concrete (reinforced)</b>

Street:	<b>Intersection of State St. and 16th St.</b>	Project:	<b>Hobart, IN</b>
City:	<b>Hobart, IN</b>	GPS Northing:	<b>2906180.996</b>
Location:		GPS Easting:	<b>2906180.996</b>
Drain Area:	<b>Southeast</b>	GPS Accuracy:	<b>Sub-Meter</b>
Cover Shape:	<b>Circular</b>	Evidence of Surcharge:	<b>No</b>
Cover Size:	<b>22.5</b>	Potential for Runoff:	<b>None</b>
Comments:

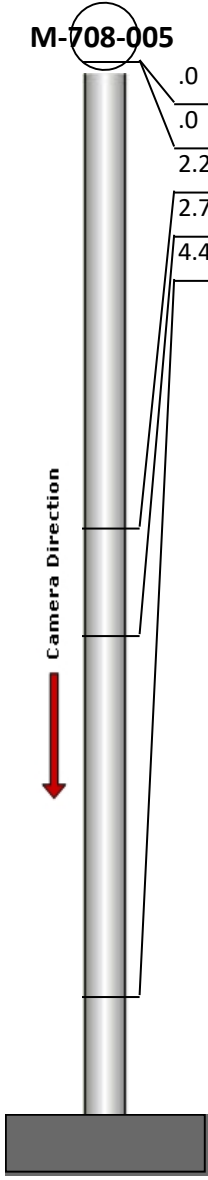
.0	MGP	General Photo	10	NA
	.0	RFJ	Roots Fine Joint	22	M 1
	2.2	MGP	General Photo	40	NA
	2.7	DSF	Deposits Settled Fine	55	M 2
	4.4	MGO	General Observation	70	NA

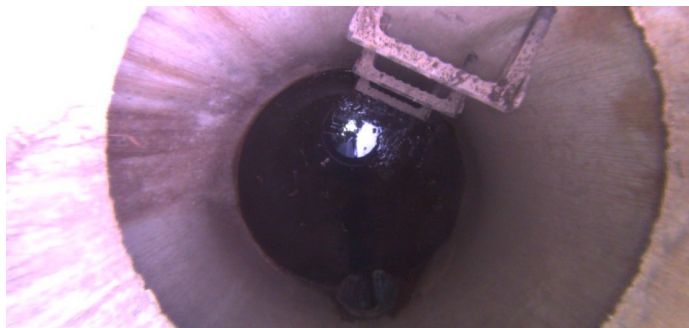
Code: **MGP**  
Description: **General Photo**

Distance (ft): **.0**  
Structural Grade: **0**  
O&M Grade: **0**  
Clock Start/From:  
Clock To:  
1st Value:  
2nd Value:  
Value Percent:  
Step: **NO**  
Remarks:

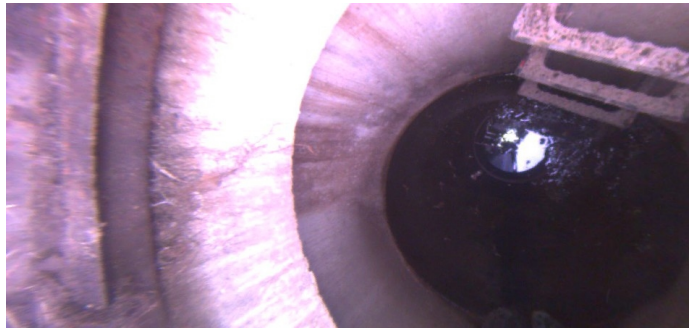
Code: **RFJ**  
Description: **Roots Fine Joint**

Distance (ft): **.0**  
Structural Grade: **0**  
O&M Grade: **1**  
Clock Start/From: **8**  
Clock To:  
1st Value:  
2nd Value:  
Value Percent:  
Step: **NO**  
Remarks:

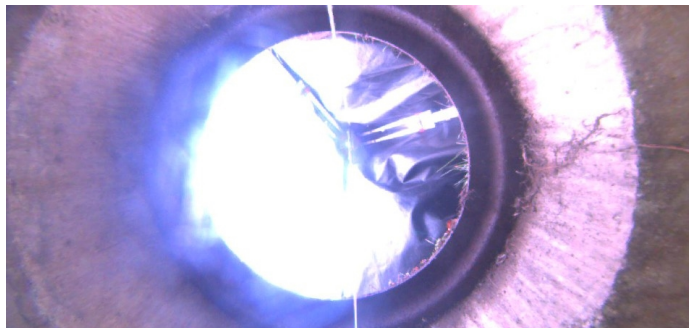
Code: **MGP**  
Description: **General Photo**

Distance (ft): **2.2**  
Structural Grade: **0**  
O&M Grade: **0**  
Clock Start/From:  
Clock To:  
1st Value:  
2nd Value:  
Value Percent:  
Step: **NO**  
Remarks:

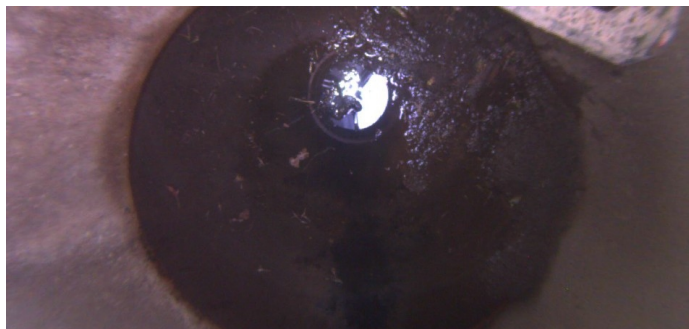
Code: **DSF**  
Description: **Deposits Settled Fine**

Distance (ft): **2.7**  
Structural Grade: **0**  
O&M Grade: **2**  
Clock Start/From: **12**  
Clock To: **12**  
1st Value:  
2nd Value:  
Value Percent: **10.000**  
Step: **NO**  
Remarks:

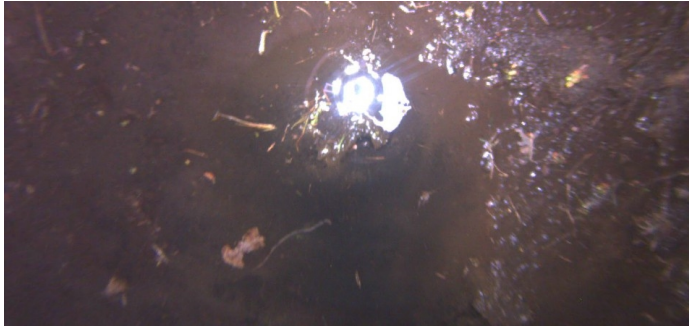
Code:	<b>MGO</b>
Description:	<b>General Observation</b>
Distance (ft):	<b>4.4</b>
Structural Grade:	<b>0</b>
O&M Grade:	<b>0</b>
Clock Start/From:	
Clock To:	
1st Value:	
2nd Value:	
Value Percent:	
Step:	<b>NO</b>
Remarks:	<b>Ins. Comp.</b>
