Manhole Inspection Report

Date:	11/02/2022	Weather:		Coding:	RZMACP
MH#:	M-708-018	Owner:	NA	Len. Surveyed:	3.5
P.O.#:		Surveyor:	Jen Costello	Rim to Invert:	4.5
Customer:		Cert. #:	U-907-5518	Wall Material:	Concrete (non-reinforced)

Street:	Hidden Oak Trail. Woodward Trail.	Project:	Missing GPS
City:	Hobart, IN	GPS Northing:	2280781.502
Location:		GPS Easting:	2906974.175
Drain Area:	Southwest	GPS Accuracy:	Sub-Meter
Cover Shape:	Circular	Evidence of Surcharge:	No
Cover Size:	24.0	Potential for Runoff:	None
Comments:

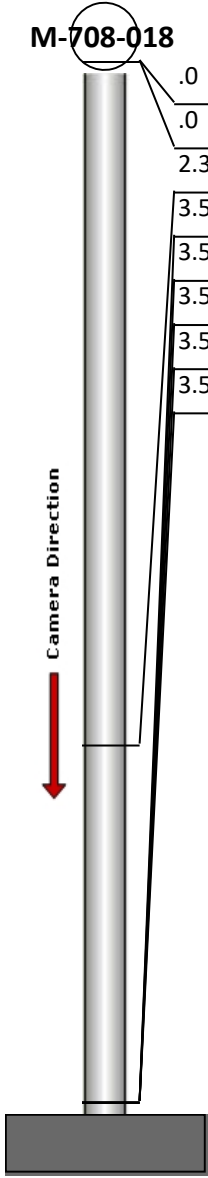
.0	MGO	General Observation	10	NA
	.0	SRI	Surface Roughness Increased	21	S 1
	2.3	SSS	Surface Spalling	38	S 2
	3.5	SAV	Surface Aggregate Visible	53	S 3
	3.5	DSF	Deposits Settled Fine	64	M 2
	3.5	MGO	General Observation	76	NA
	3.5	SRI	Surface Roughness Increased	87	S 1
	3.5	SAV	Surface Aggregate Visible	98	S 3

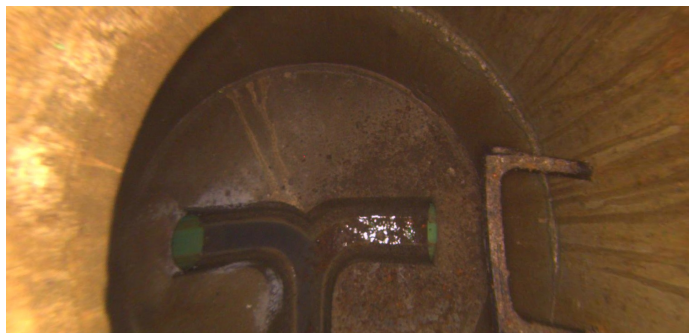
Code: **MGO**
Description: **General Observation**

Distance (ft): **.0**
Structural Grade: **0**
O&M Grade: **0**
Clock Start/From:
Clock To:
1st Value:
2nd Value:
Value Percent:
Step: **NO**
Remarks: **access mh**

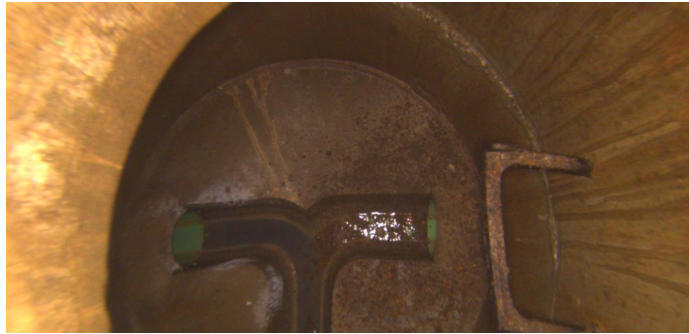
Code:	SRI
Description:	Surface Roughness Increased
Distance (ft):	.0
Structural Grade:	1
O&M Grade:	0
Clock Start/From:	12
Clock To:	12
1st Value:	
2nd Value:	
Value Percent:	
Step:	NO
Remarks:

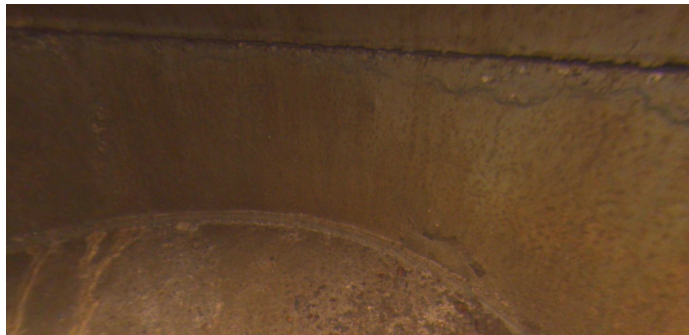
Code:	SSS
Description:	Surface Spalling
Distance (ft):	2.3
Structural Grade:	2
O&M Grade:	0
Clock Start/From:	12
Clock To:	12
1st Value:	
2nd Value:	
Value Percent:	
Step:	NO
Remarks:

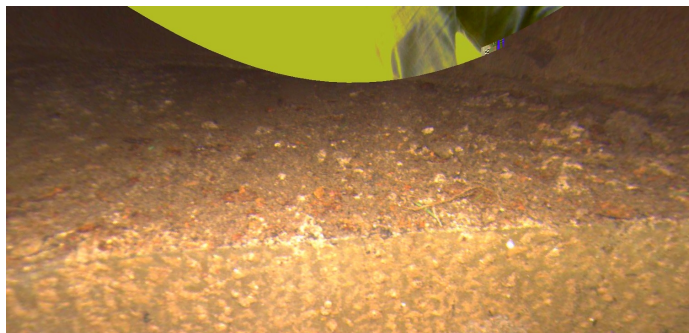
Code:	SAV
Description:	Surface Aggregate Visible
Distance (ft):	3.5
Structural Grade:	3
O&M Grade:	0
Clock Start/From:	12
Clock To:	12
1st Value:	
2nd Value:	
Value Percent:	
Step:	NO
Remarks:

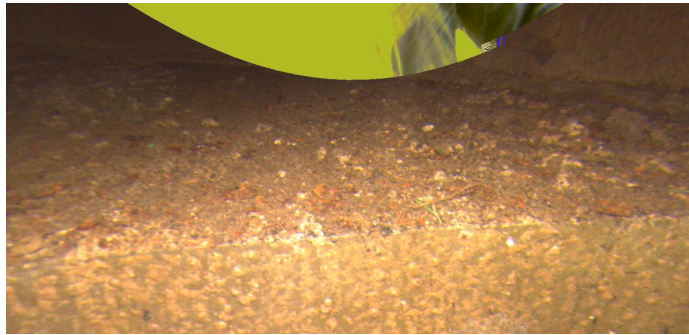
Code: **DSF**
Description: **Deposits Settled Fine**

Distance (ft): **3.5**
Structural Grade: **0**
O&M Grade: **2**
Clock Start/From: **12**
Clock To: **12**
1st Value:
2nd Value:
Value Percent: **5.000**
Step: **NO**
Remarks:

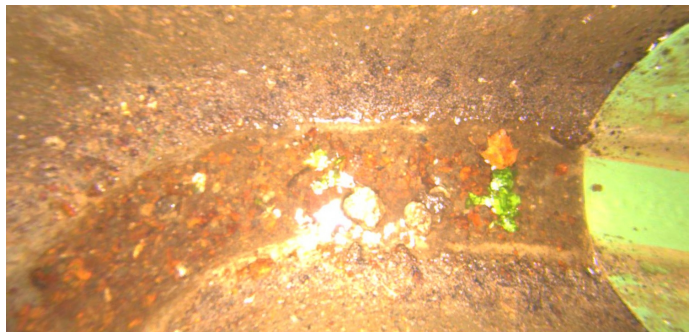
Code: **MGO**
Description: **General Observation**

Distance (ft): **3.5**
Structural Grade: **0**
O&M Grade: **0**
Clock Start/From:
Clock To:
1st Value:
2nd Value:
Value Percent:
Step: **NO**
Remarks: **end of survey**

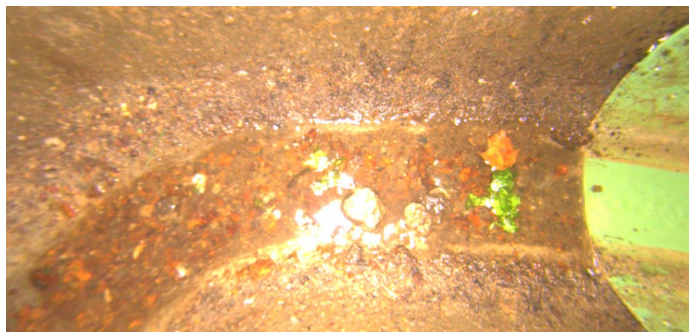
Code: **SRI**
Description: **Surface Roughness Increased**

Distance (ft): **3.5**
Structural Grade: **1**
O&M Grade: **0**
Clock Start/From: **12**
Clock To: **12**
1st Value:
2nd Value:
Value Percent:
Step: **NO**
Remarks:

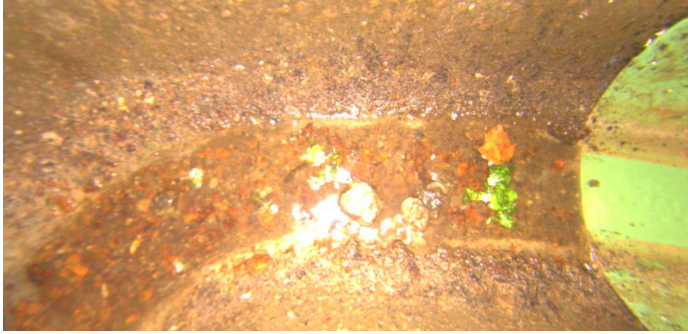
Code:	SAV
Description:	Surface Aggregate Visible
Distance (ft):	3.5
Structural Grade:	3
O&M Grade:	0
Clock Start/From:	3
Clock To:	9
1st Value:	
2nd Value:	
Value Percent:	
Step:	NO
Remarks:
