Manhole Inspection Report

Date:	04/19/2018	Weather:		Coding:	RZMACP
MH#:	M-708-103	Owner:	NA	Len. Surveyed:	8.2
P.O.#:		Surveyor:	John Kuglmaier	Rim to Invert:	8.9
Customer:		Cert. #:	U-1215-07002349	Wall Material:	Concrete (reinforced)

Street:	Bracken Parkway. 710' East of Lake	Project:	Hobart, IN
City:	Hobart, IN	GPS Northing:	2905382.854
Location:		GPS Easting:	2905382.854
Drain Area:	Southwest	GPS Accuracy:	Sub-Meter
Cover Shape:	Circular	Evidence of Surcharge:	No
Cover Size:	22.5	Potential for Runoff:	None
Comments:

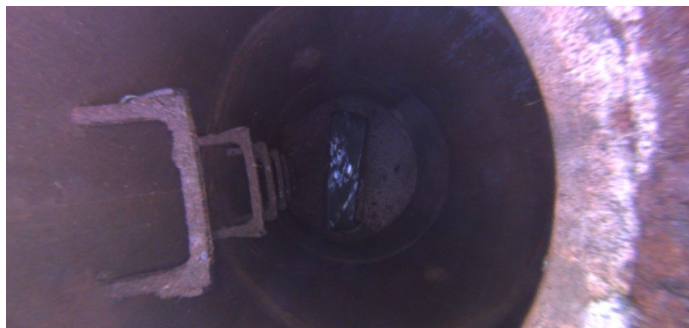
Code: **MGP**
Description: **General Photo**

Distance (ft): **.0**
Structural Grade: **0**
O&M Grade: **0**
Clock Start/From:
Clock To:
1st Value:
2nd Value:
Value Percent:
Step: **NO**
Remarks:

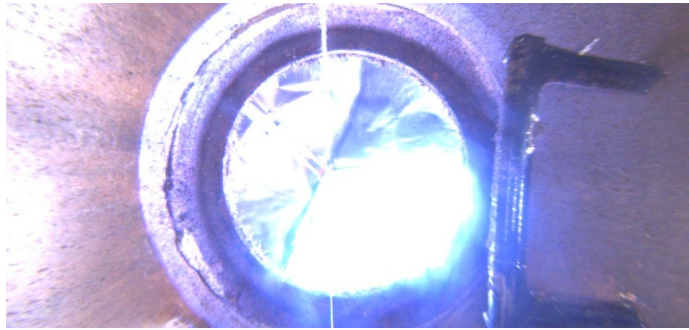
Code: **MGP**
Description: **General Photo**

Distance (ft): **2.7**
Structural Grade: **0**
O&M Grade: **0**
Clock Start/From:
Clock To:
1st Value:
2nd Value:
Value Percent:
Step: **NO**
Remarks:

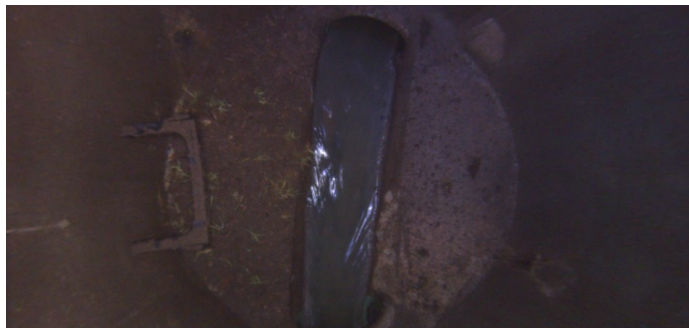
Code: **DSF**
Description: **Deposits Settled Fine**

Distance (ft): **5.3**
Structural Grade: **0**
O&M Grade: **2**
Clock Start/From: **6**
Clock To: **12**
1st Value:
2nd Value:
Value Percent: **5.000**
Step: **NO**
Remarks:

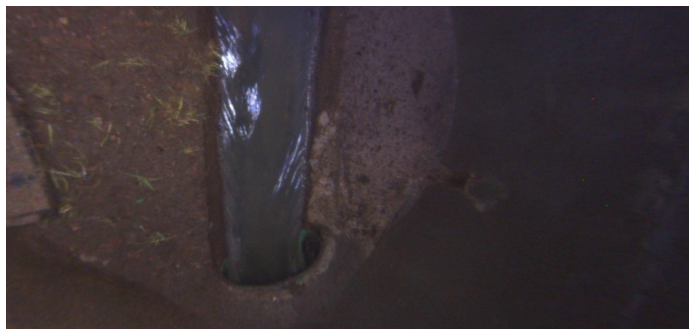
Code: **IS**
Description: **Infil Stain**

Distance (ft): **6.1**
Structural Grade: **0**
O&M Grade: **0**
Clock Start/From: **4**
Clock To:
1st Value:
2nd Value:
Value Percent:
Step: **NO**
Remarks:

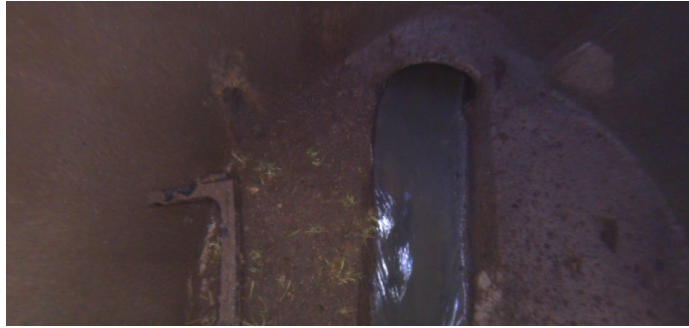
Code: **IS**
Description: **Infil Stain**

Distance (ft): **6.1**
Structural Grade: **0**
O&M Grade: **0**
Clock Start/From: **10**
Clock To:
1st Value:
2nd Value:
Value Percent:
Step: **NO**
Remarks:

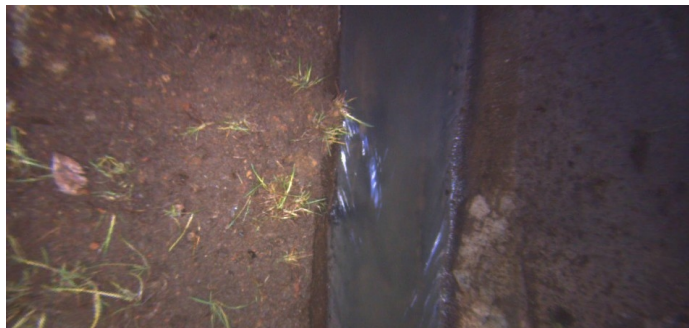
Code: **MGO**
Description: **General Observation**

Distance (ft): **7.1**
Structural Grade: **0**
O&M Grade: **0**
Clock Start/From:
Clock To:
1st Value:
2nd Value:
Value Percent:
Step: **NO**
Remarks: **Ins. Comp.**
